Following are few bullet points about the WEAK Symbol Bug:

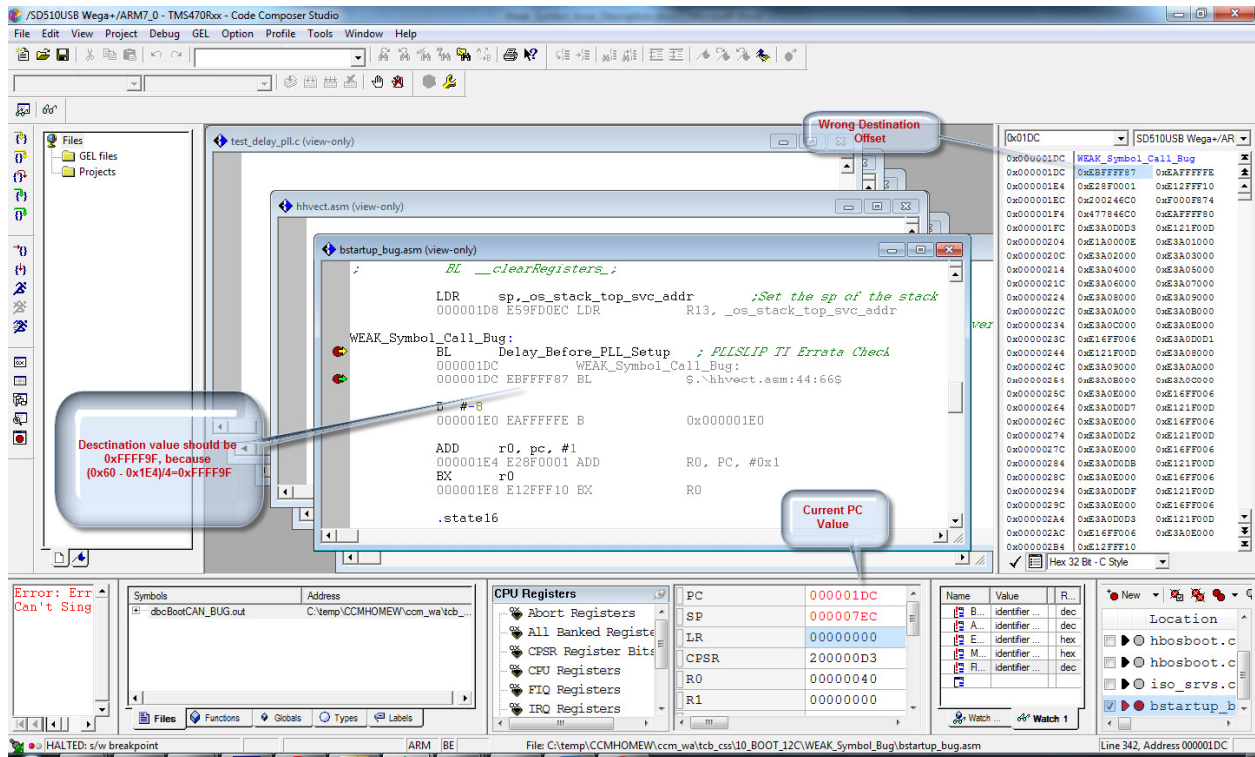
6> The problem is in dbcBootCAN\_BUG.out file and not within dbcBootCAN\_BUG.hex file as I have loaded dbcBootCAN\_BUG.out file in debugger and verified the result.

7> Shown below is the Code Composer Dump during “BL Delay\_Before\_PLL\_Setup” instruction, when I loaded dbcBootCAN\_BUG.out file into the ARM7TDMI CPU and ran it.

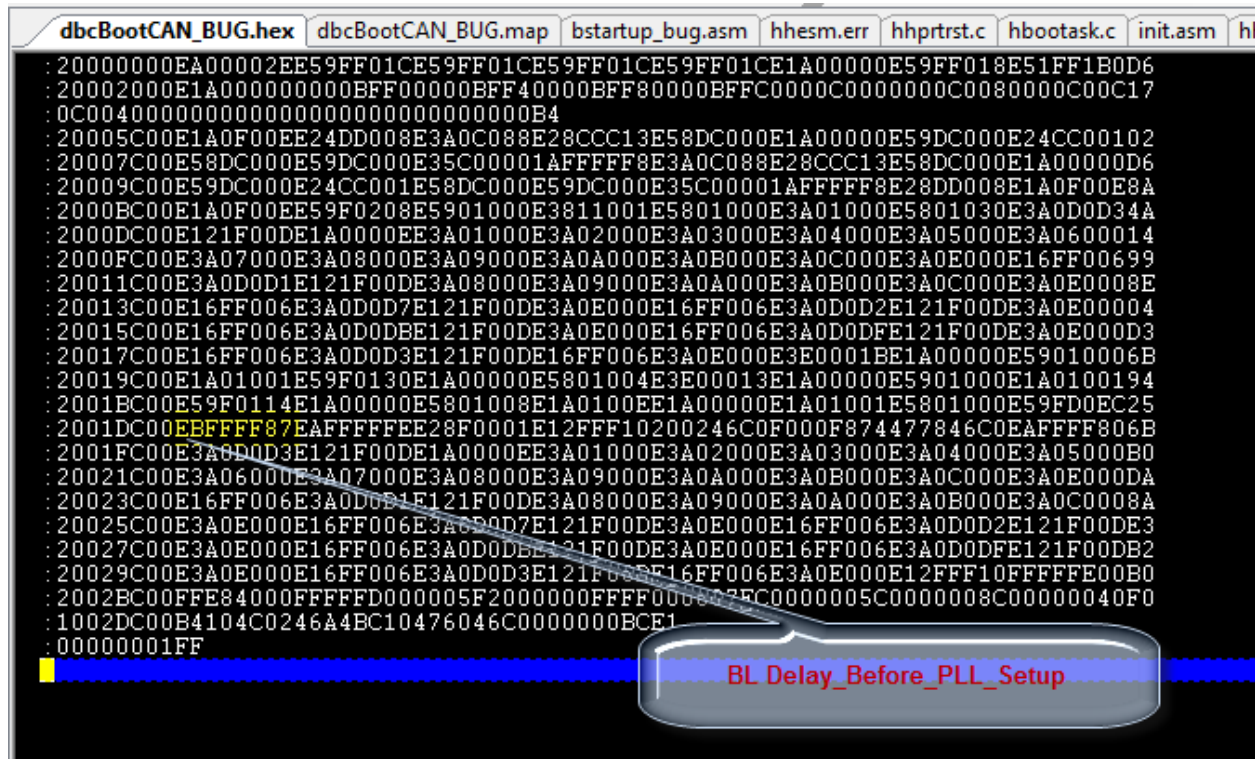
Hence, the expected value at address 0x1DC within HEX file output should be:

0xEBFFFF9F, where

6> In the HEX file at that address you will see instead

0xEBFFFF87

8> Below is a snapshot of dbcBootCAN\_BUG.hex, showing the wrong OFFSET Address for “BL Delay\_Before\_PLL\_Setup” instruction as present within bstartup\_bug.asm file.
