Schematic

Troubleshooting – Ethernet waveforms

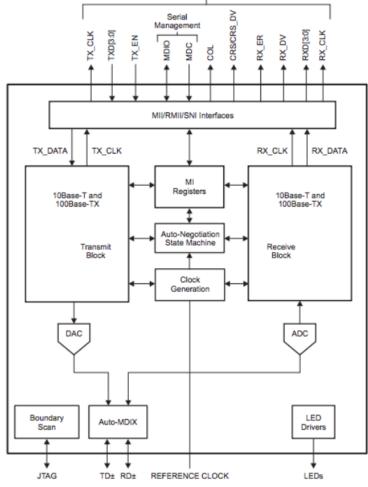
Figure 2-1. Device Block Diagram

MII/RMII/SNI

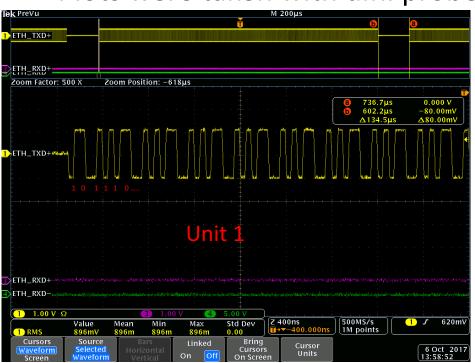
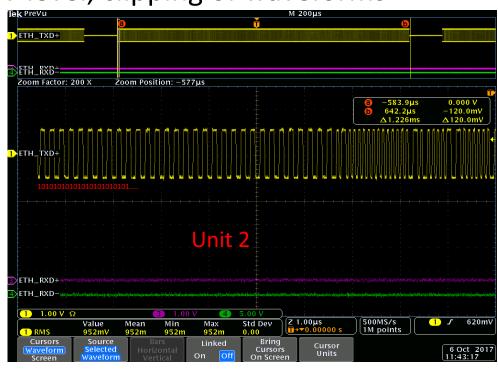
- Start of frame
- Plots were taken with diff. probe at 850mV level, clipping of waveforms

Preamble appears to be incorrect
