DESIGN

Two-chip solution of TFP401 and SN75LVDS83B used to convert DVI input to LVDS output.

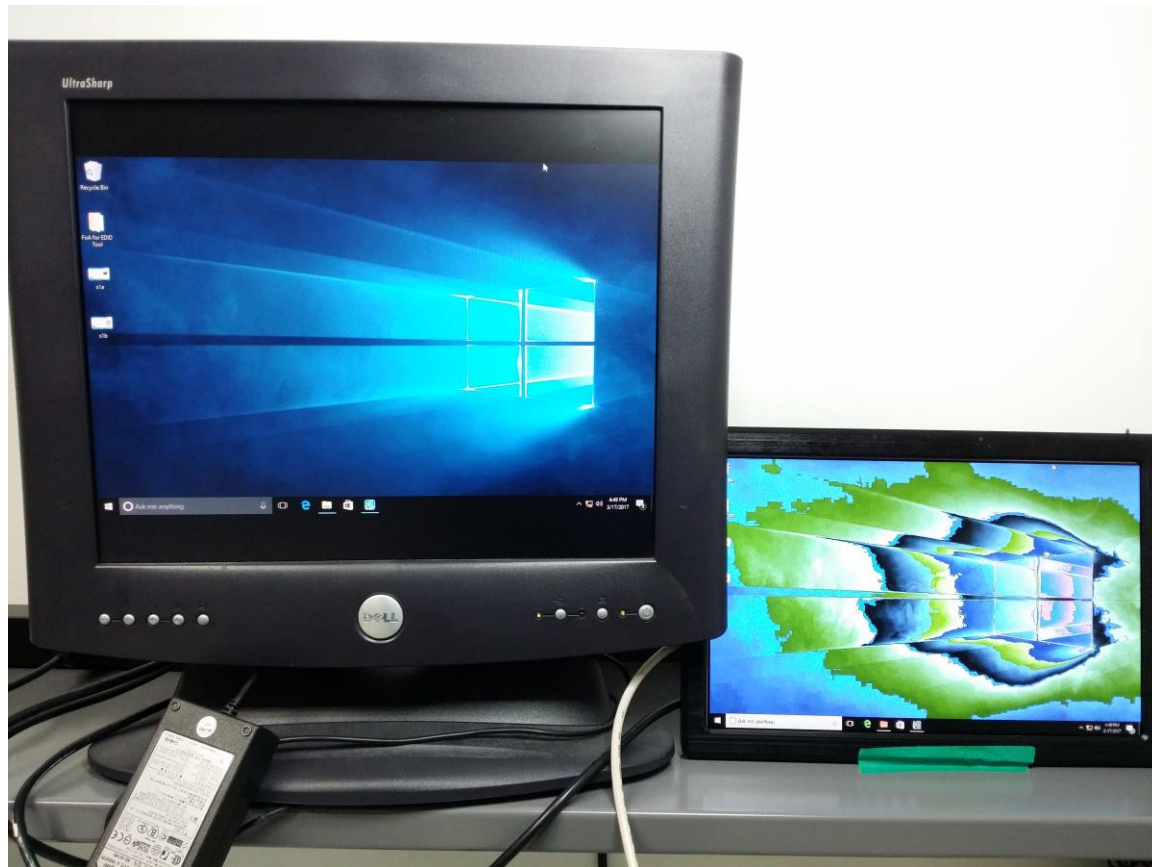
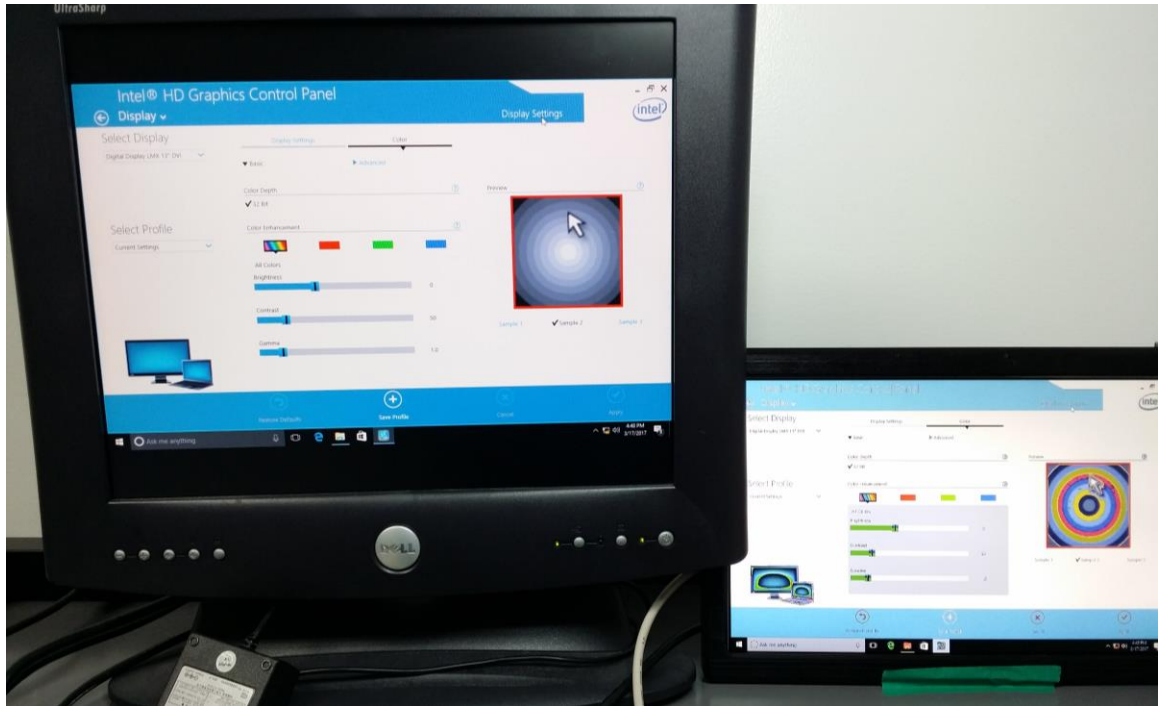
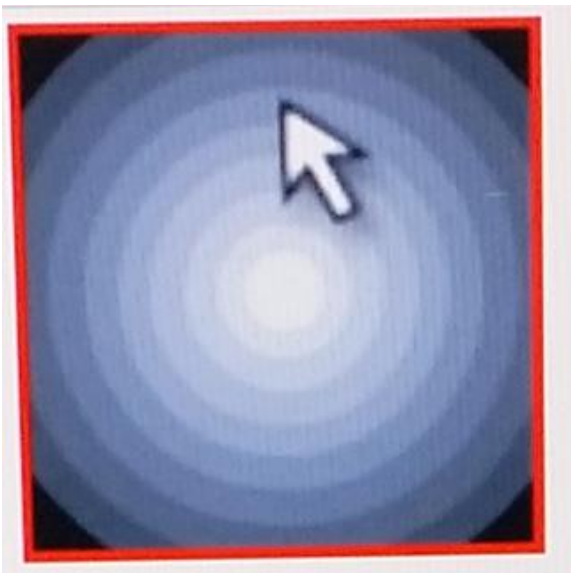
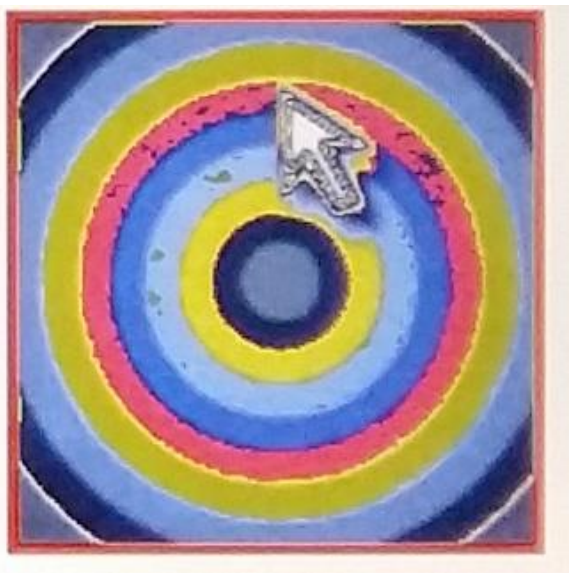
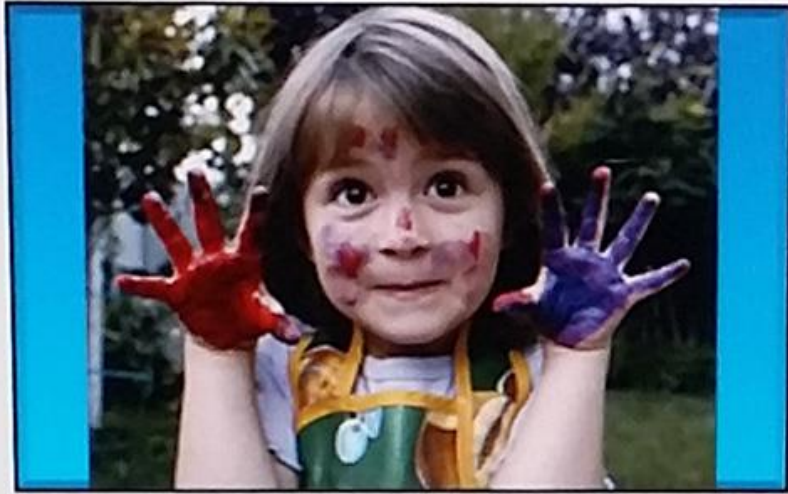
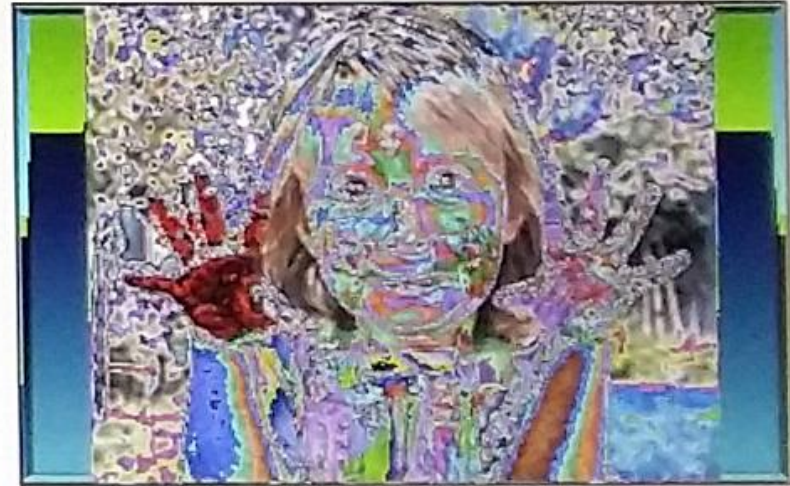
Resulting video image is messed up. "True" Red, Green, Blue, Black and White all seem to be relatively okay, but all other colors are very incorrect, with ridged lines rather than smooth color gradients. Also, the text is not crisp. See images below (working image on left side, bad image on right side).

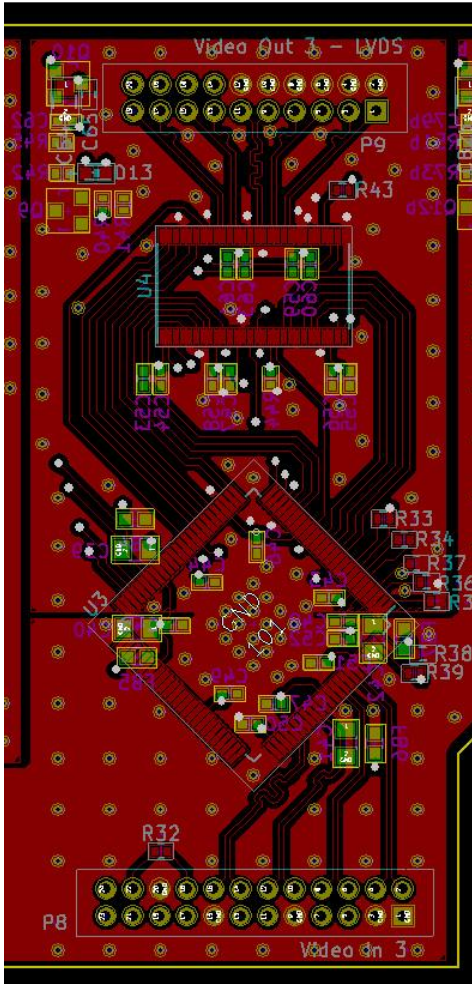
Top Layer

NOTE: Top and Bottom layer footprints visible on all layers.

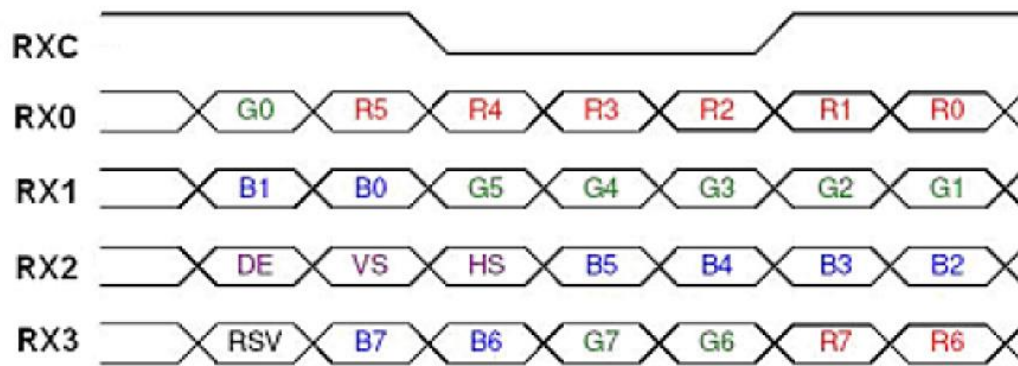
PANEL SPECS

- TFT LCD Monitor
- WXGA (1280 x 800 pixels) resolution
- 16.2M colors

FRC = "High" for 8 bits LVDS Input
