Product Test Report

Manufacturer: TI**Model / PN: THS4521IDR****Sample Qty.: 4 PCS****Date Received: 2023/08/10****Approved by:** 刘敏颖**Checked by:** 刘建锦**Prepared by:** 周子勤**Seal of Testing Center****Date Reported:** 2023-08-22

1. Test Purpose

The tests are performed to found the root cause of failed samples.

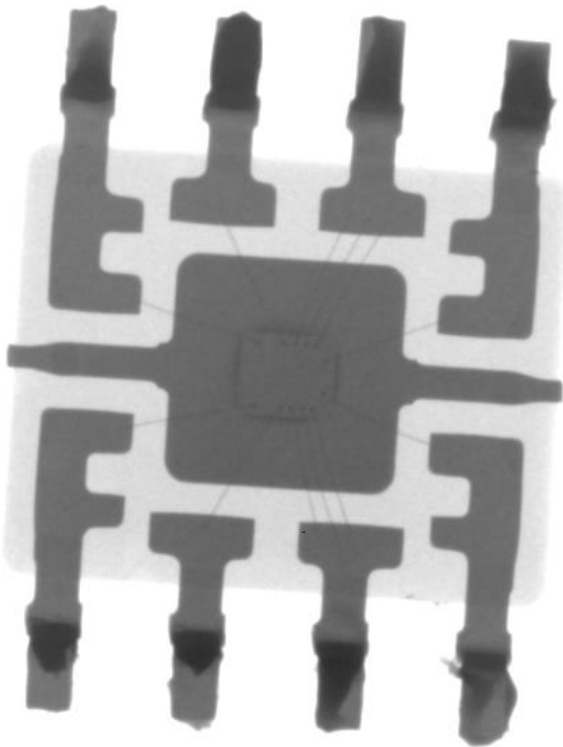
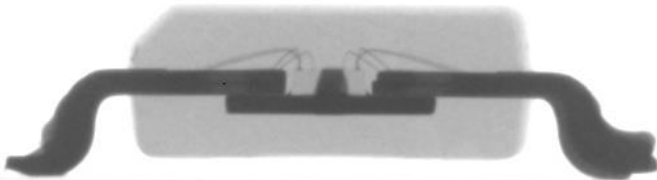
No.	Top View
NG1

No anomaly was found in the internal structure of the sample. The internal structure of the three samples is consistent.
