• CRU Description:

Unit#1: no voice

• FA Result:

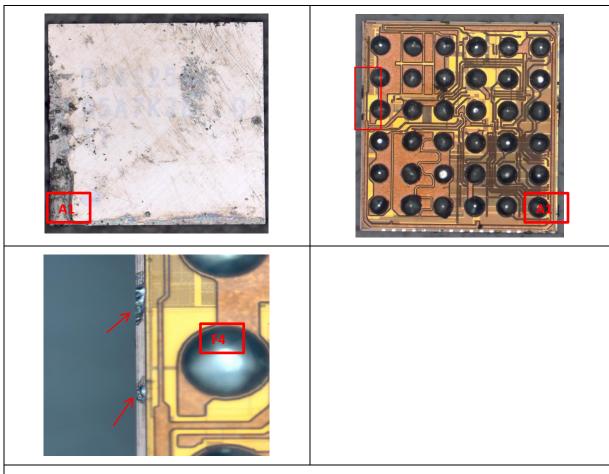
Unit#1 is observed damage and cannot do any further analysis.

Unit#1was damaged at power supply or GND metal line or inner circuit, so the unit would possible fail as no voice, low voice, or no output.
