To TI Support:

Below please find the “schematic” and PCB layout you requested. Unfortunately, this design was performed more than 20 years ago, and the schematic entry and PCB layout were both carried out using tools that are now lost to the ages. As a result, the full schematic is no longer available. Likewise, for the PCB artwork, a print of the resulting Gerber data is all that remains. The board doesn’t have a silkscreen, but I’ve highlighted the component placement as best I could on the attached Gerber plots (see below).

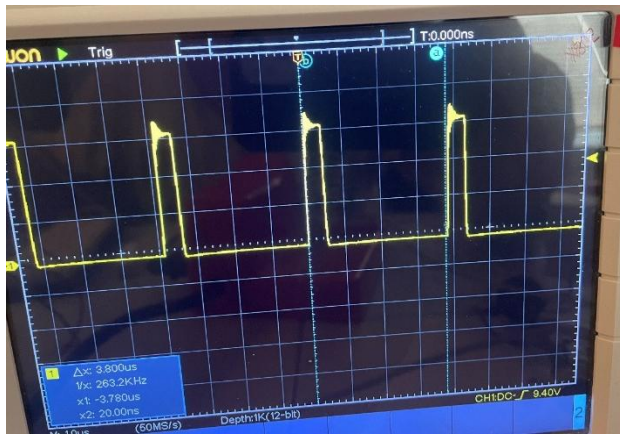
Trace 2) Switch output while scope probe is on current limit adjust pin (all-out current limit ??)

Three scope traces are attached. The first shows the switch output of the LM2679. This capture was taken after the board was running for ~1 hour. The switch output remained stable throughout that time. The 2nd scope trace came as a result of probing the current limit adjust pin of the LM2679 at the end of the 1 hour. As soon as the scope probe comes in contact with the current limit adjust pin, the part immediately goes into what appears to be an all-out current limit. The third trace shows the switch output after the scope probe on the current limit adjust pin was removed. The LM2679 was unwilling/unable to return to a stable switching state. But, if the scope probe on the switch output is then removed for an instant, and immediately put back in place, the switch output has now returned to the stable state as shown in the first capture. I can probe other pins on the LM2679, but any attempt to examine the current limit adjust pin has a quite detrimental effect on the switch waveform. Putting a capacitor between the current limit adjust pin and ground per your suggestion has the same effect. So, for whatever reason, something in my design is making the LM2679 current adjust circuit extremely sensitive. Thanks for any thoughts or suggestions you might have.

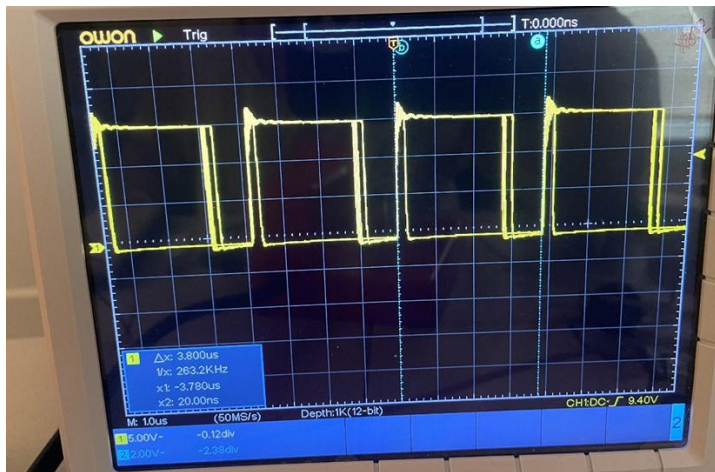
Trace 3) Unstable switch output after scope probe on current limit adjust pin is removed. (subsequently removing scope probe from the switch output for an instant returns the switch output to the stable state shown in Trace 1)
