# Inquiring about abnormal output characteristics of

## TI TPS7A2036DBVR

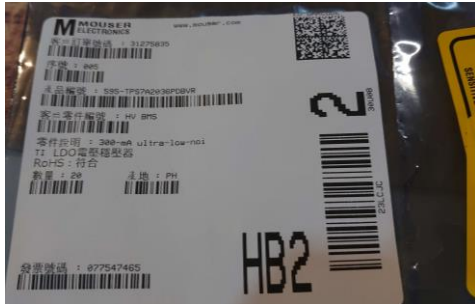
After purchasing the TPS7A2036DBVR from Mouser, I conducted detailed circuit testing and found highly abnormal waveforms at the output. I hope TI can provide some technical support or problem analysis.

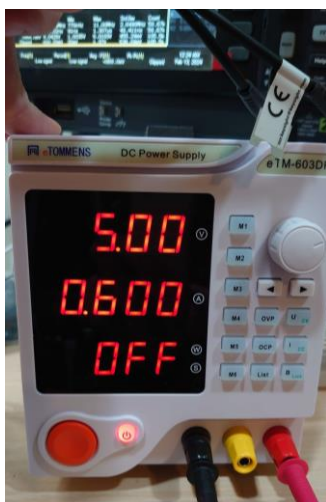
- c. The input power is supplied to the experimental circuit using an adjustable linear power supply, adjusted to provide a 5V output at 0.6A CC. Later, to rule out potential supply-related issues, I adjusted it to 3A CC, but it had no effect on the abnormal behavior.

The voltage waveform at the input breakpoint on the Breadboard is depicted in the provided image. This waveform was recorded when there was a 20 $\Omega$  load at the LDO output. The peak-to-peak voltage is approximately 2mV under no-load conditions.

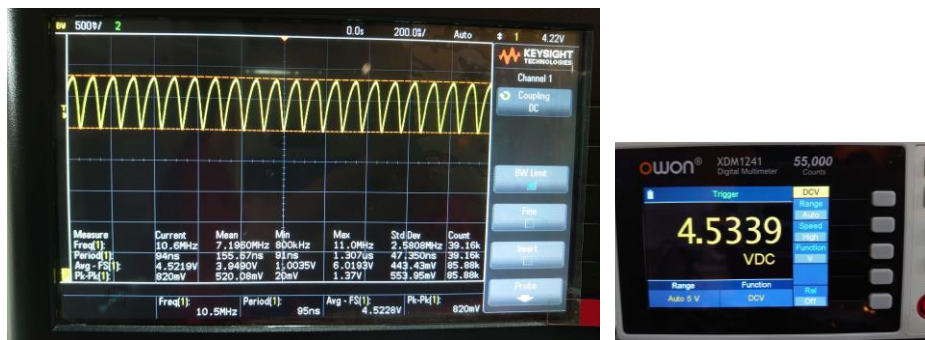
- a. Under no-load conditions, the LDO can output 3.6V as measured using a desktop multimeter. Additionally, in AC coupling mode on the oscilloscope, there is no significant ripple observed. Everything appears to be normal under this condition.
- b. Subsequently, when applying a 330Ω load between the output and GND, the output starts to behave abnormally. Significant voltage ripple can be observed on the oscilloscope, and measurement with a desktop multimeter reveals an output voltage of 4.53V, as shown in the image.
