CUSTOMER RETURNED FAR / CAR

FA Report #:	FAR250587	Customer:	DURA AUTOMOTIVE PVT LTD
Package:	Mini DomiLED	Requestor:	Hemaraj Balakrishna
Dominant Part Number:	DNW-PJG-V2W-I1L3	Received Date:	30.04.2025
Customer Part Number:	NA	Response Date:	08.05.2025 09.05.2025 Updated
Lot No.:	D24505EC.01 (B6X7)	Quantity Received:	2 PCB modules
		Quantity Analyzed:	2 pieces LEDs

1.0 BACKGROUND

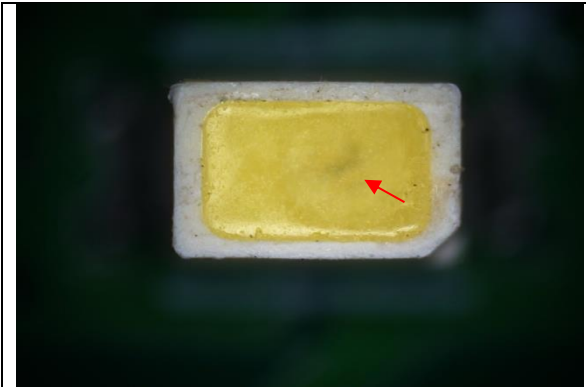
2.1 The complained LEDs were proceeded for optical inspection via high power scope; it revealed blackish appearance at inner package for No Short Circuit LED while no anomaly for Short Circuit LED, as shown in Fig 2a - Fig 2d.

<p>Fig 2a : No Short Circuit LED: Top view observed blackish appearance at inner package</p>	<p>Fig 2b : No Short Circuit LED: Side view observed no anomaly on soldering</p>

- 3.1 Optical inspection revealed blackish appearance at inner package for No Short Circuit LED while no anomaly for Short Circuit LED.
- 3.2 X-ray inspection revealed no anomaly.

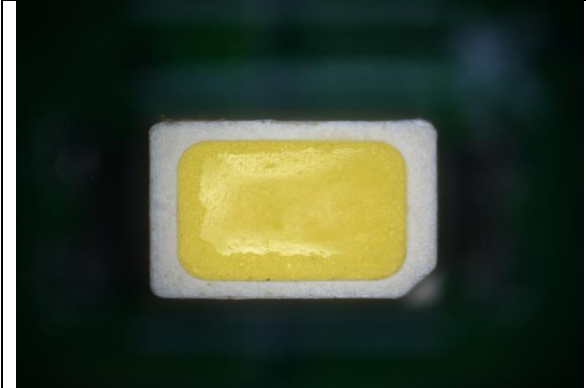
<p>Fig 2c : Short Circuit LED: Top view observed no anomaly on top encapsulant surface</p>	<p>Fig 2d : Short Circuit LED: Side view observed no anomaly on soldering</p>

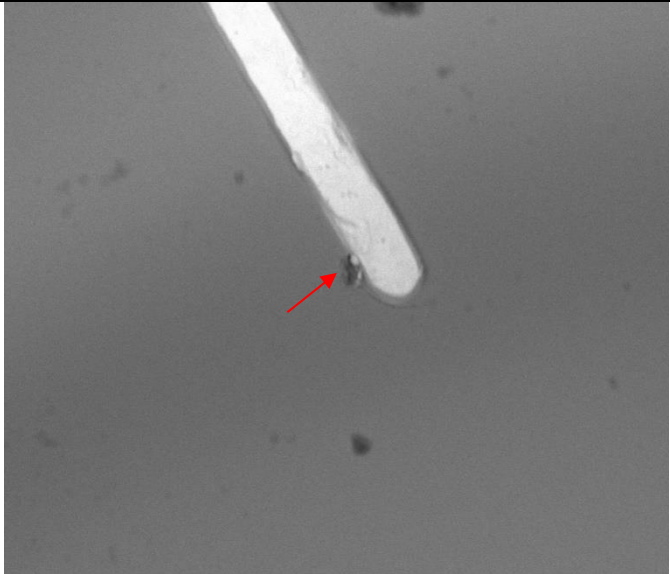
Fig 4f : Short Circuit LED:
SEM closed up view observed blow hole on Die
surface near metal trace

- 3.4 Chemical decapsulation followed by SEM & optical inspection revealed burn mark on Die surface for No Short Circuit LED while blow hole on Die surface near metal trace for Short Circuit LED which may result from EOS.

- 3.5 Based on FA analysis, burn mark & blow hole on Die surface had led to conclusion that LED failure was caused by electrical overstressed. These observations showed LED was subjected to current or voltage that are beyond the specification limits, or operated beyond its absolute maximum ratings as specified in data sheet, which is common causes of EOS events.
