GIP UCC3818A FA test waveform

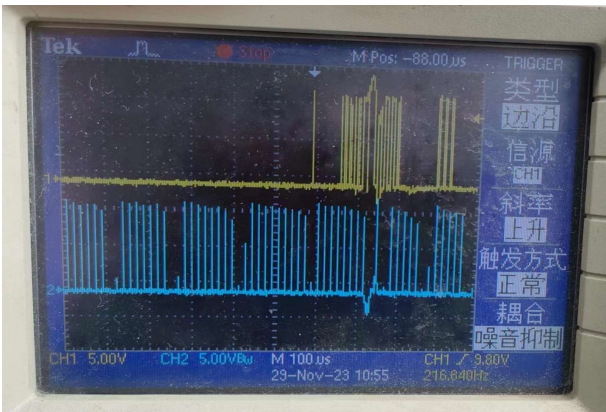
Test Point: PIN16 DRVOUT, PIN15 VCC

1. No load-PIN16. CH1: NG IC Board have abnormal noise , CH2: OK IC Board no abnormal noise

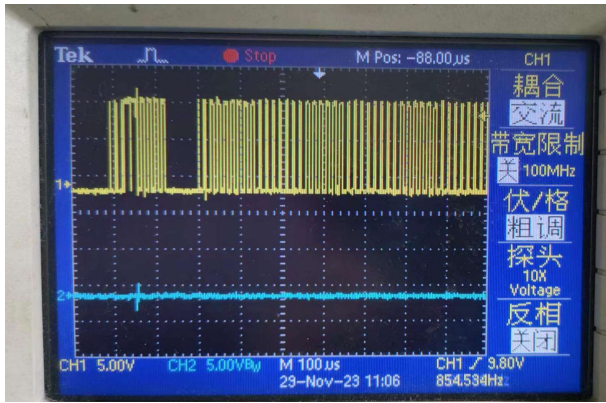
2. 56V 1.5A load-PIN 16 NG IC Board have abnormal noise

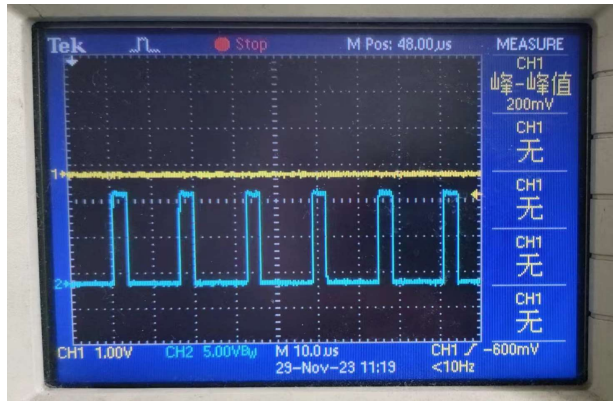
56V 1.5A load-PIN 16 OK IC Board no abnormal noise

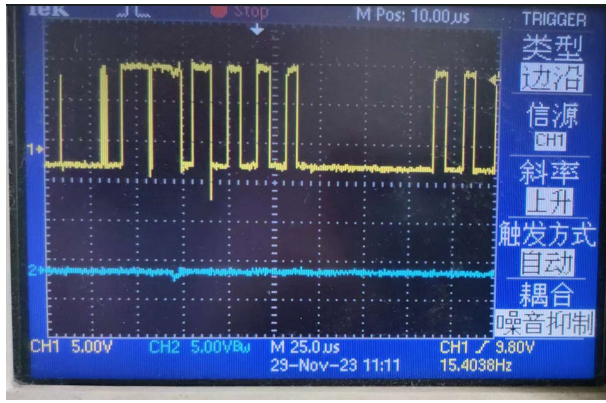
3. 56V 2.5A load-PIN16 NG IC Board have abnormal noise

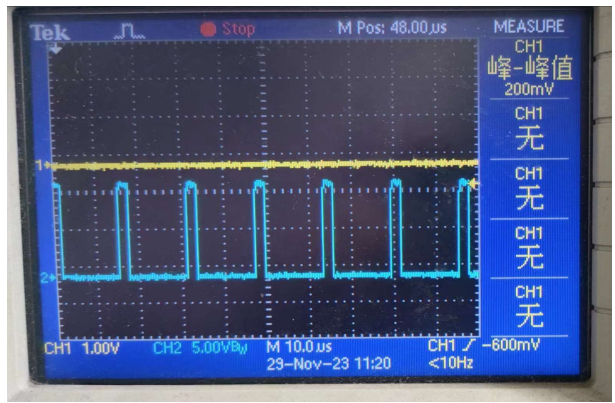
56V 2.5A load-PIN 16 OK IC Board no abnormal noise

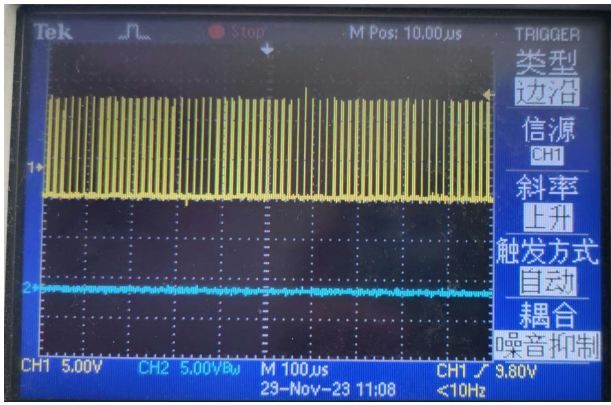
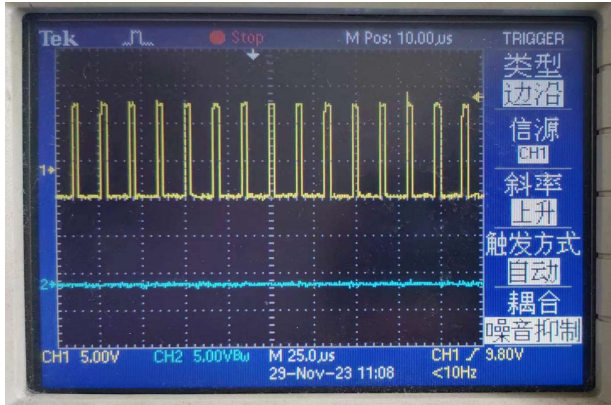
4. 56V 3A load-PIN16 NG IC Board no abnormal noise

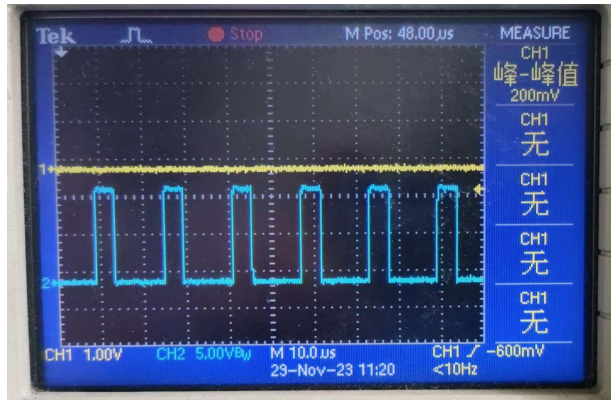
6V 3A load-PIN16 OK IC Board no abnormal noise

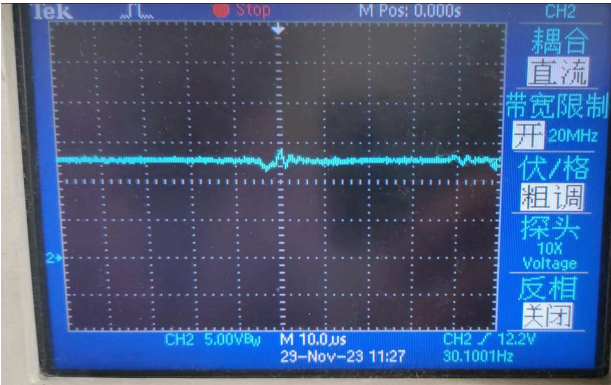
5. PIN15-VCC: NG Board with 1.5A Load have abnormal noise

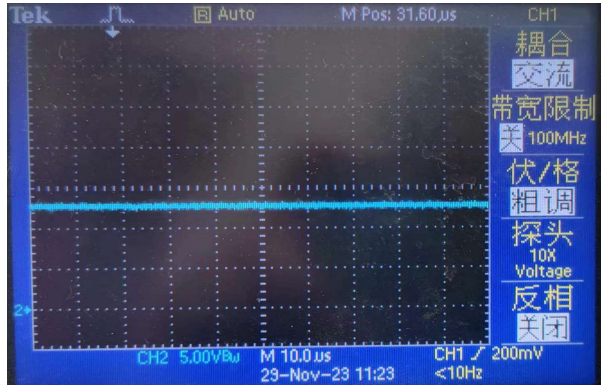
PIN15-VCC: OK Board with 1.5A Load no abnormal noise

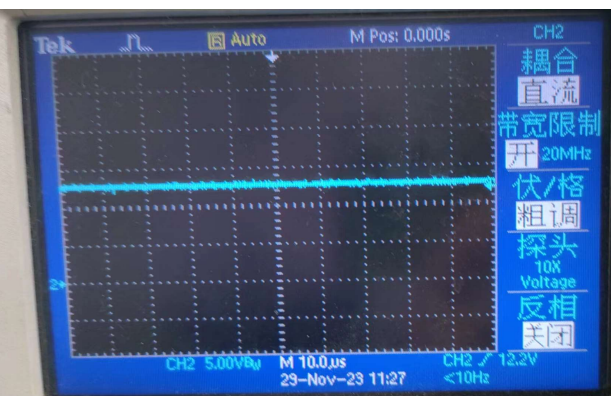
6. PIN15-VCC: NG Board with 3A Load no abnormal noise

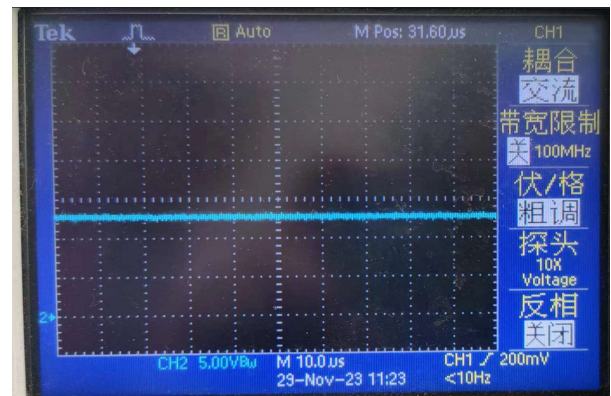
PIN15-VCC: OK Board with 3A Load no abnormal noise
