- **Package Analysis:**

- **External Package Examination:**

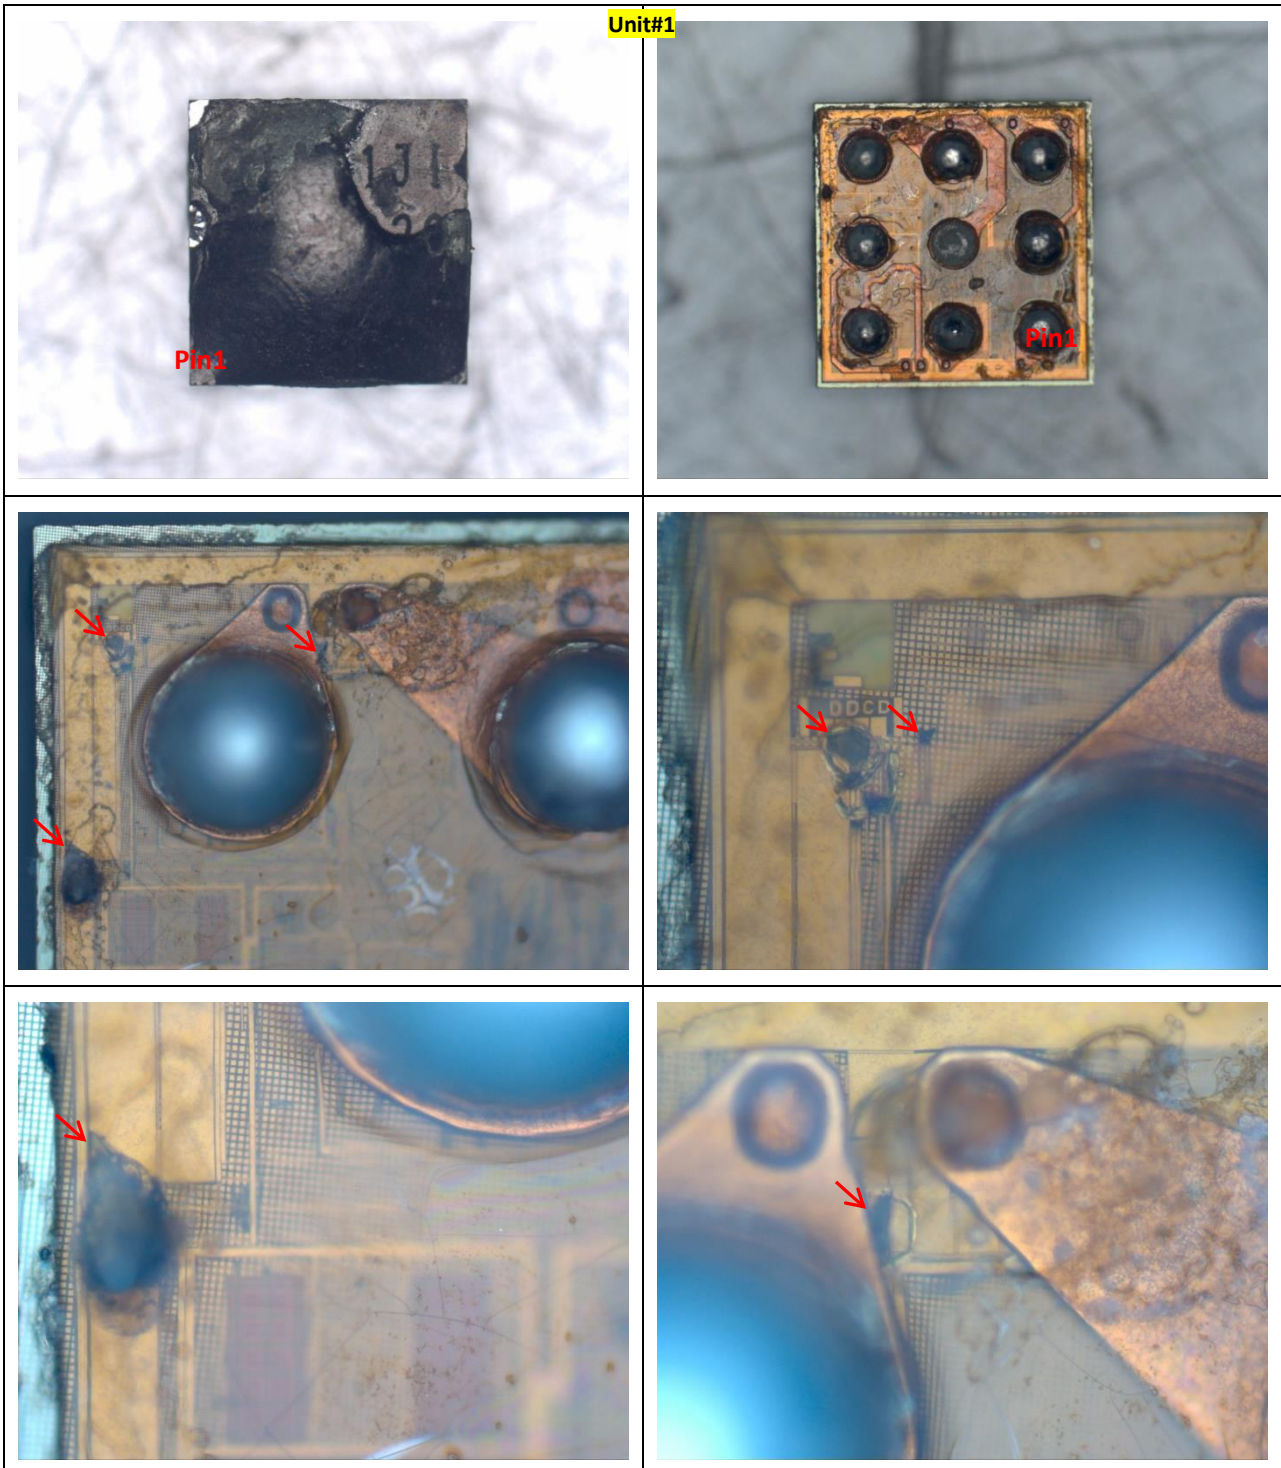
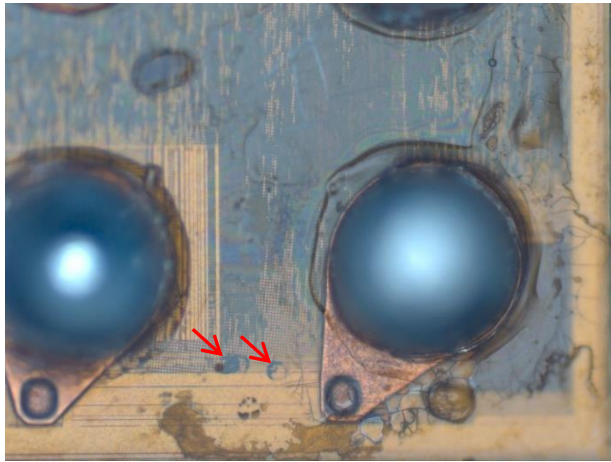
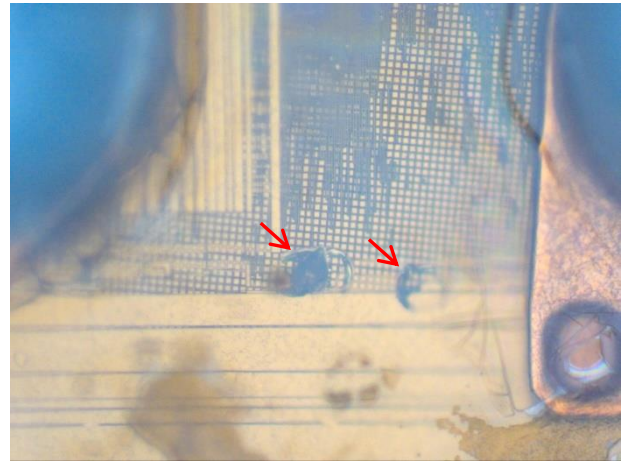
Figure 1. Optical pictures of package surface

Optical inspection was performed on returned units. Flash metal and abnormal PI were observed on both units.

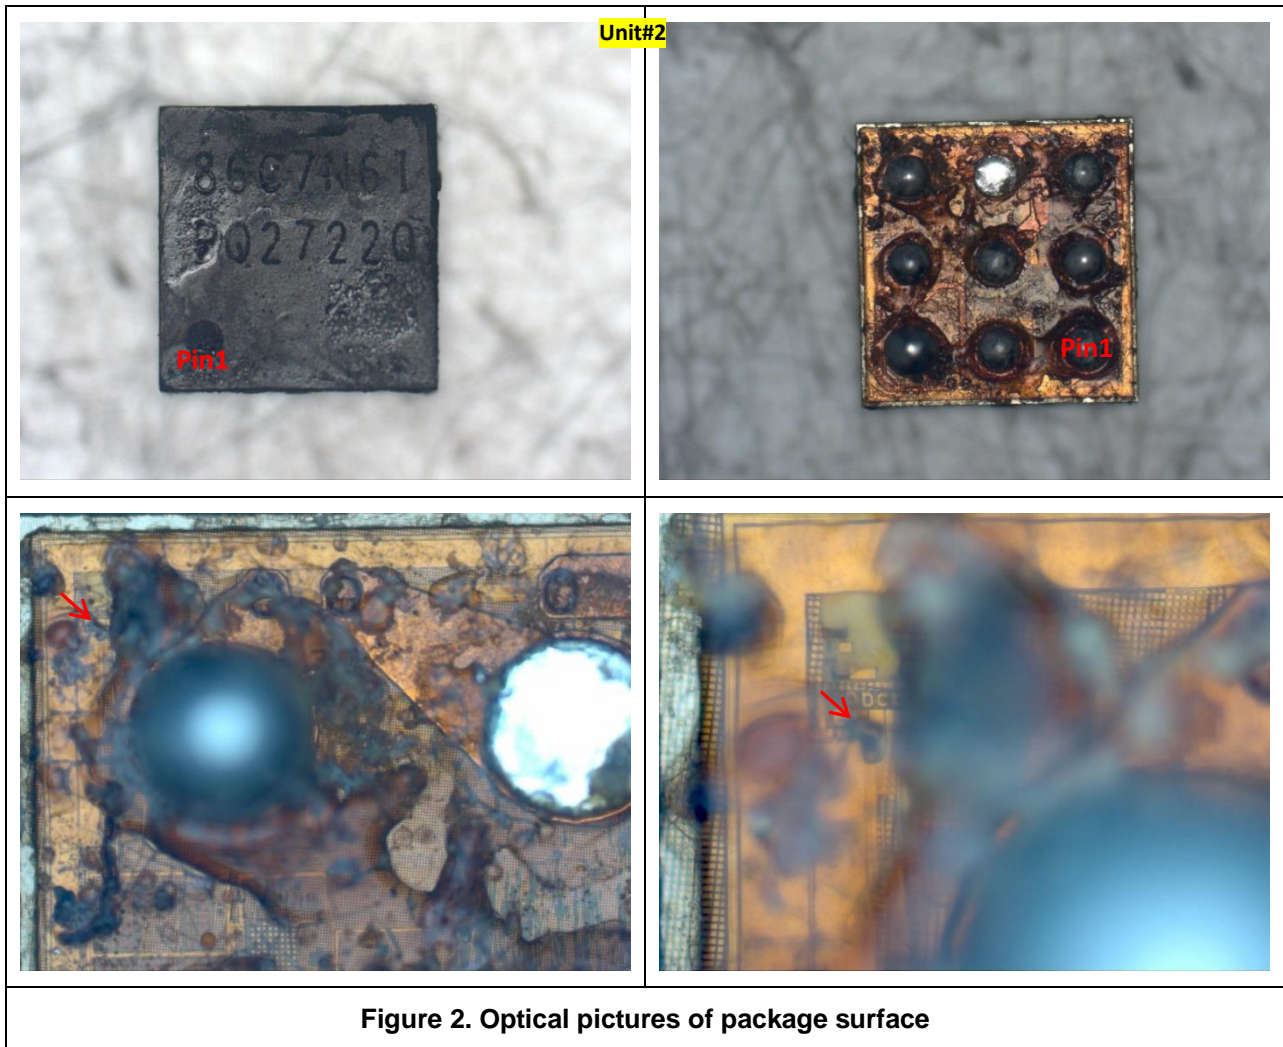
Optical inspection was performed on returned units. Flash metal and abnormal PI were observed on both units.
