UCC28513 questions, Alex W., 11/17/2022

- The boost stage design is based on UCC28513. The PFC stage works well up to 200-220Vac input. Above this voltage range there are significant distortions at the points where sinusoidal input voltage reaches to its positive and negative peaks
- Output voltage is 385Vac
- Input voltage range is 85-264Vac; 50/60Hz
- The load on DC link output is 120W max
- Boost stage switching frequency is 277kHz
- Verified that the Vcc aux supply and Vref are stable
- Observed that the AC ripple on DC link goes up at around 200Vac but not sure it this is the reason or the result
- Observed that the duty cycle is about 70% at the peak sine wave at 85Vac but drops down to ~15% at the peaks of 220Vac at which point I start get distortions on the input current.
- The provided test results are at ~30W output power. It was observed that changing the load did not affect the behavior at around 220Vac.

UCC28513 questions to TI, Alex W., 11/17/2022

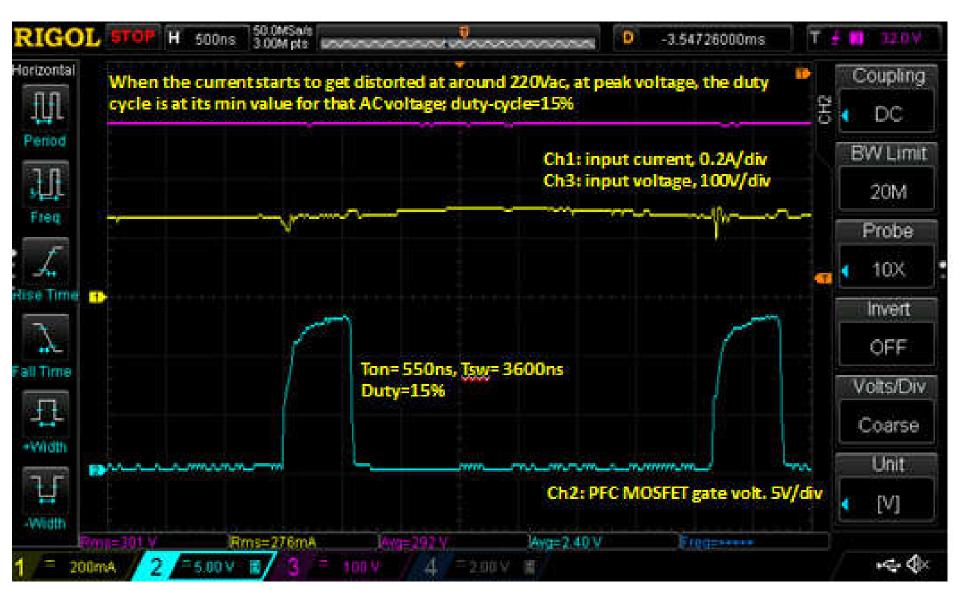
At the peak of sinewaves when distortion starts, the duty cycle of boost MOSFET is about 15%

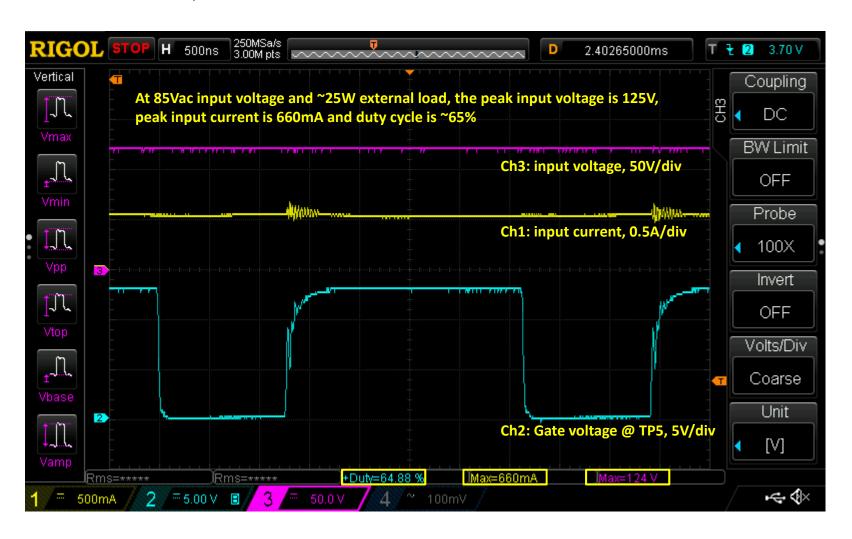
Ch4: Rogowski probe, CWTUM-015-B, is used to measure the high frequency switching ripple only.

In addition, a $100m\Omega$ and $20m\Omega$ sense resistor was connected in series with inductor and the voltage across the resistor was measured with a differential probe. However, doing so resulted in further instability and distortion and therefore abandoned.

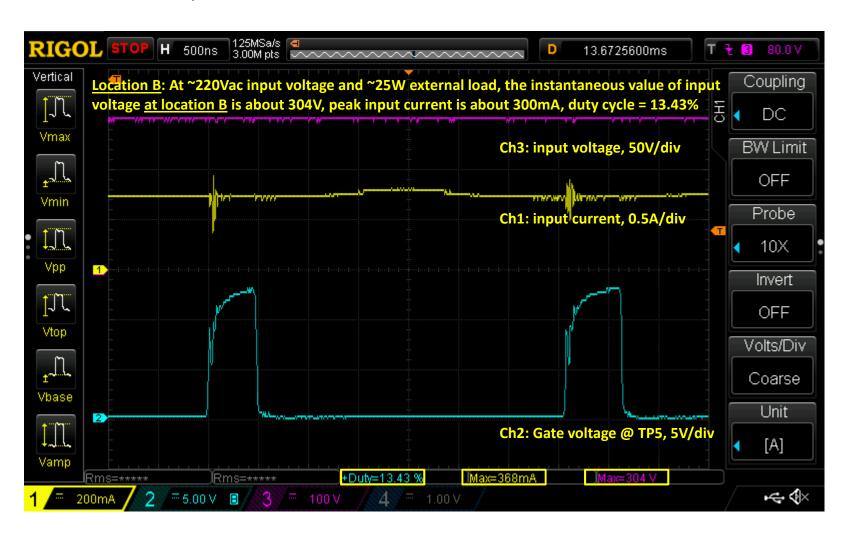
Ch1: Current probe is Fluke 80i-110S, which has limited bandwidth and is used to measure 60Hz input current

Ch4: Current probe is Rogowski CWTUM-015-B, which can measure high frequency only.

At the peak of 85Vac input voltage and ~25W external load, the instantaneous value of input voltage is 132V, peak input current is 660mA, duty cycle = 64.28%

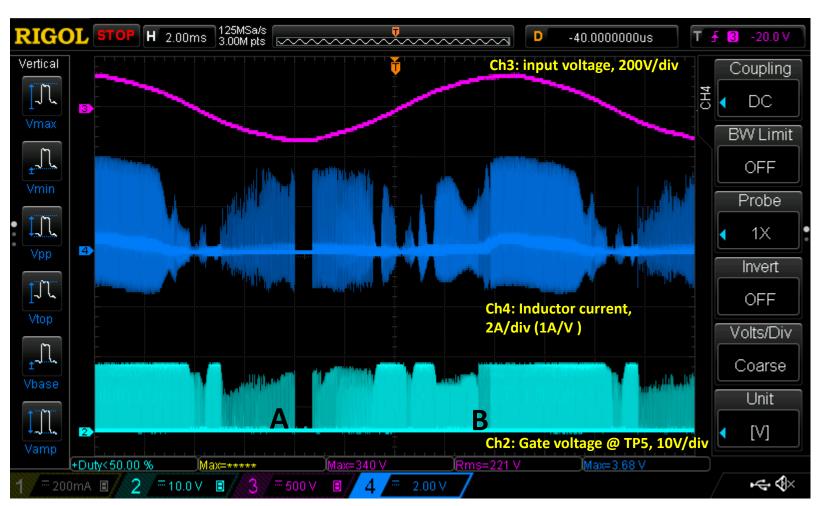
Ch1: Fluke 80i-110S, which has limited bandwidth

Ch4: Tek TCPA300 w/ TCP312 Current probe

At ~230Vac input voltage and ~25W external load, distortions observed.

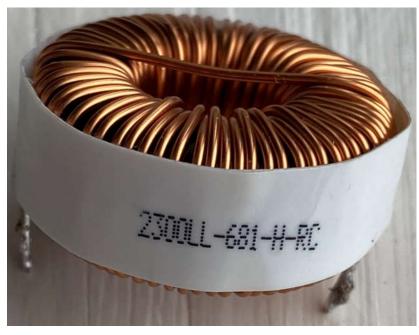
Trying out with PFC boost inductors that are built by using toroid cores with no overlapping windings

Inductor #1: Bourns PN: 2300LL-681-H-RC, 680uH Built by using toroid core, single layer winding. However, some amount of winding overlapping is visible.

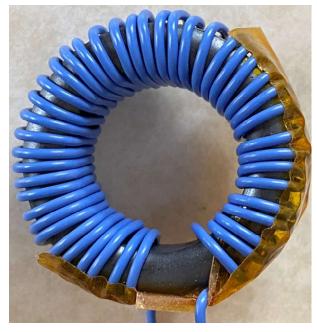
Inductor #2: Homemade by using toroid core Wurth PN: 7427015 and 43 turns of single layer winding.

Inductance measured at 1.39mH @ 300kHz.
