UCC28513 questions, Alex W., 11/17/2022

- The boost stage design is based on UCC28513. The PFC stage works well up to 200-220Vac input. Above this voltage range there are significant distortions at the points where sinusoidal input voltage reaches to its positive and negative peaks
- Output voltage is 385Vac
- Input voltage range is 85-264Vac; 50/60Hz
- The load on DC link output is 120W max
- Boost stage switching frequency is 277kHz
- Verified that the Vcc aux supply and Vref are stable
- Observed that the AC ripple on DC link goes up at around 200Vac but not sure if this is the reason or the result
- Observed that the duty cycle is about 70% at the peak sine wave at 85Vac but drops down to ~15% at the peaks of 220Vac at which point I start get distortions on the input current.
- The provided test results are at ~30W output power. It was observed that changing the load did not affect the behavior at around 220Vac.

UCC28513 questions to TI, Alex W., 11/17/2022

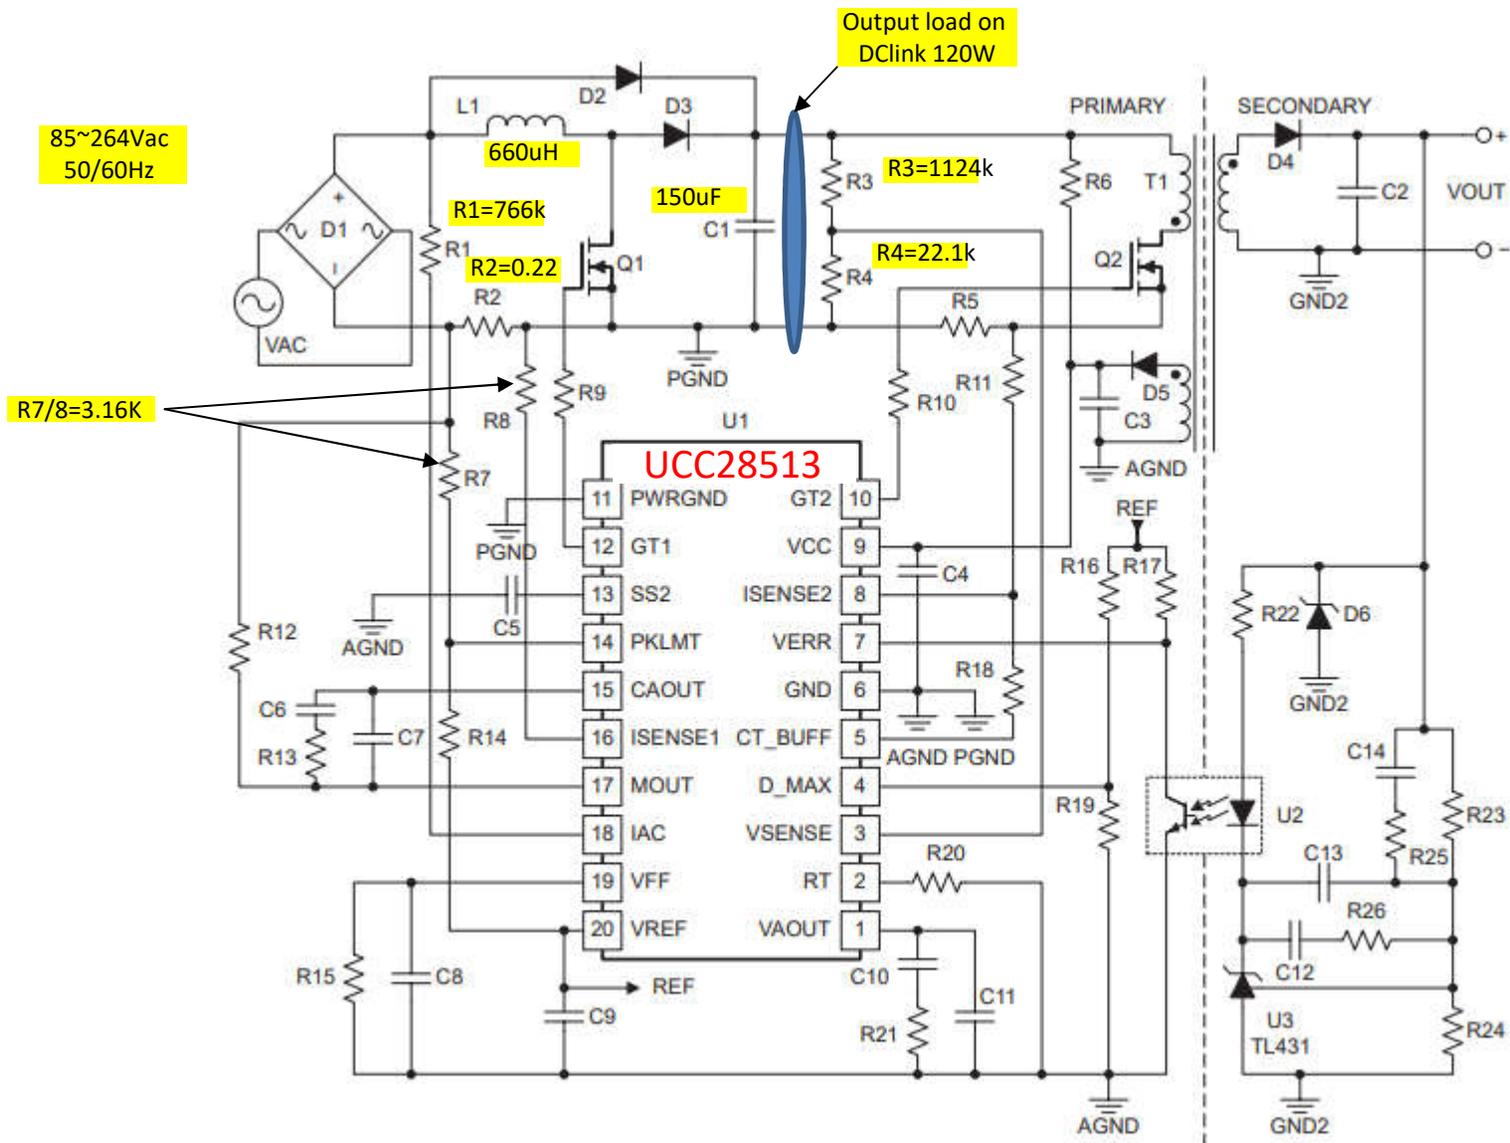
RefDes on data sheet	RefDes in design	values
R1	R47+R50	766K
R2	R43	0.22
R8/R12	R4/R9	3.16K
R3	R44+R49	1124K
R4	R60	22.1k
C1	C32	150uF
L1	L2	660uH
R13	R10	15.8K
C6	C6	680pF
C7	C8	150pF
R15	R11	30.1K
C8	C9	4.7uF
C10	C1	1.5uF
C11	C2	150nF
R21	R1	48.7K
R14	R13	10K
R7	R5	1.18K
C9	C4	1uF

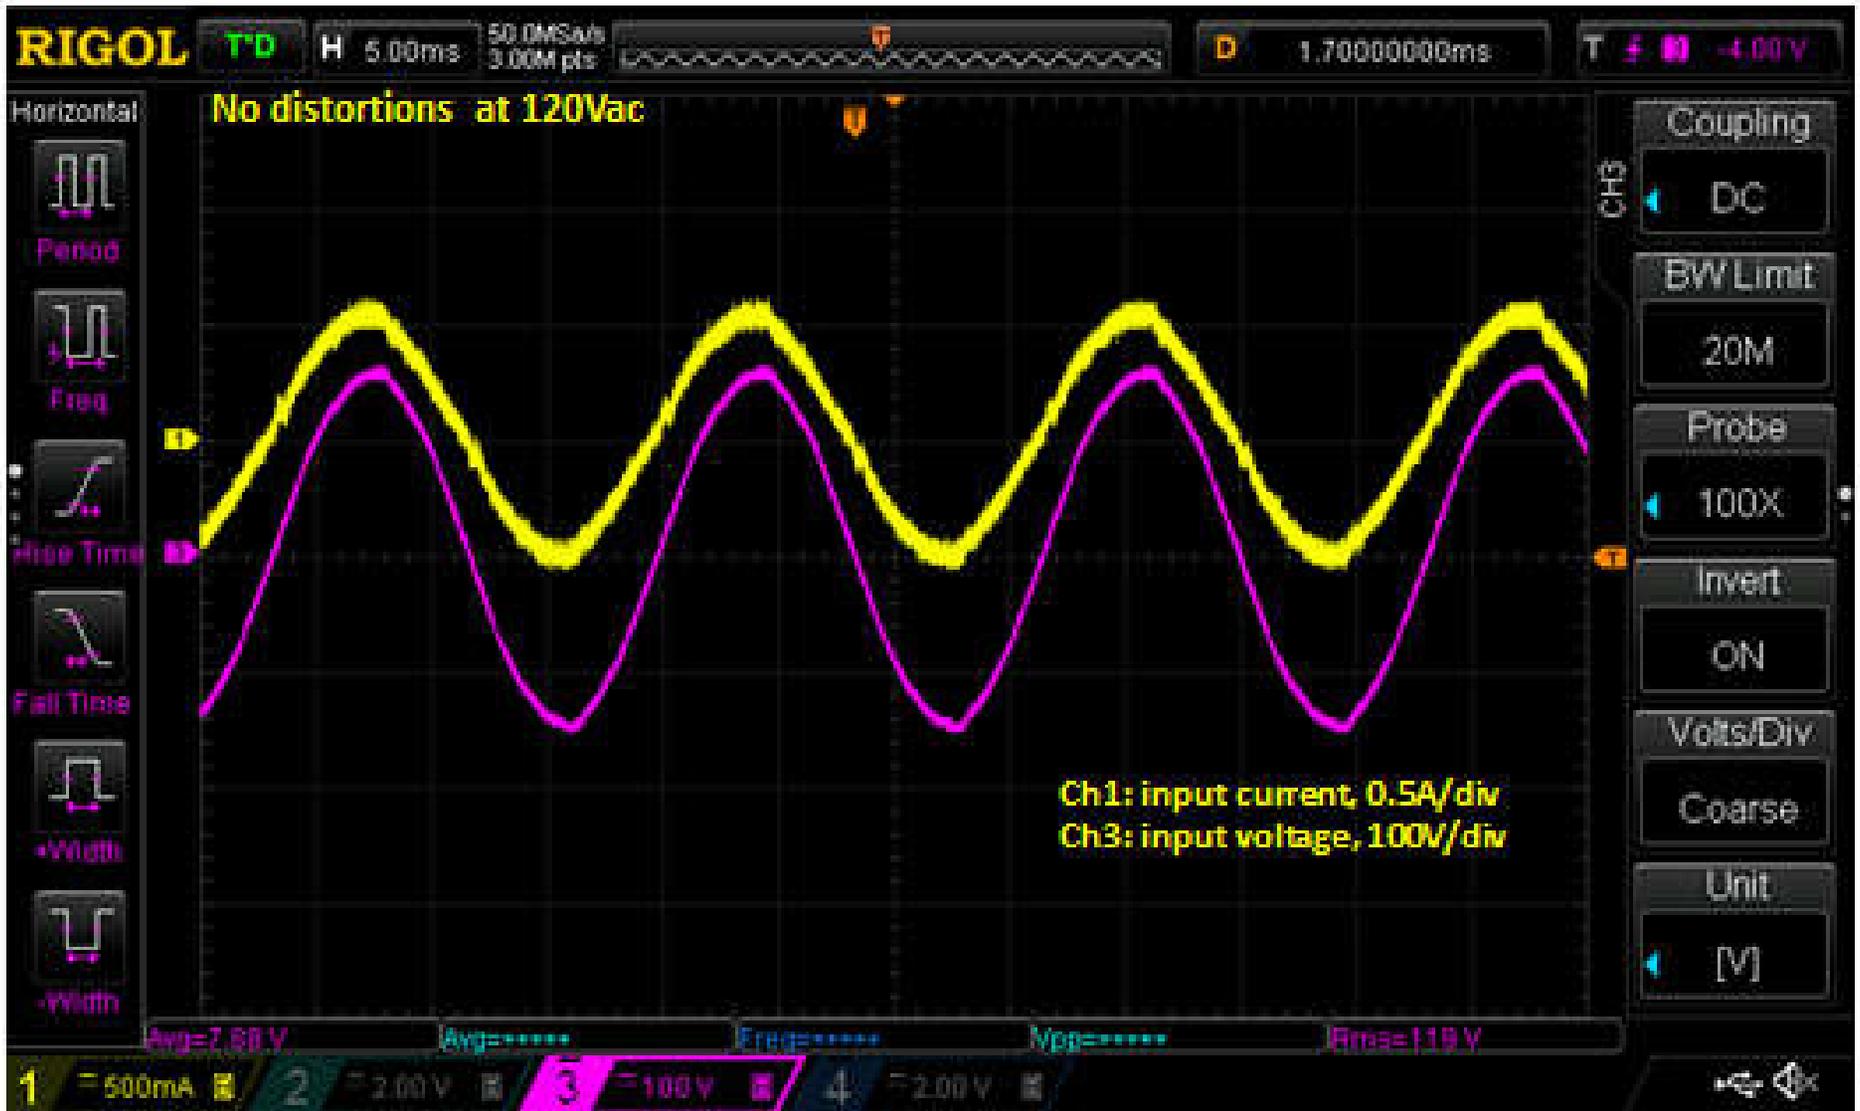
No distortions at 200Vac input, displacement between current and voltage is probably caused by the input capacitors on EMI filter

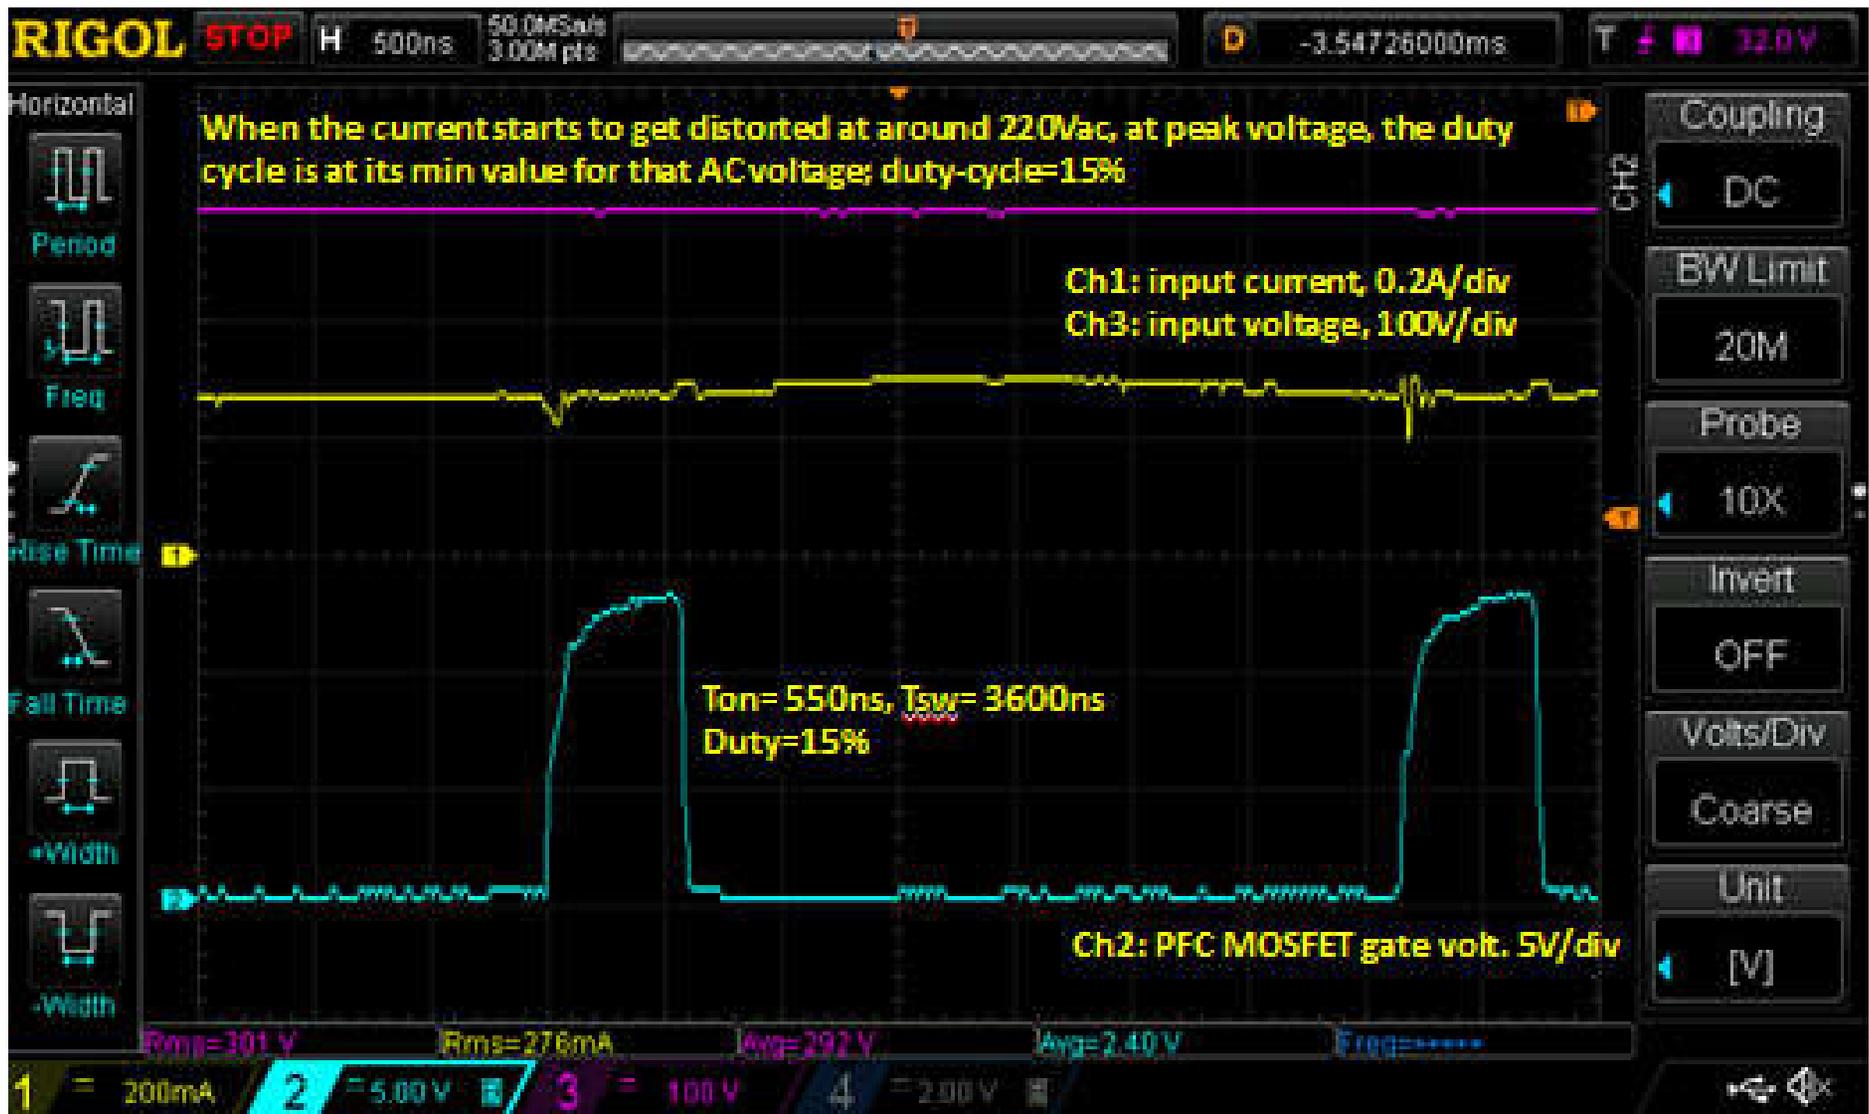
At the peak of sinewaves when distortion starts, the duty cycle of boost MOSFET is about 15%

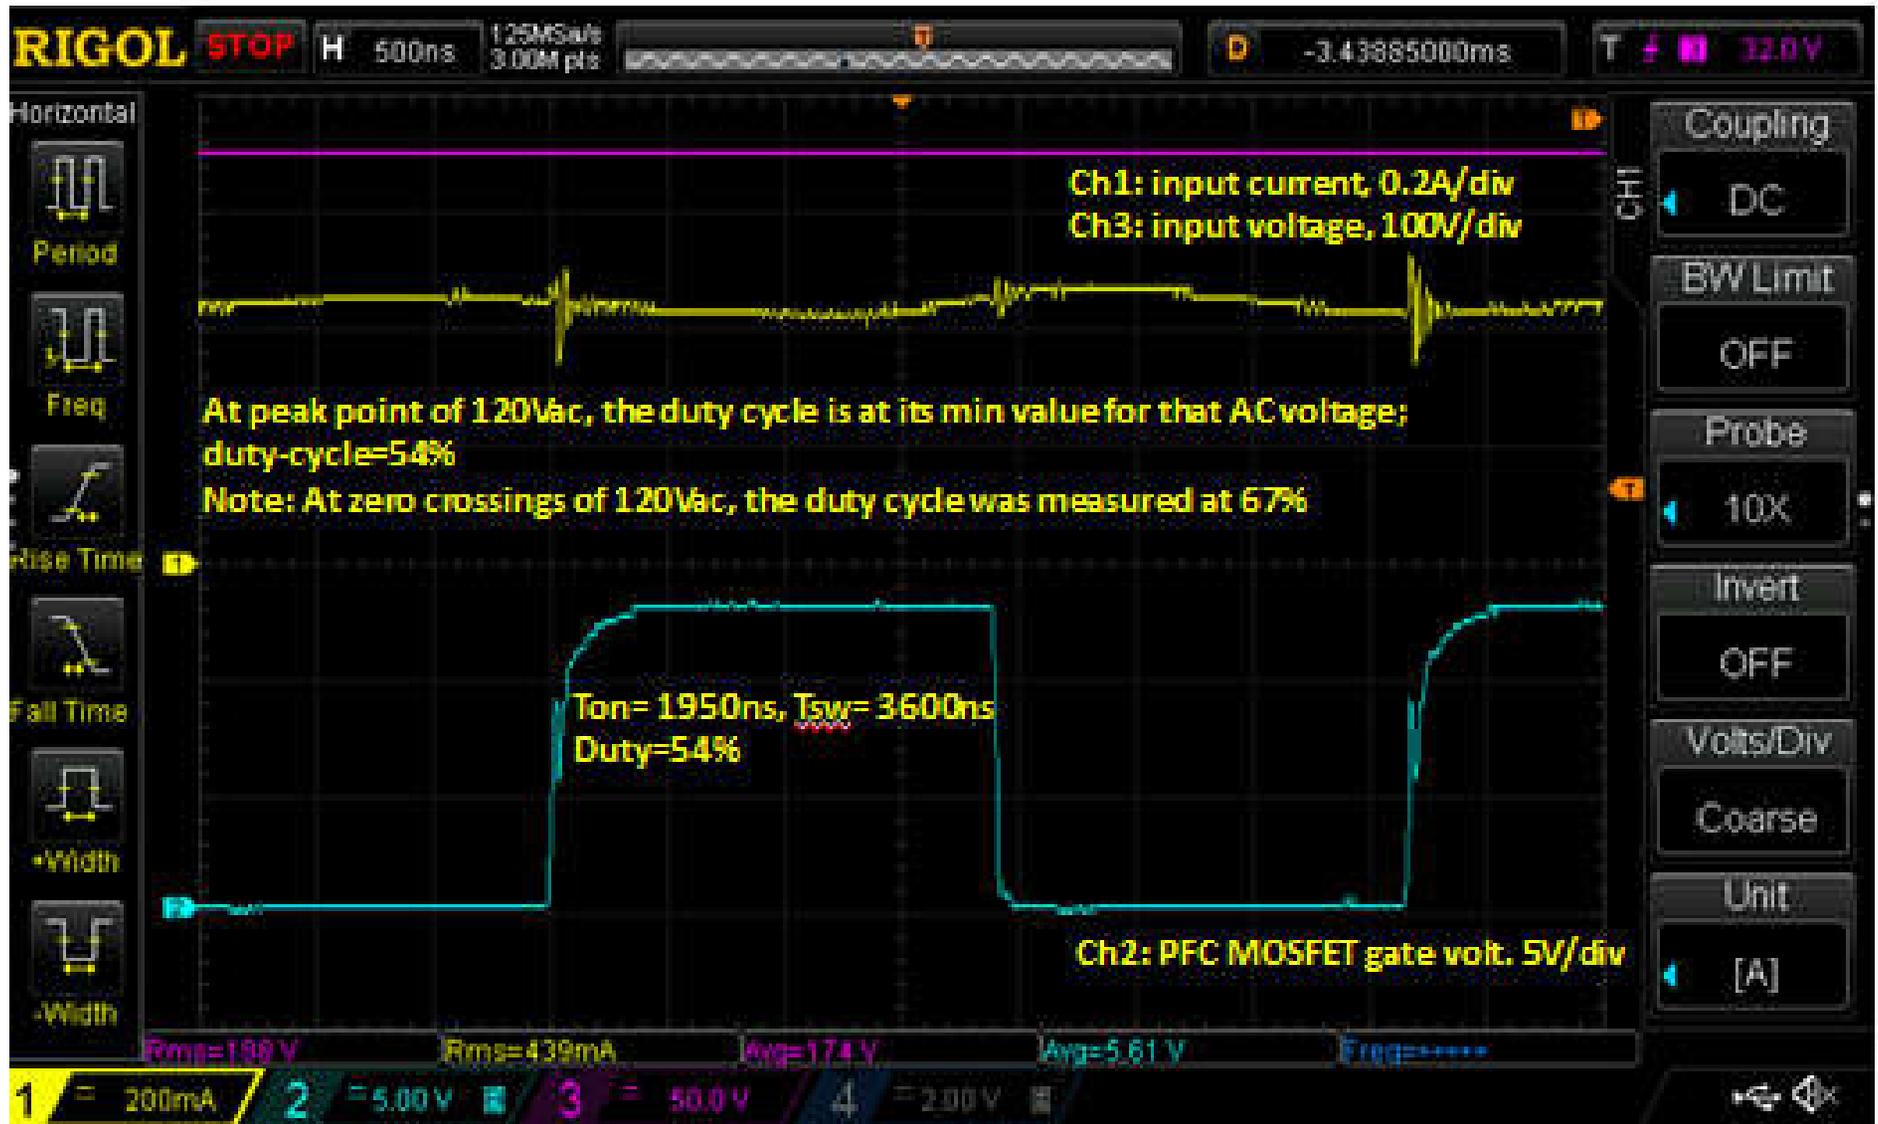
At the peak of sinewaves at 120Vac, the duty cycle of boost MOSFET is about 54%

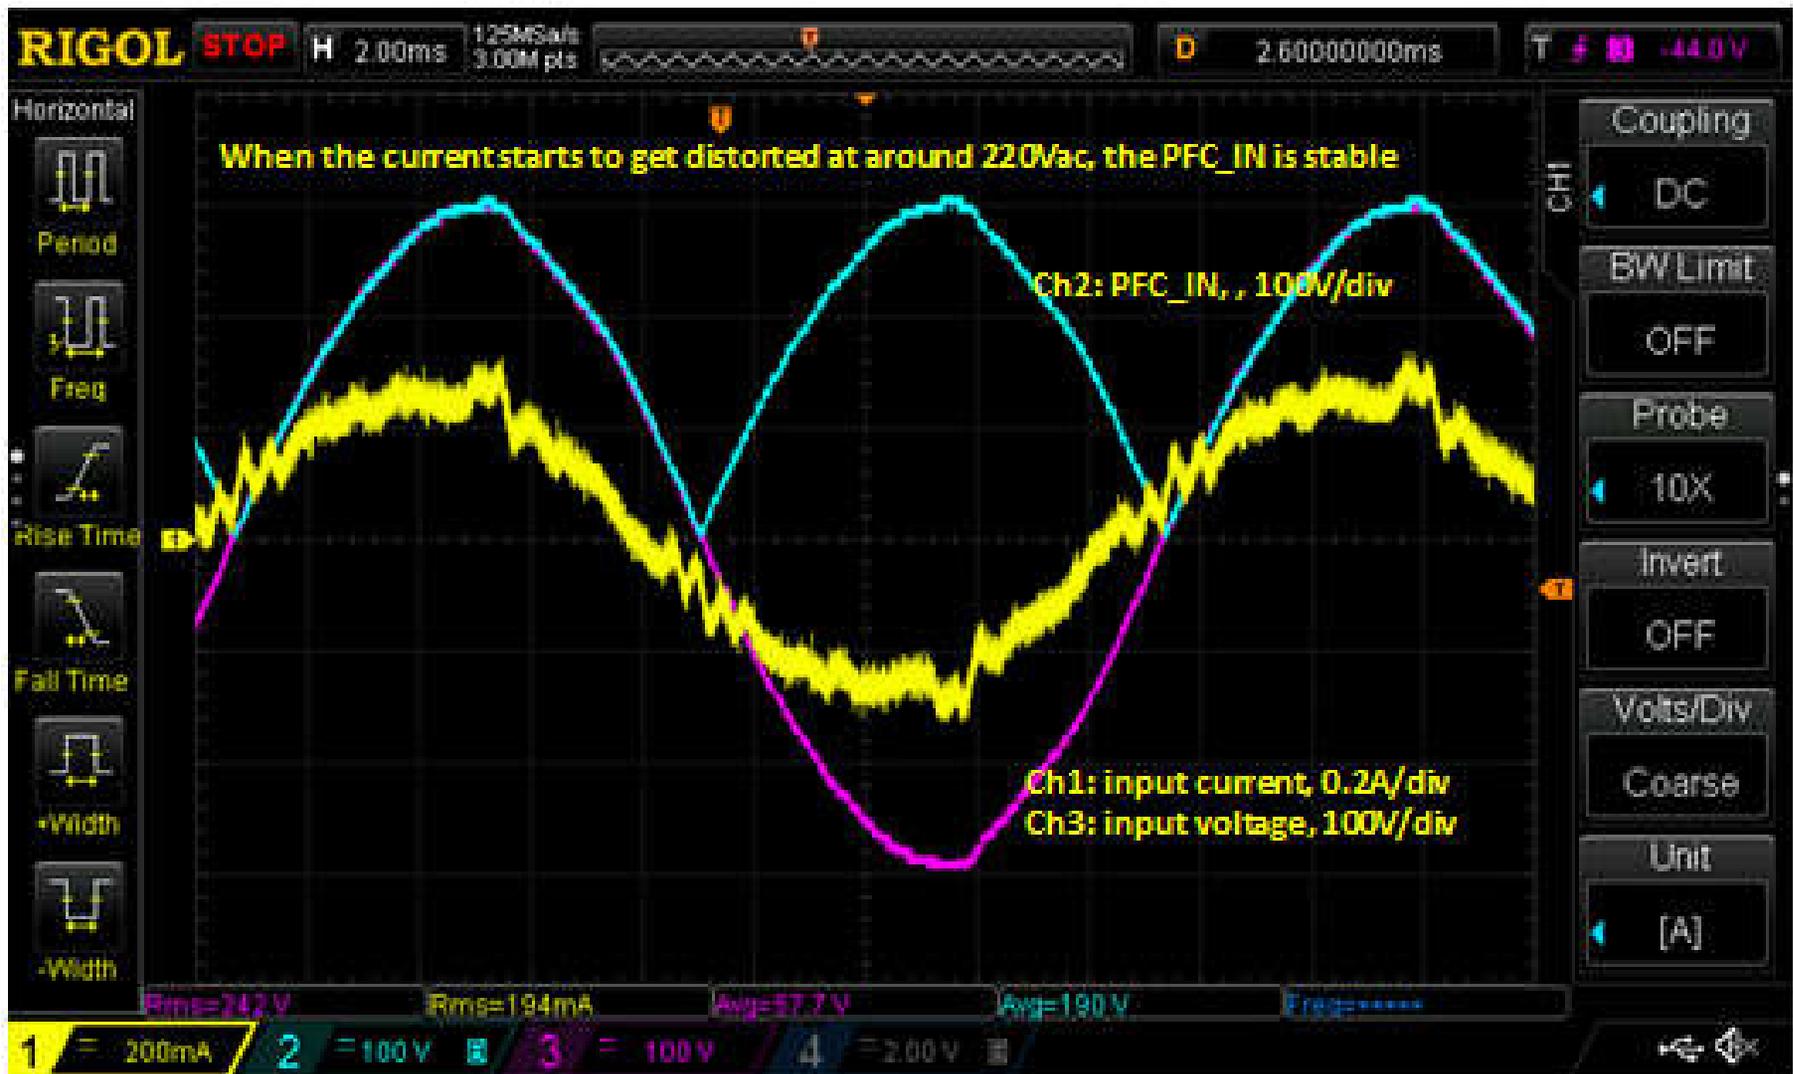
At 220Vac when distortions starts, the rectified input voltage (used for Vff) is shown below

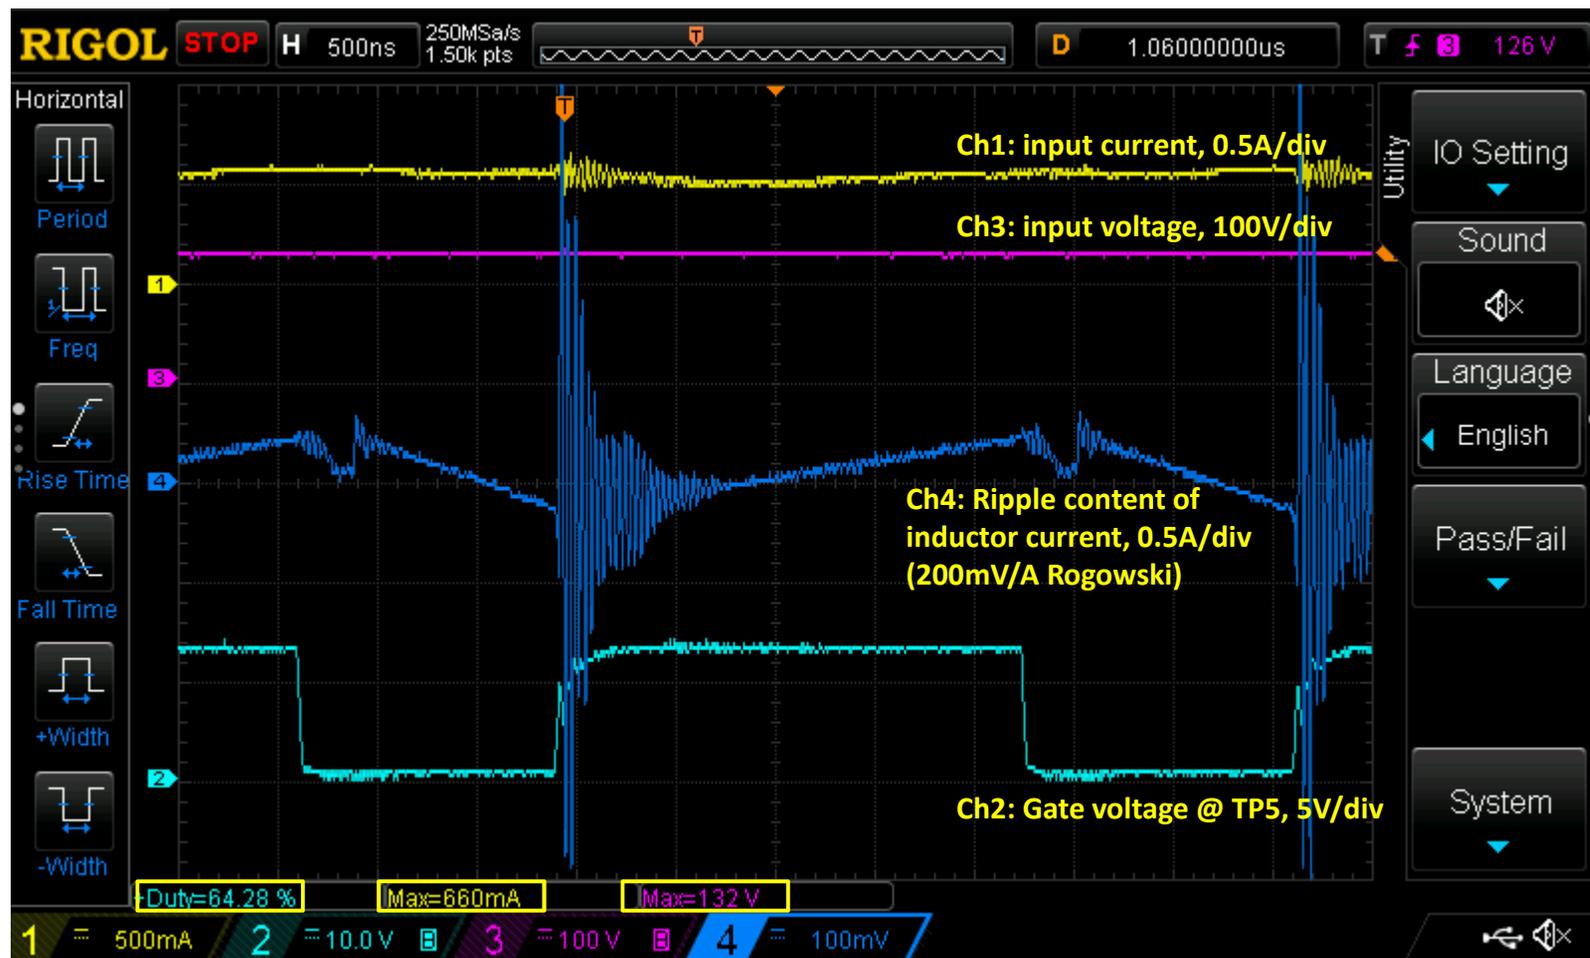
At the peak of 85Vac input voltage and ~25W external load, the instantaneous value of input voltage is 132V, peak input current is 660mA, duty cycle = 64.28%

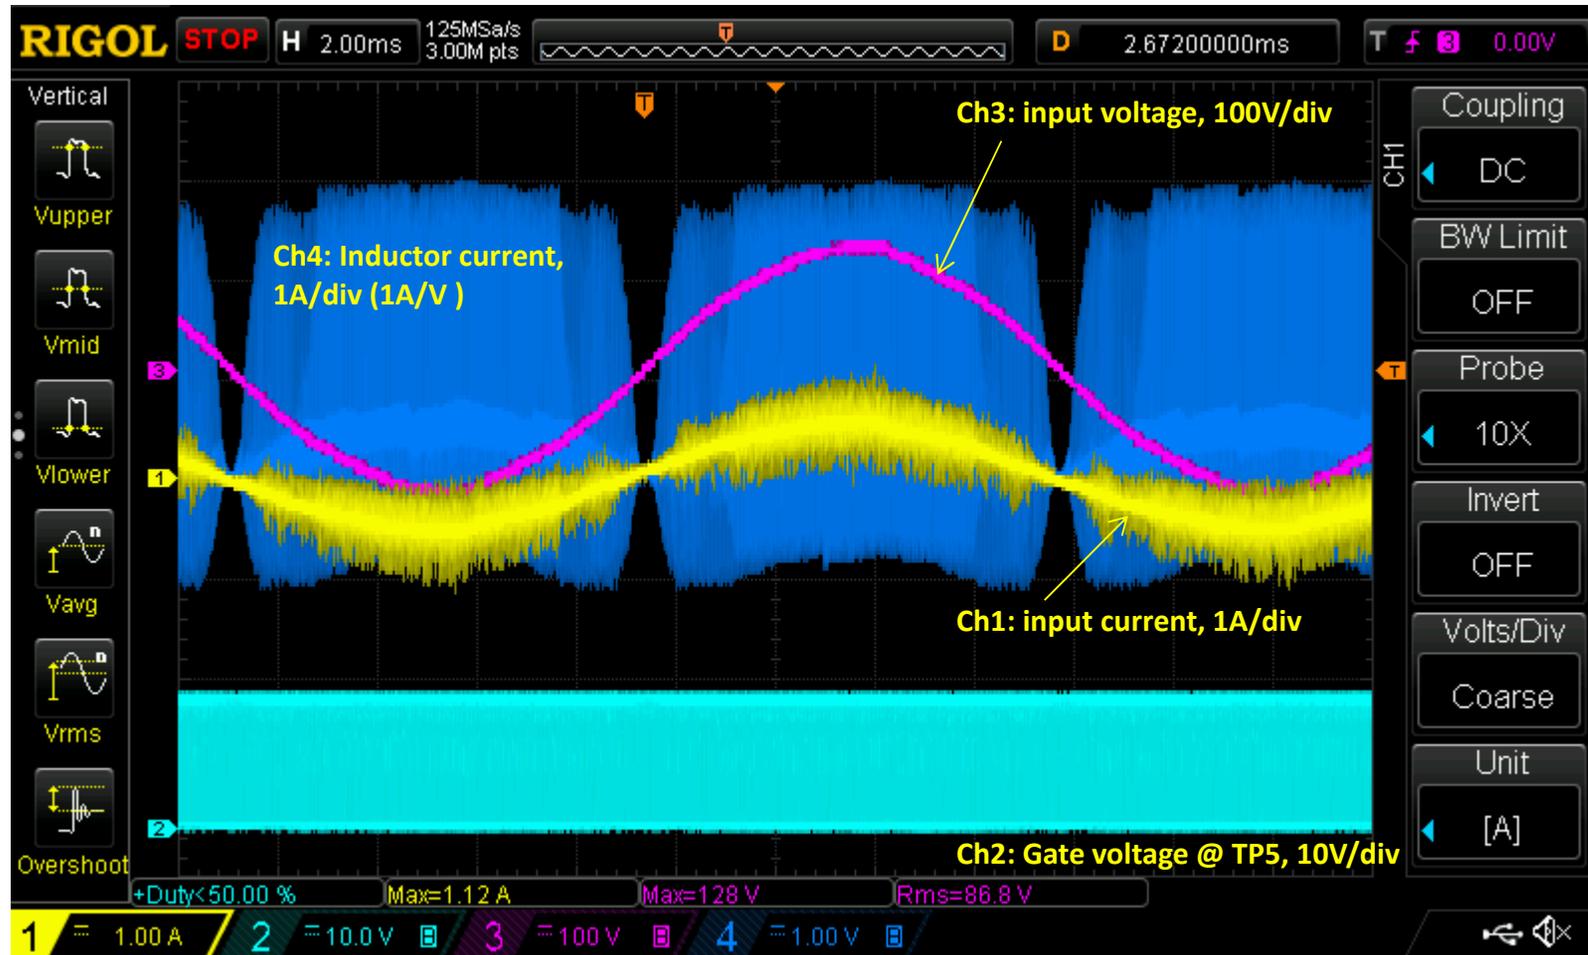
At 85Vac input voltage and ~25W external load, no major distortions observed

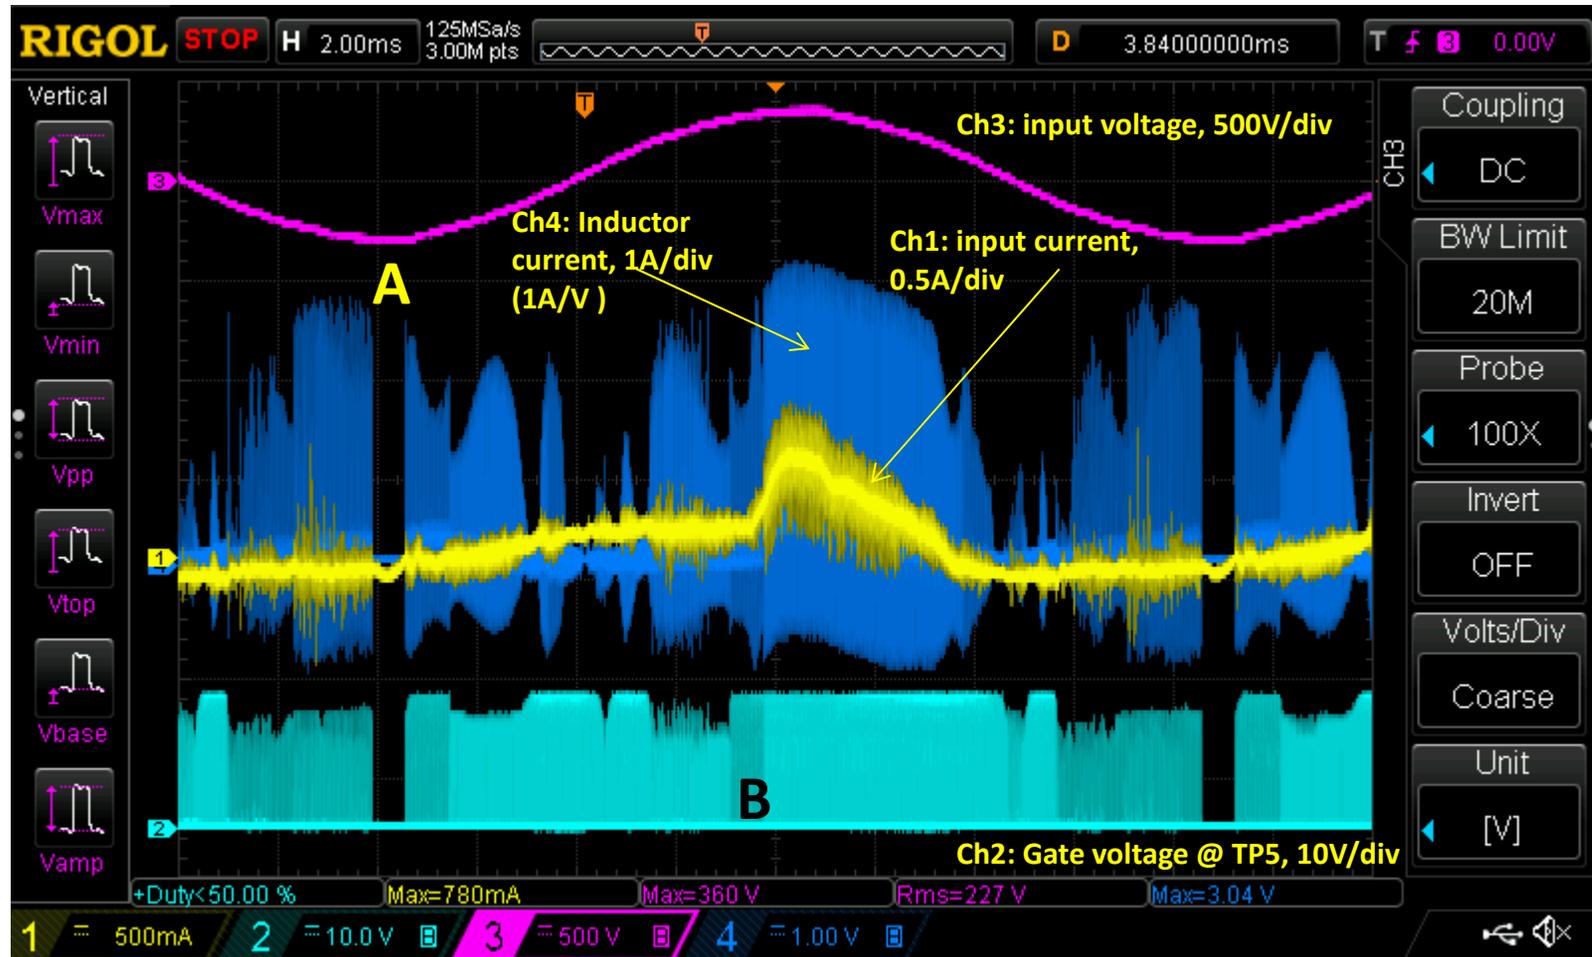
At ~230Vac input voltage and ~25W external load, distortions observed. See next slides for location A, B details

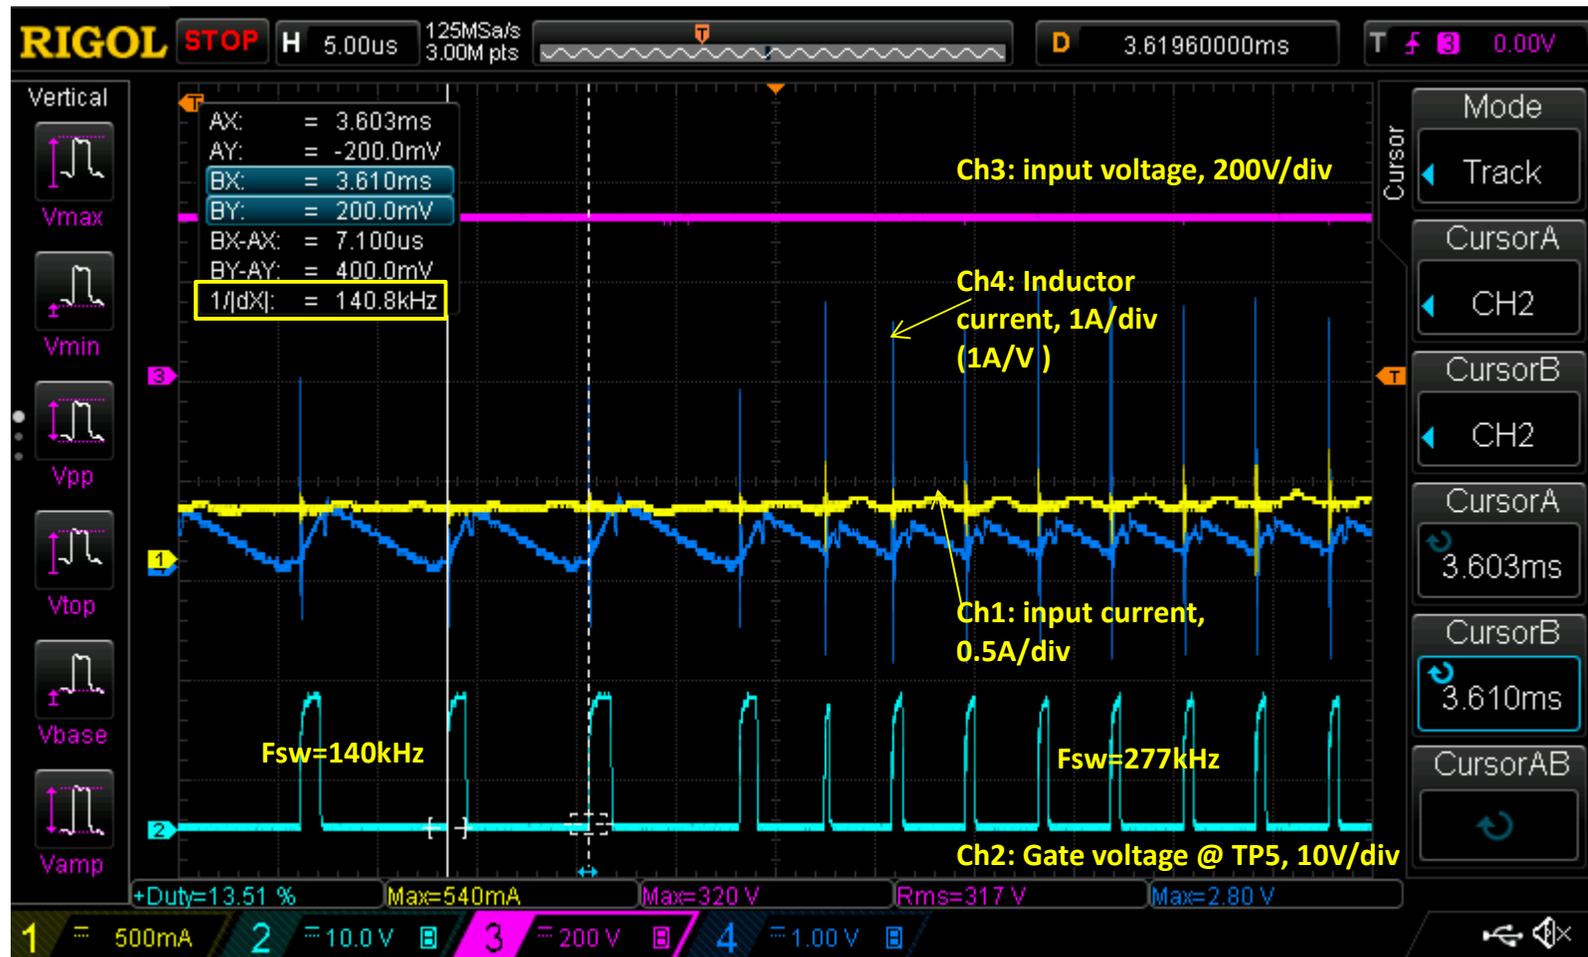
At the positive peaks of input voltage, the switching frequency is reduced to about $\frac{1}{2}$ and this results in “flat top” on the current waveform. After that the switching frequency is raised and around that time the current surge is observed

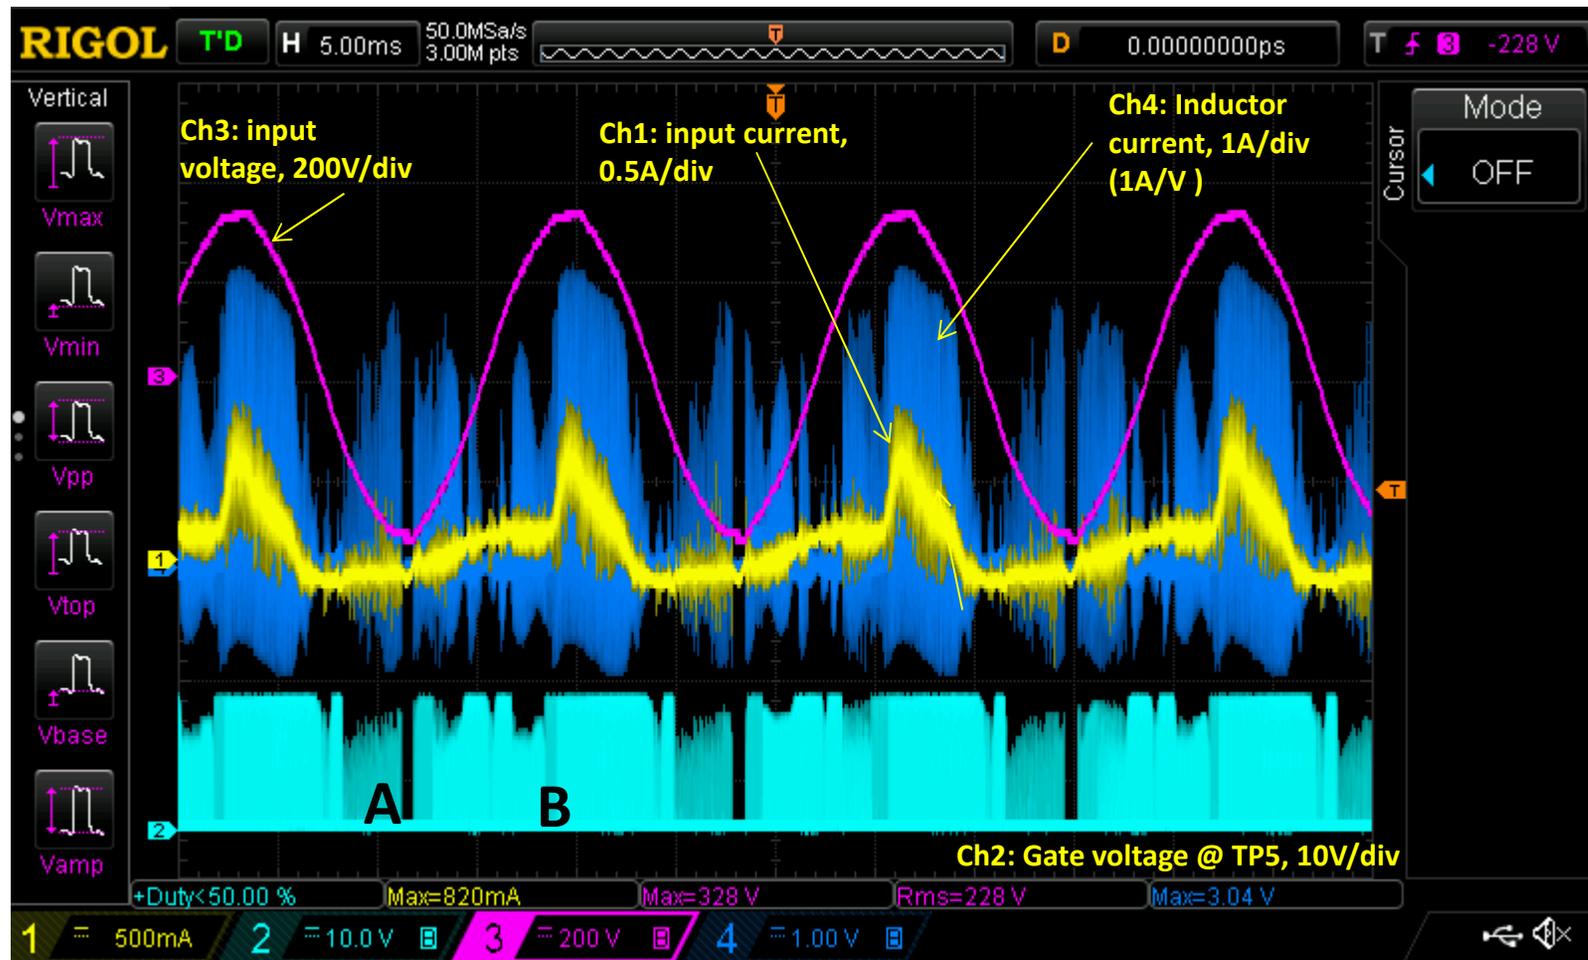
At 230Vac input, 25W external load, the view of locations A (negative peak) and location B (positive peak)

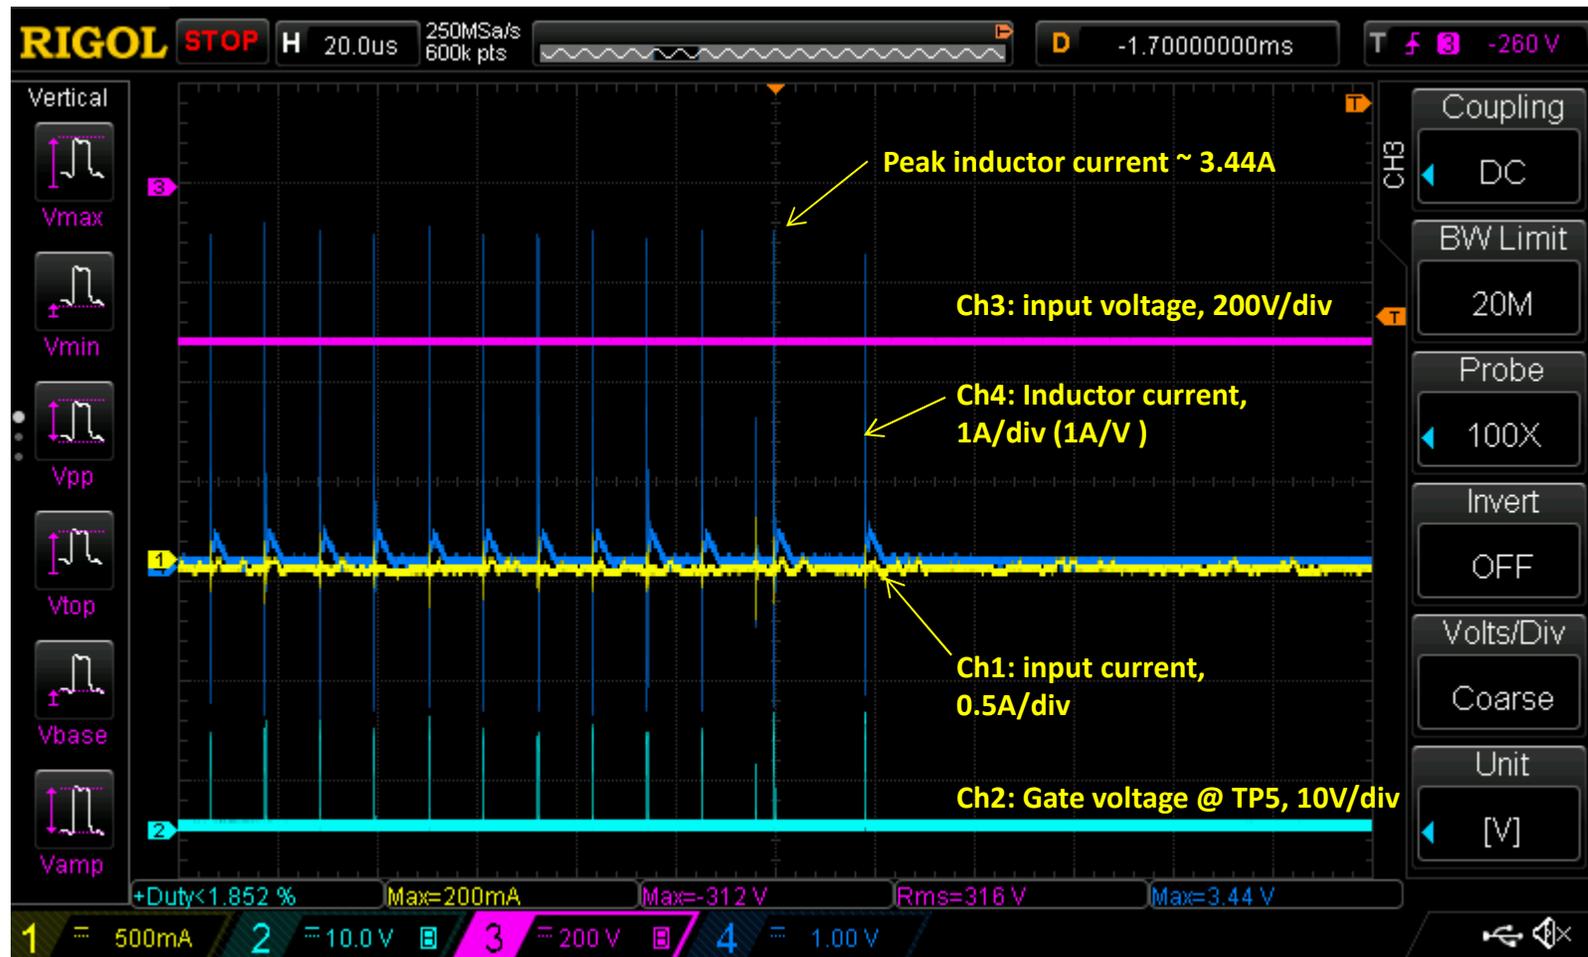
Location A: Current probe on Ch1 has low BW and is used to measure input current only.

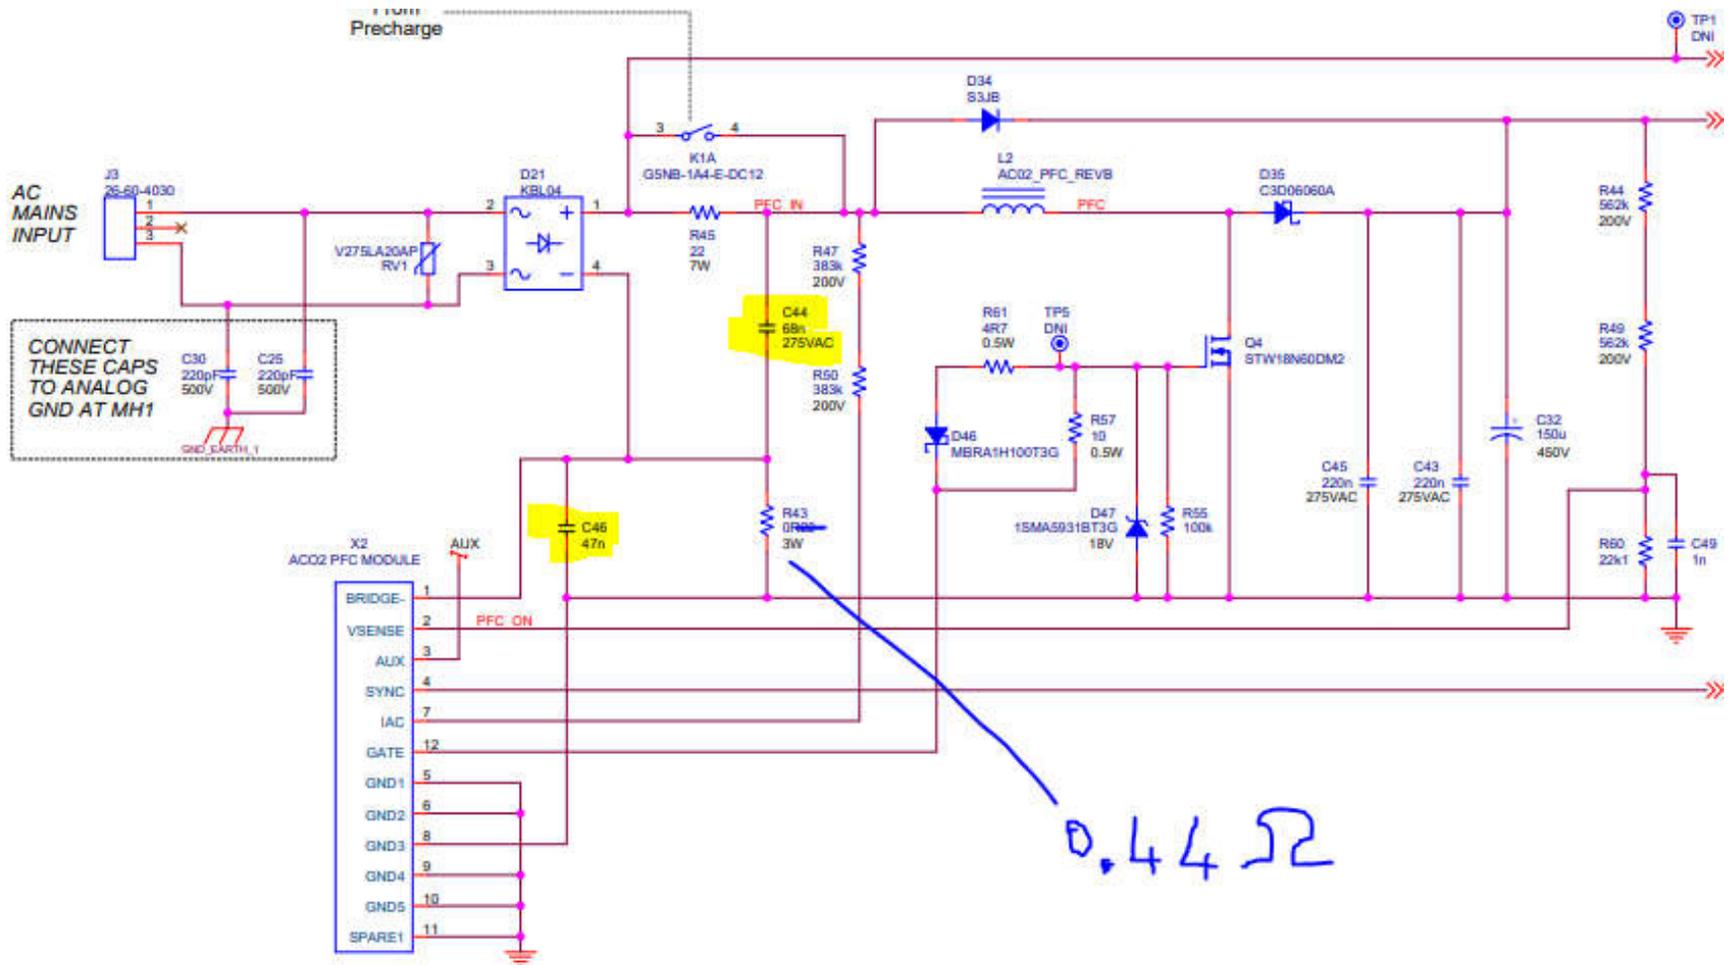
There is a 68nF cap after the rectifier. It is increased to 2x68=136nF, did not observe any improvements

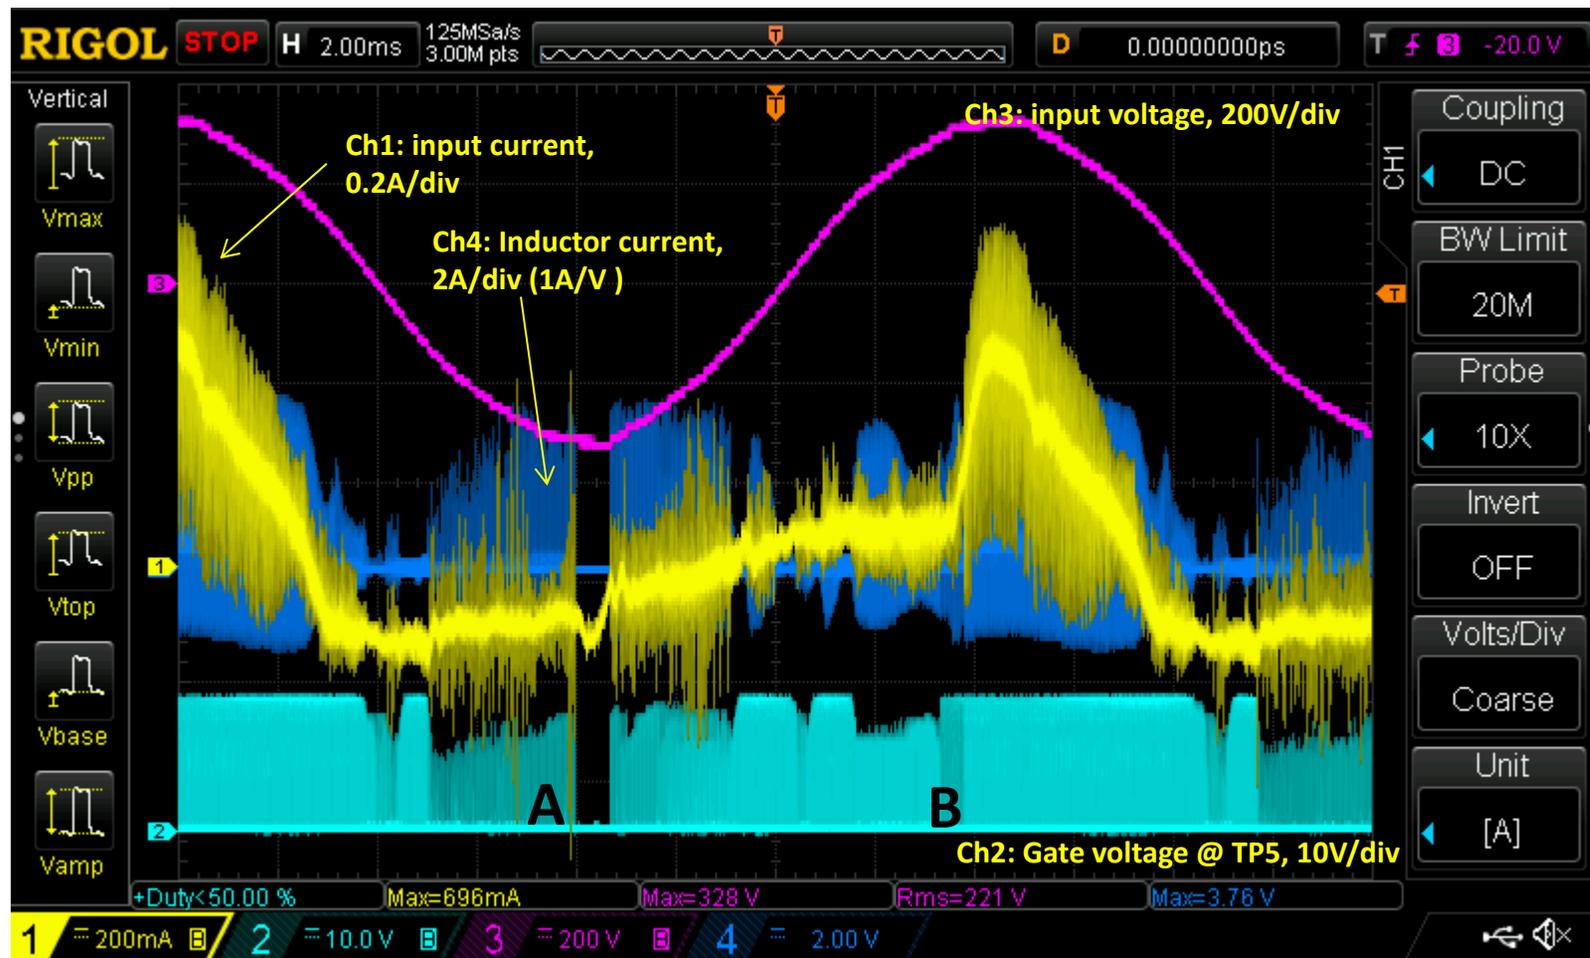
Added 100pF across the R5 (R7 on data sheet), did not observe any improvements
