UCC28513 questions, Alex W., 11/17/2022

- The boost stage design is based on UCC28513. The PFC stage works well up to 200-220Vac input. Above this voltage range there are significant distortions at the points where sinusoidal input voltage reaches to its positive and negative peaks
- Output voltage is 385Vac
- Input voltage range is 85-264Vac; 50/60Hz
- The load on DC link output is 120W max
- Boost stage switching frequency is 277kHz
- Verified that the Vcc aux supply and Vref are stable
- Observed that the AC ripple on DC link goes up at around 200Vac but not sure if this is the reason or the result
- Observed that the duty cycle is about 70% at the peak sine wave at 85Vac but drops down to ~15% at the peaks of 220Vac at which point I start get distortions on the input current.
- The provided test results are at ~30W output power. It was observed that changing the load did not affect the behavior at around 220Vac.

UCC28513 questions to TI, Alex W., 11/17/2022

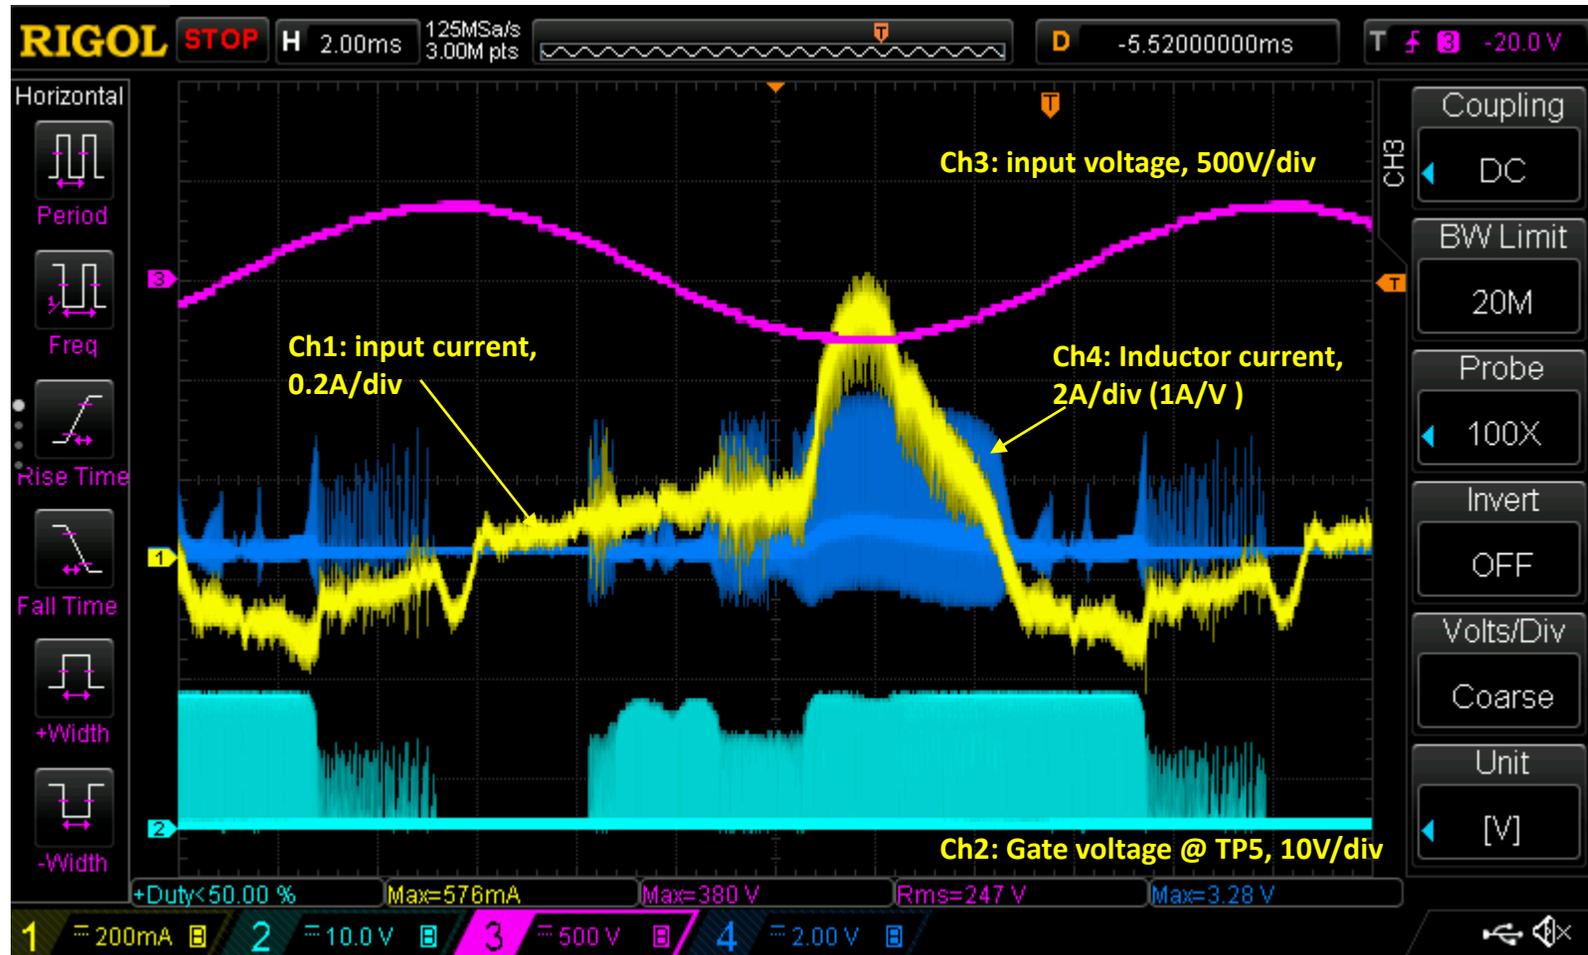
At ~230Vac input voltage and ~25W external load, major distortions observed

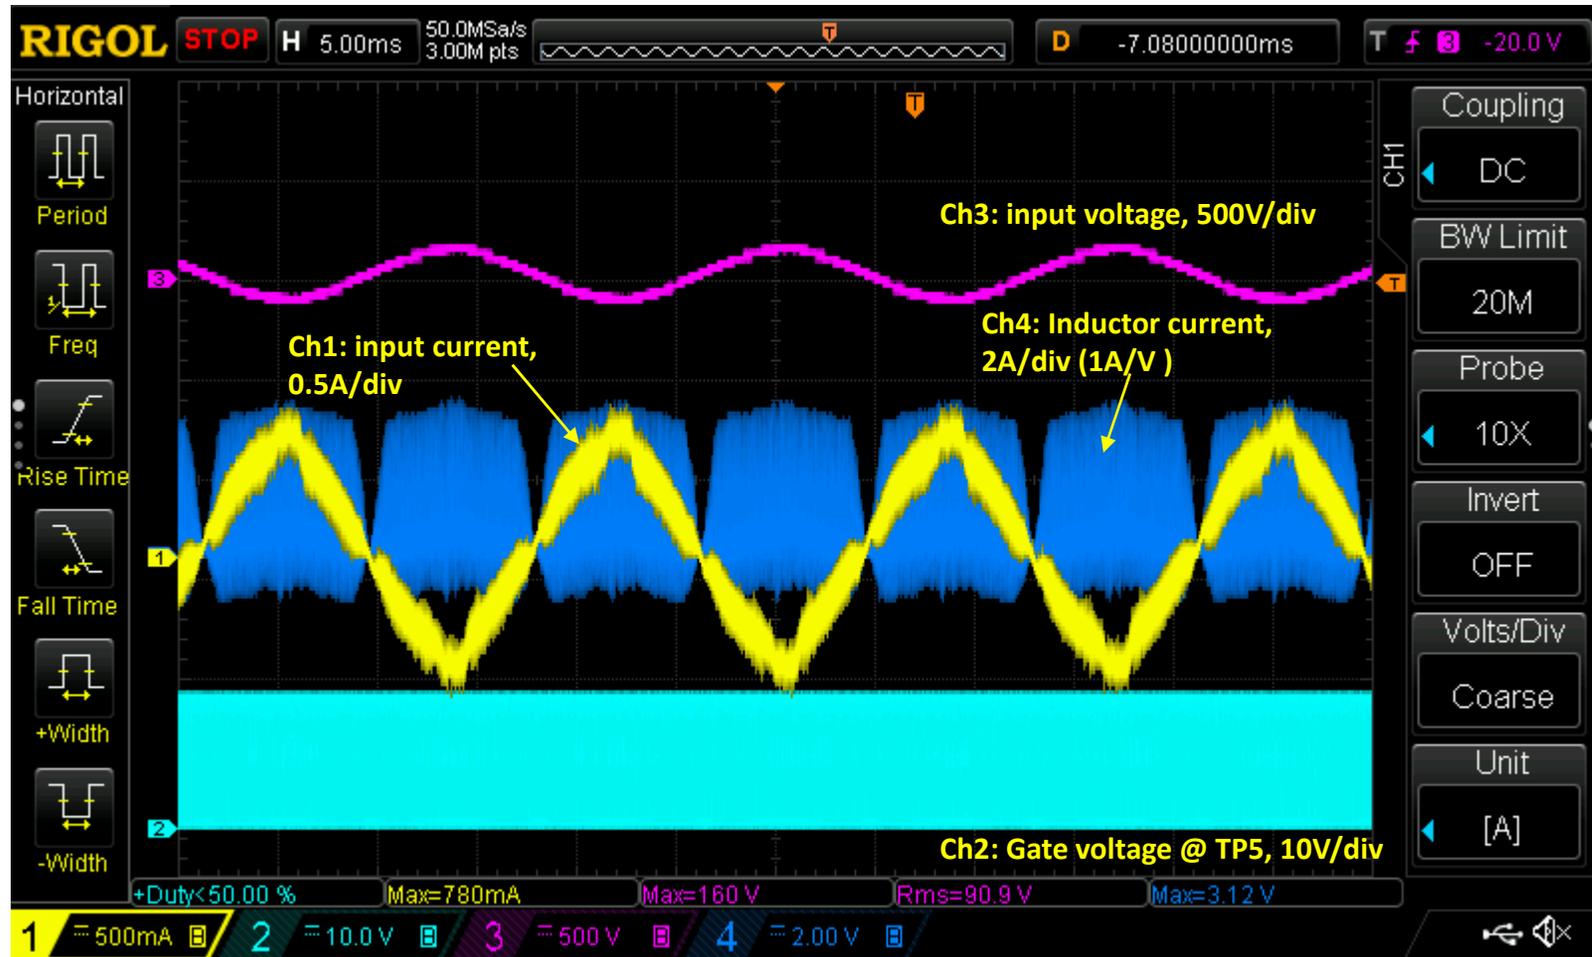
At 90Vac input voltage, no C46, no major distortions observed

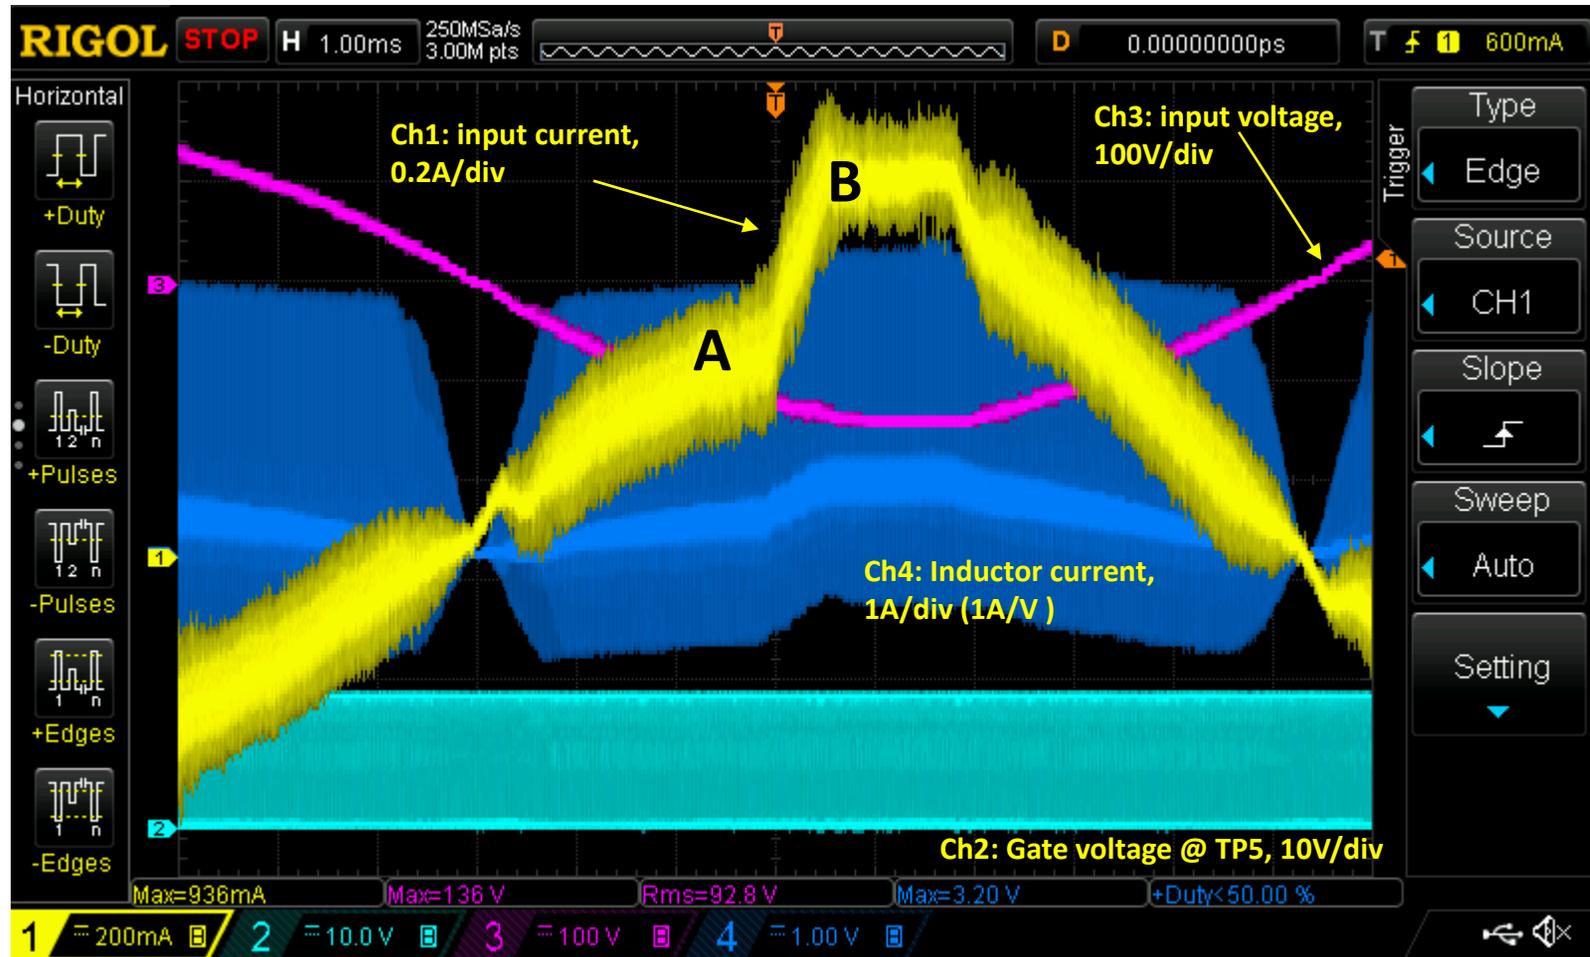
At ~100Vac input voltage, no C46, distortions started, notice the current surge from location A to B

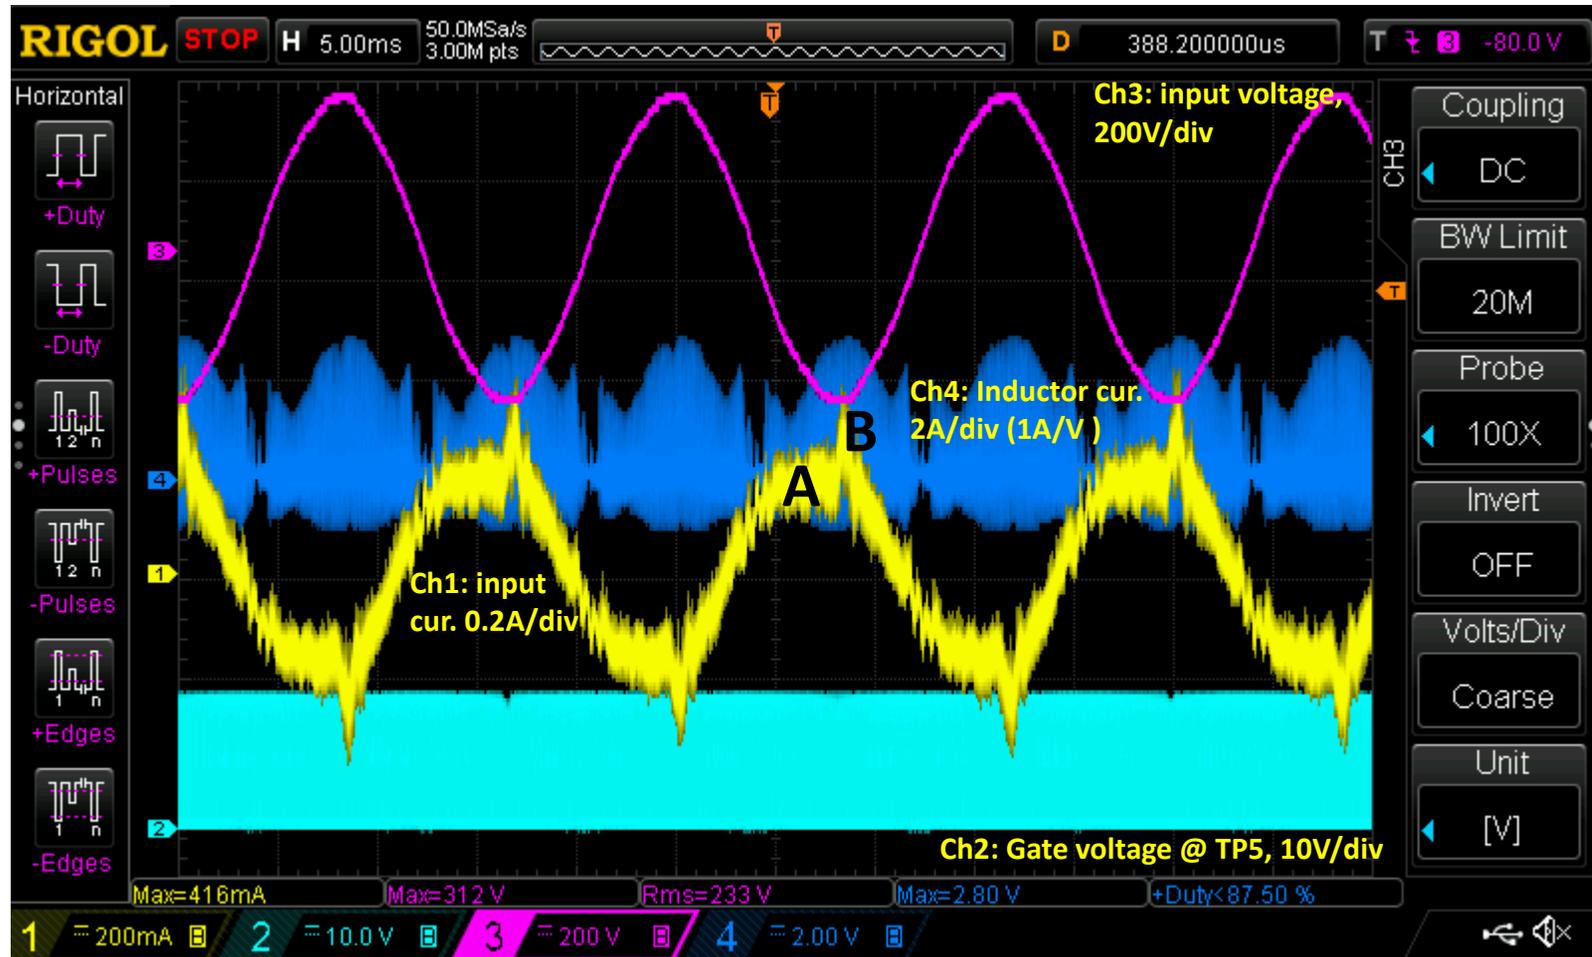
At ~230Vac input voltage, C46=100nF, symmetric distortions show up on peaks of voltage waveform

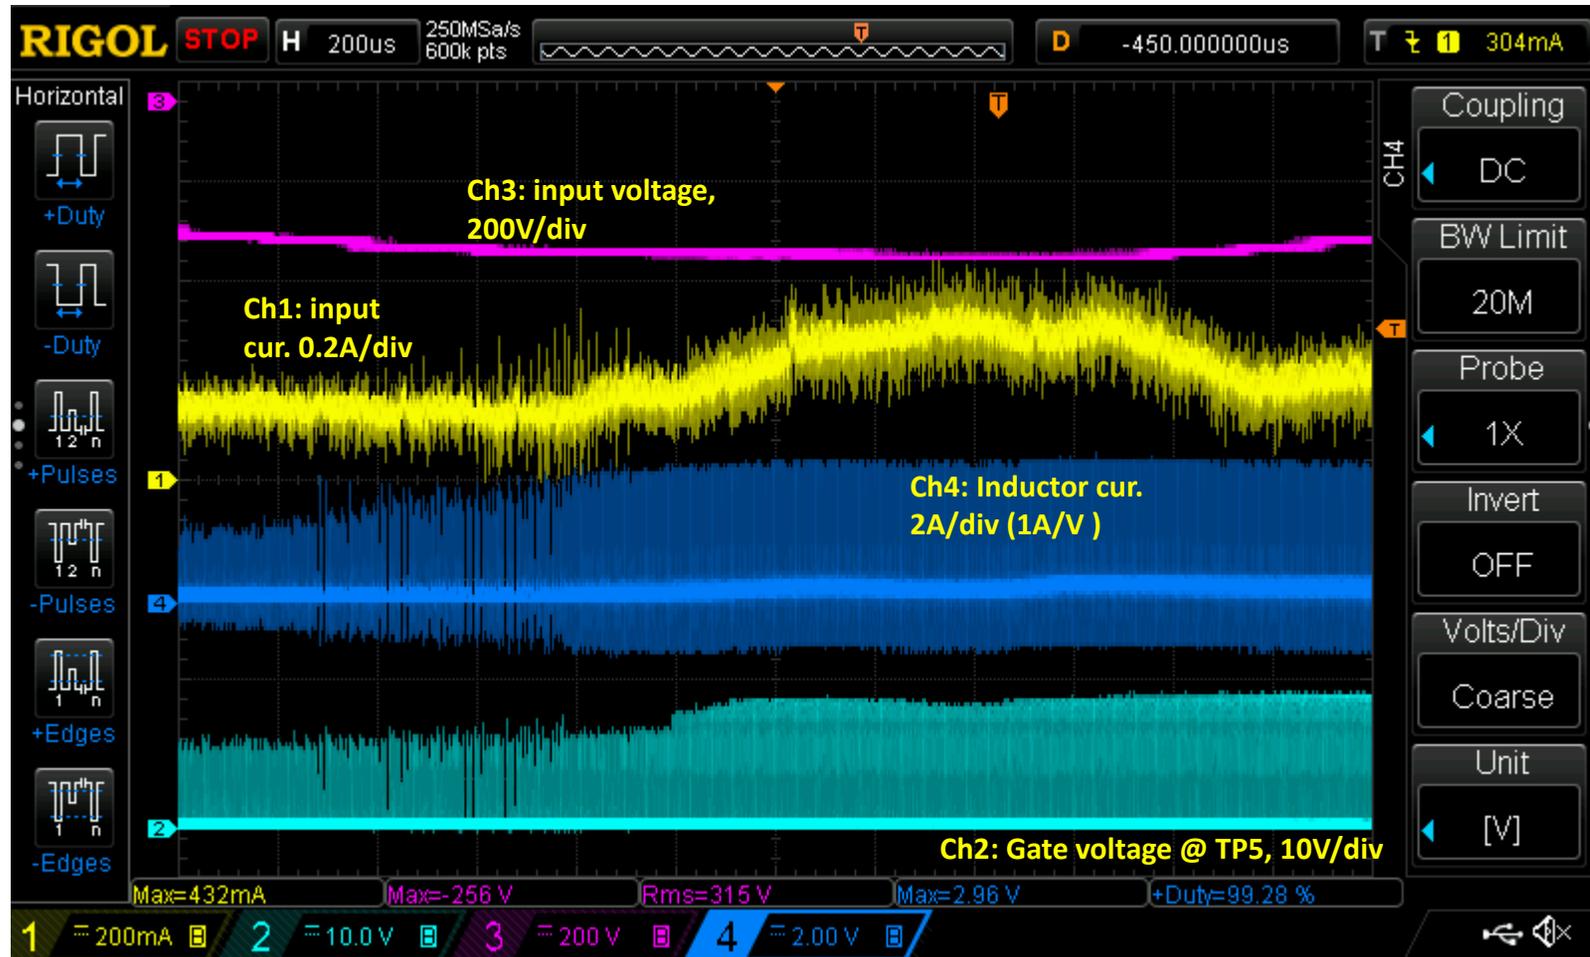
At ~230Vac input voltage, $C_{46}=100\text{nF}$, location A; ON times gets very small & pulses start to drop

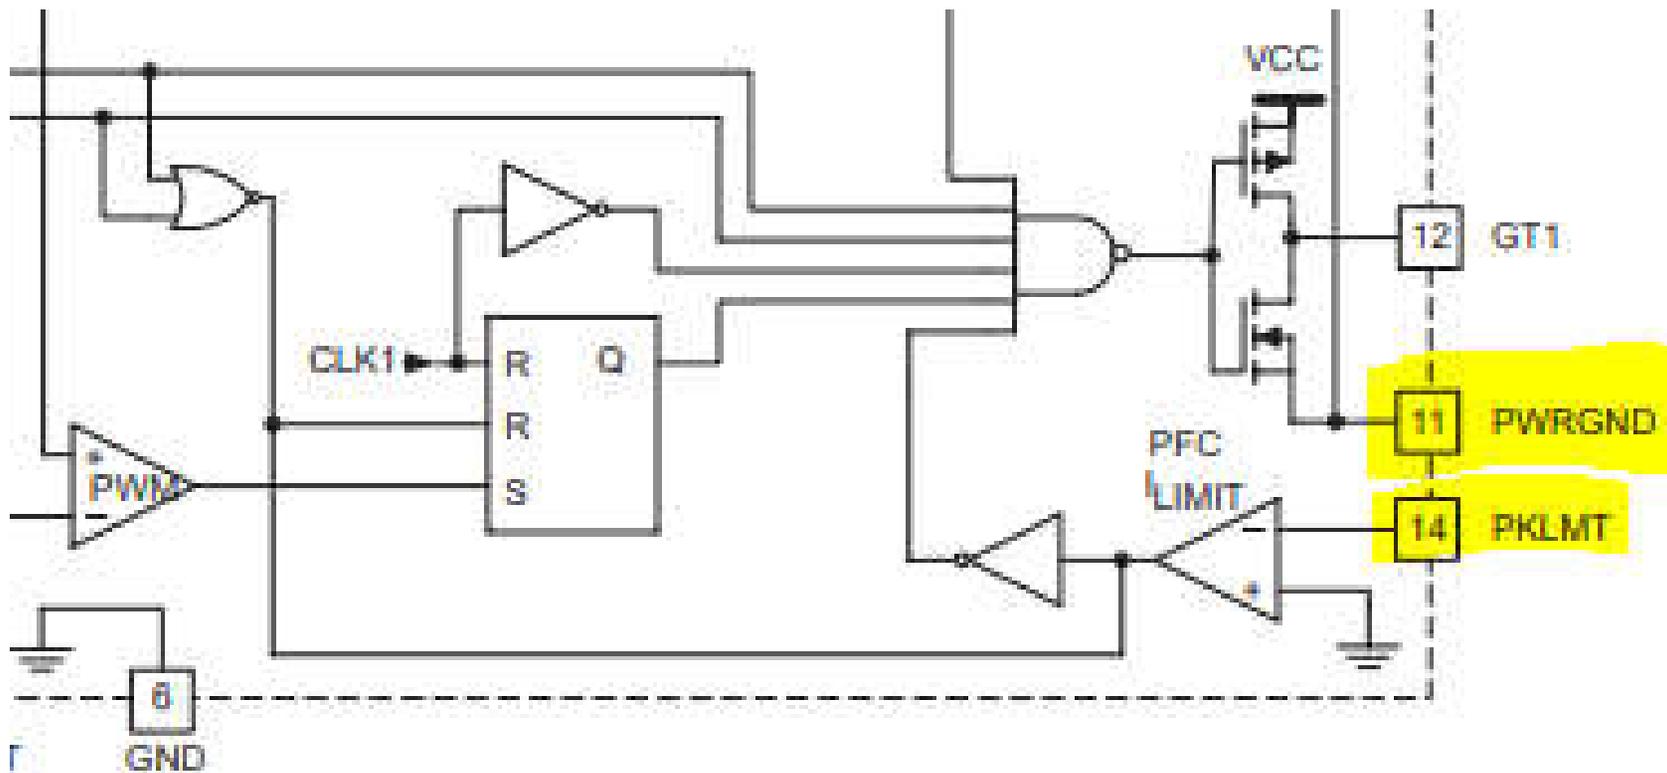
100pF leaded ceramic capacitor was connected from pin14 (PKLMT) to pin11 (PWRGND). No improve observed
After that, a 1nF capacitor was added from pin14 to pin11, and again no improvements were observed

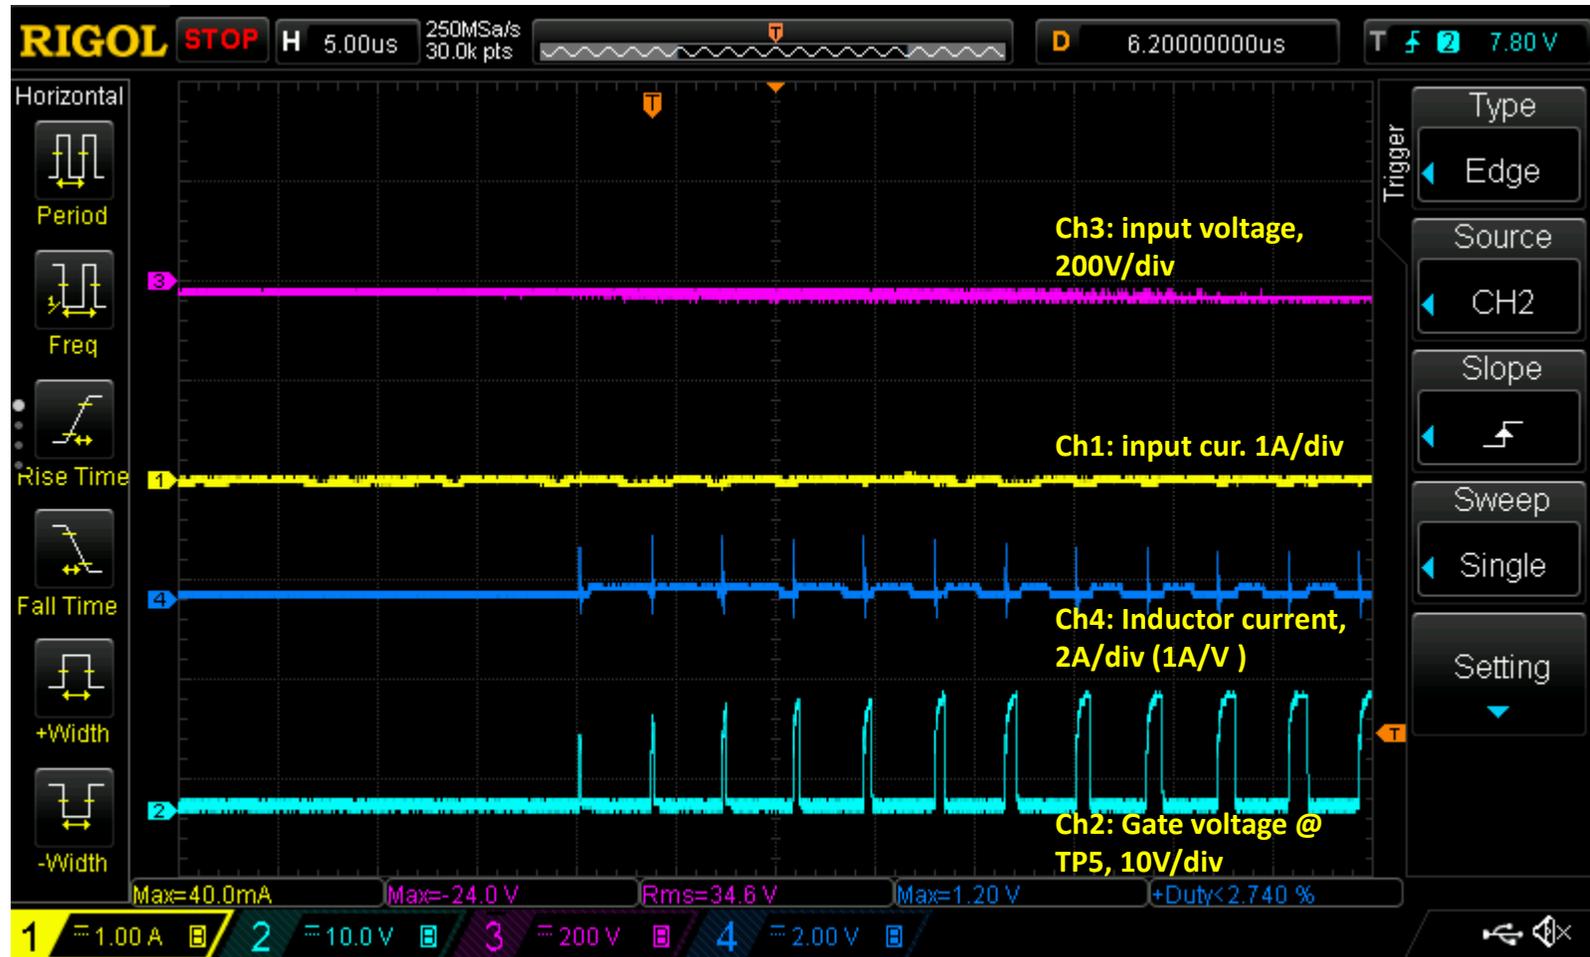
At the time when PFC stage starts operating, it seems like the ON time pulse-width starts from zero and increases slowly

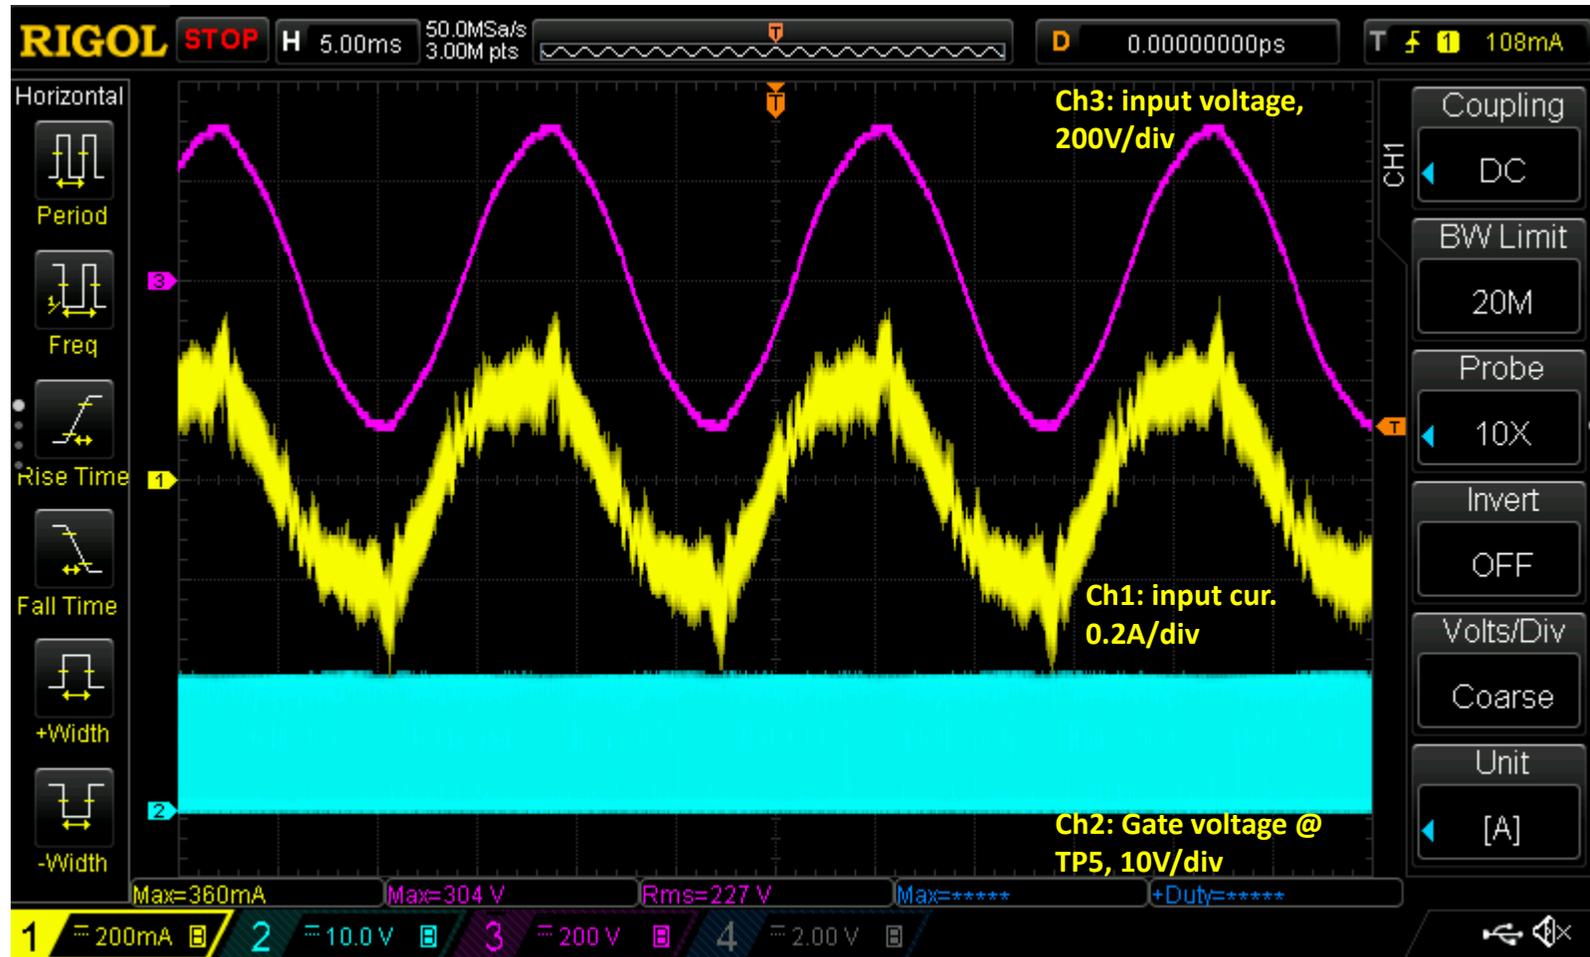
With 1nF from PKLMT (pin14) to GND (pin11), distortions start at around 220Vac
(also tried 100pF from pin14 to pin11, no improvements were observed)

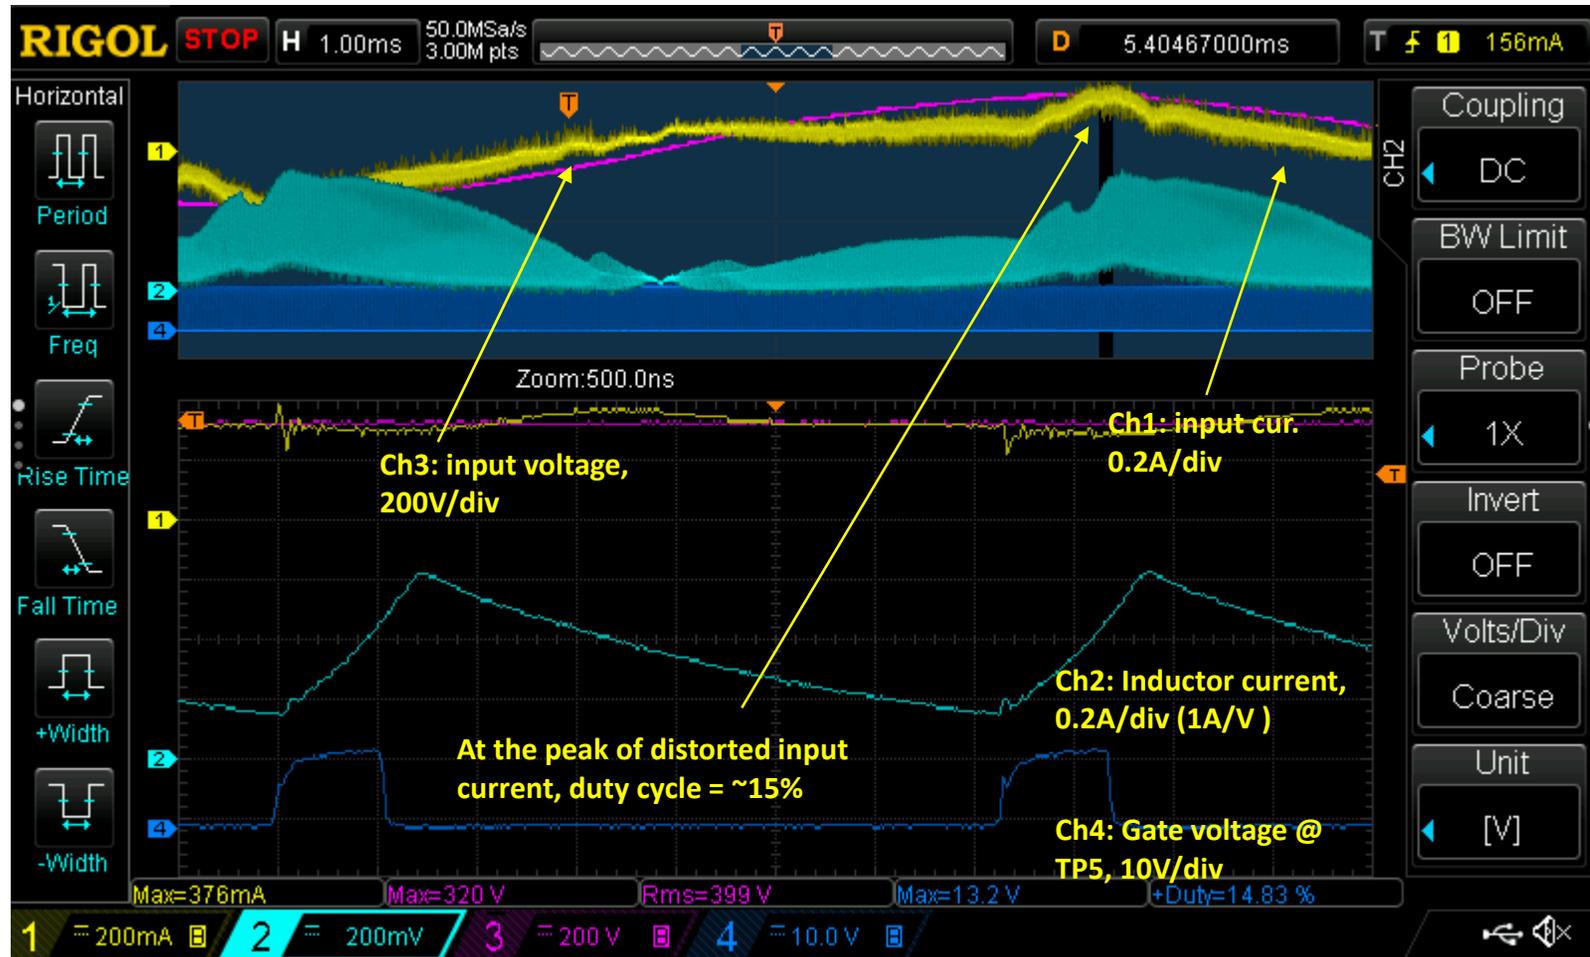
Homemade toroid inductor; @ 235Vac, major distortions in current waveform. Notice that there are no turn-on spikes in inductor current waveform

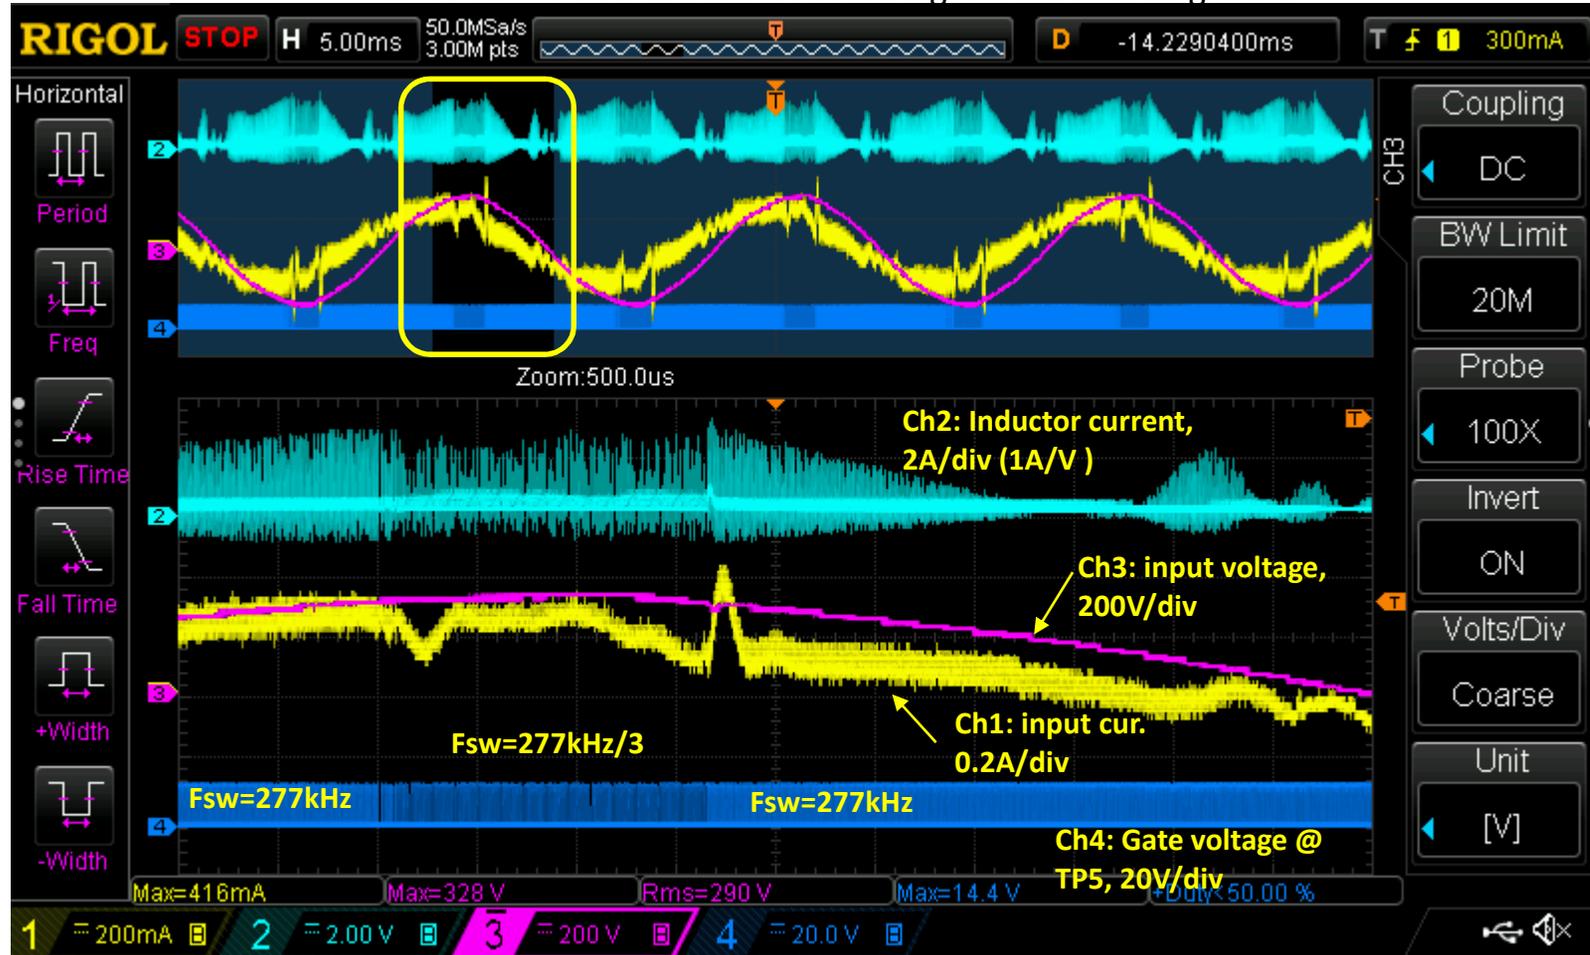
Notice that the switching frequency is reduced to 1/3rd at the peak of input voltage and then changes back to Fsw and current distortions are observed during the transitioning times

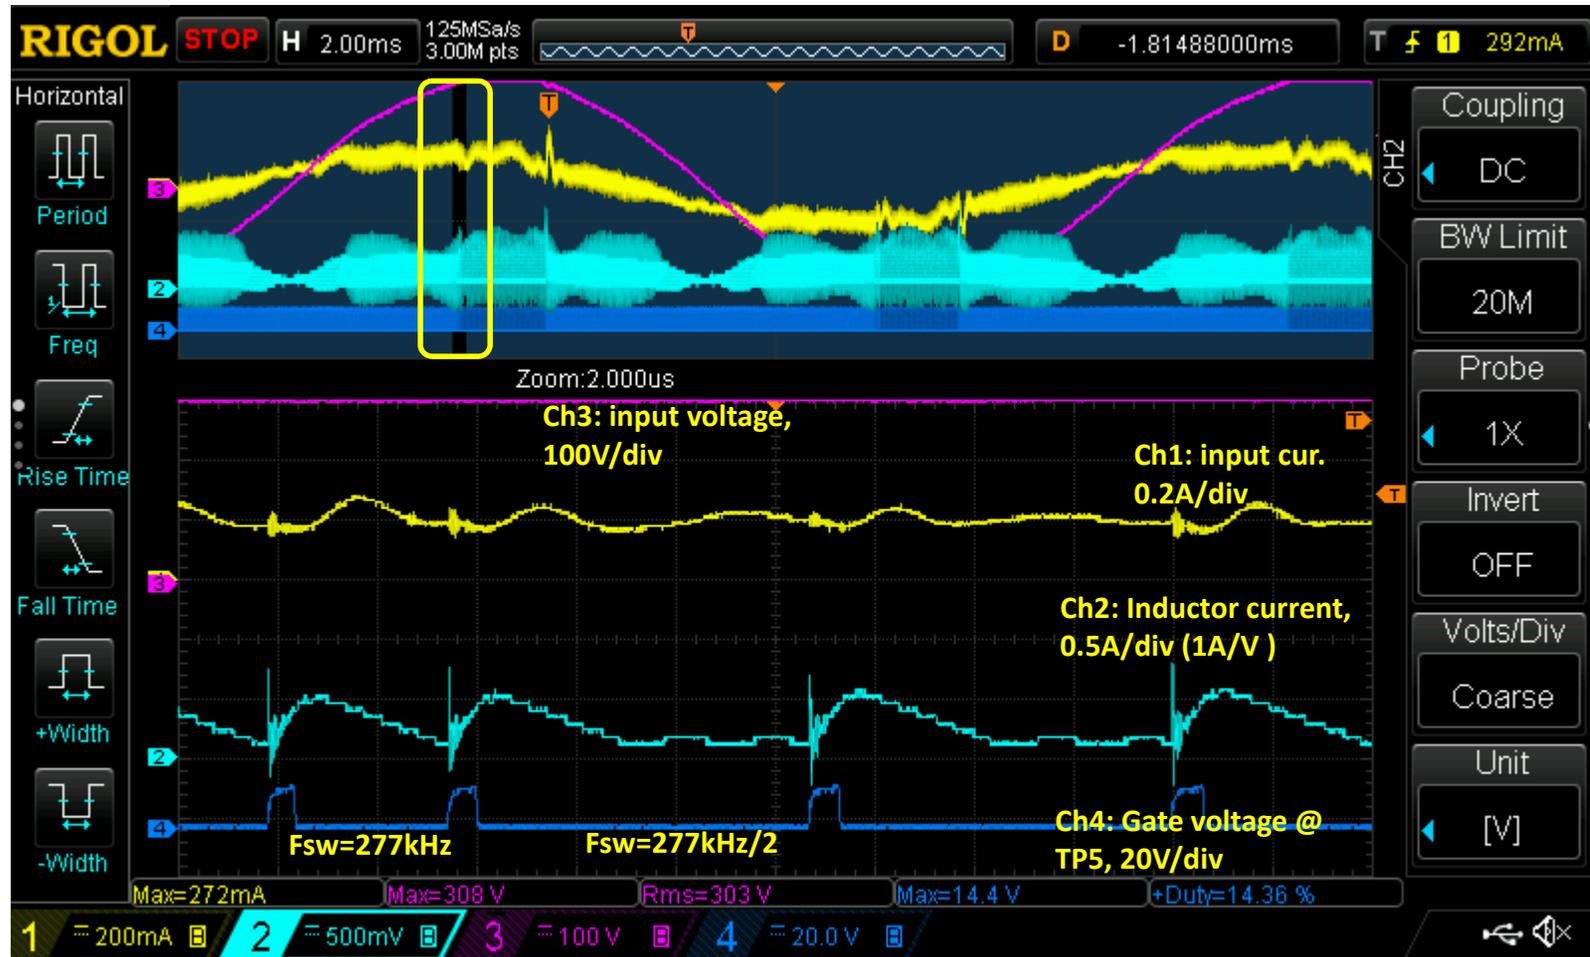
Distortions start at around 220Vac; as input voltage reaches its peak, switching frequency is reduced by half

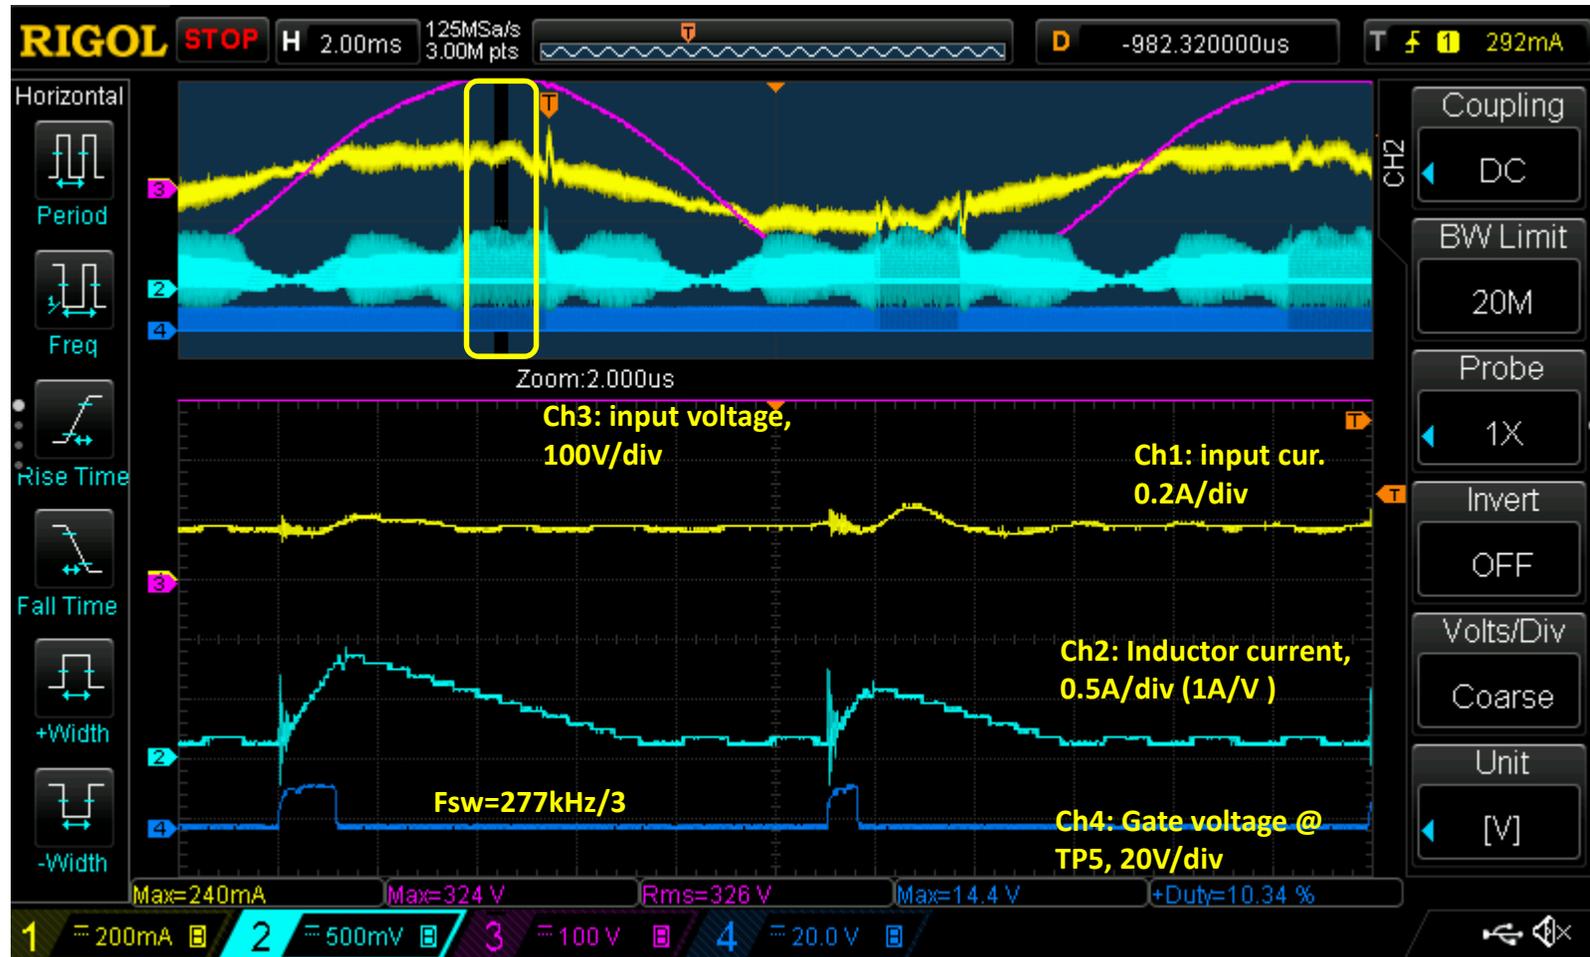
Distortions start at around 220Vac; at the peak of input voltage , switching frequency is reduced to 1/3 rd

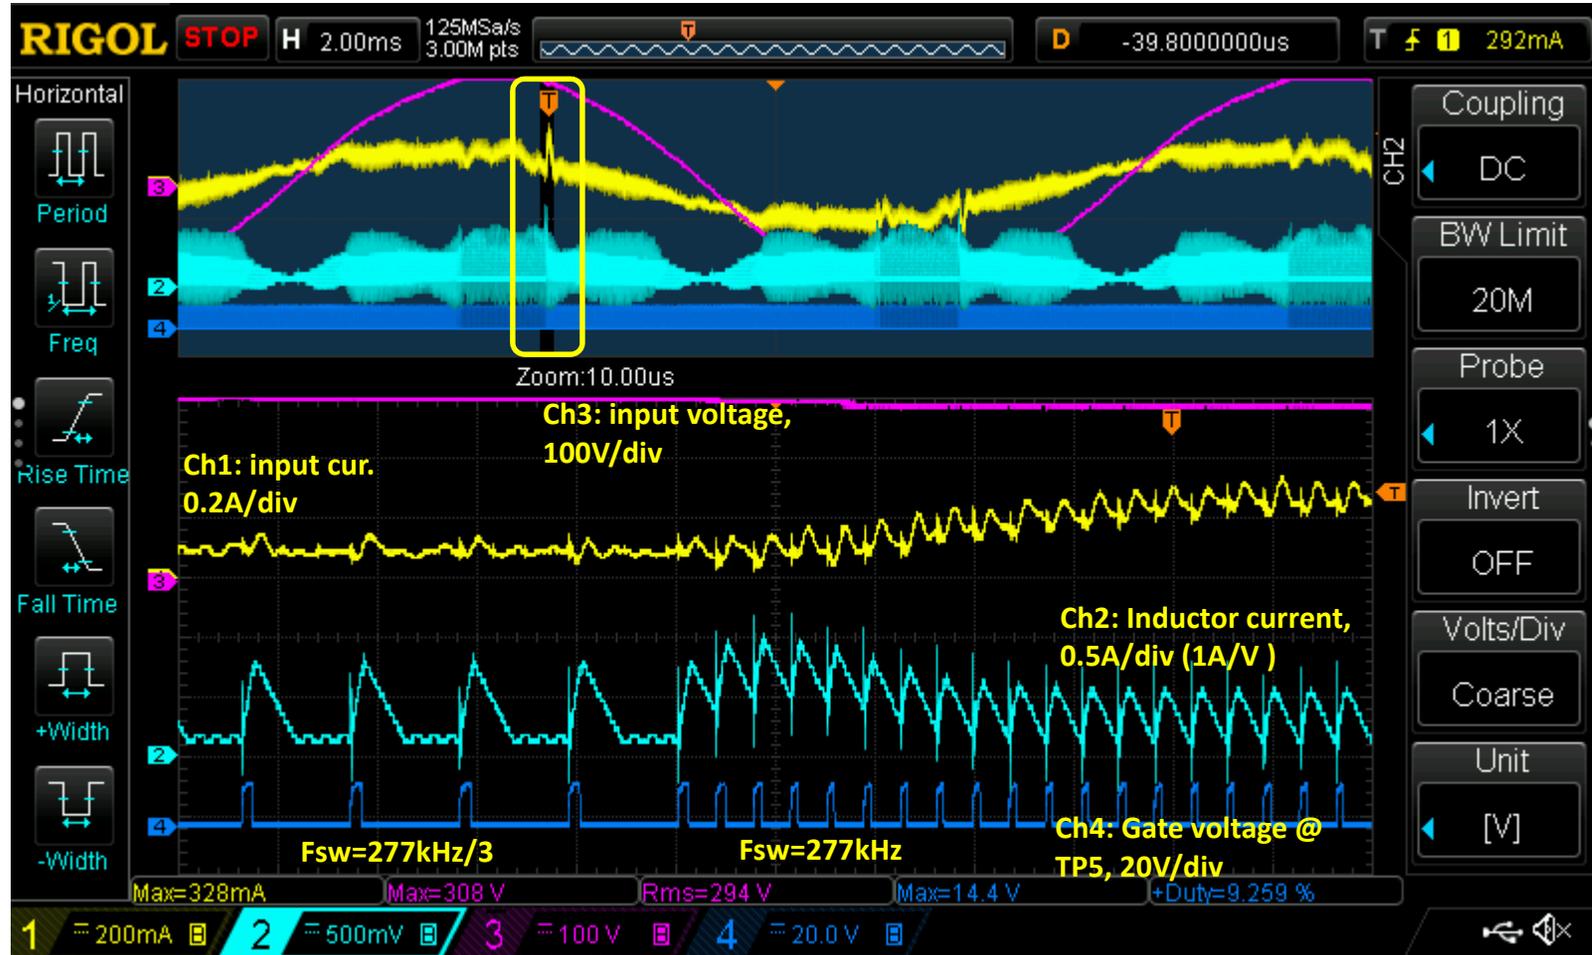
Distortions start at around 220Vac; current distortions observed as the switching frequency changes back to 277kHz

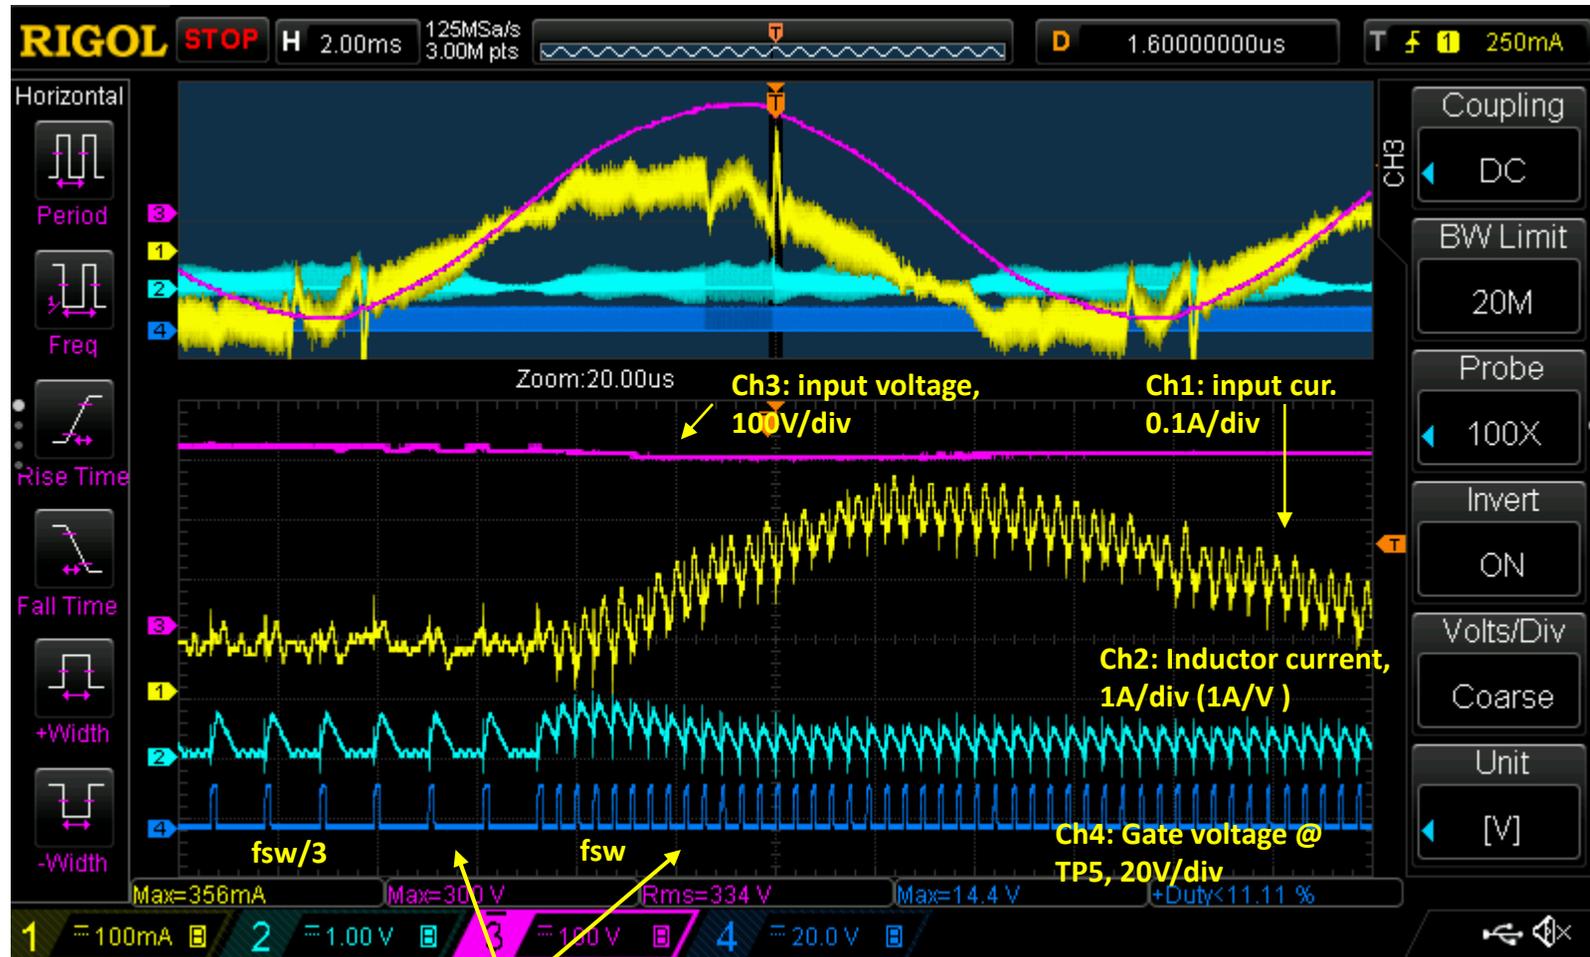
At around 230Vac, current distortions appear

Switching frequency was reduced to 1/3rd and then increased back; at which point current spike was observed

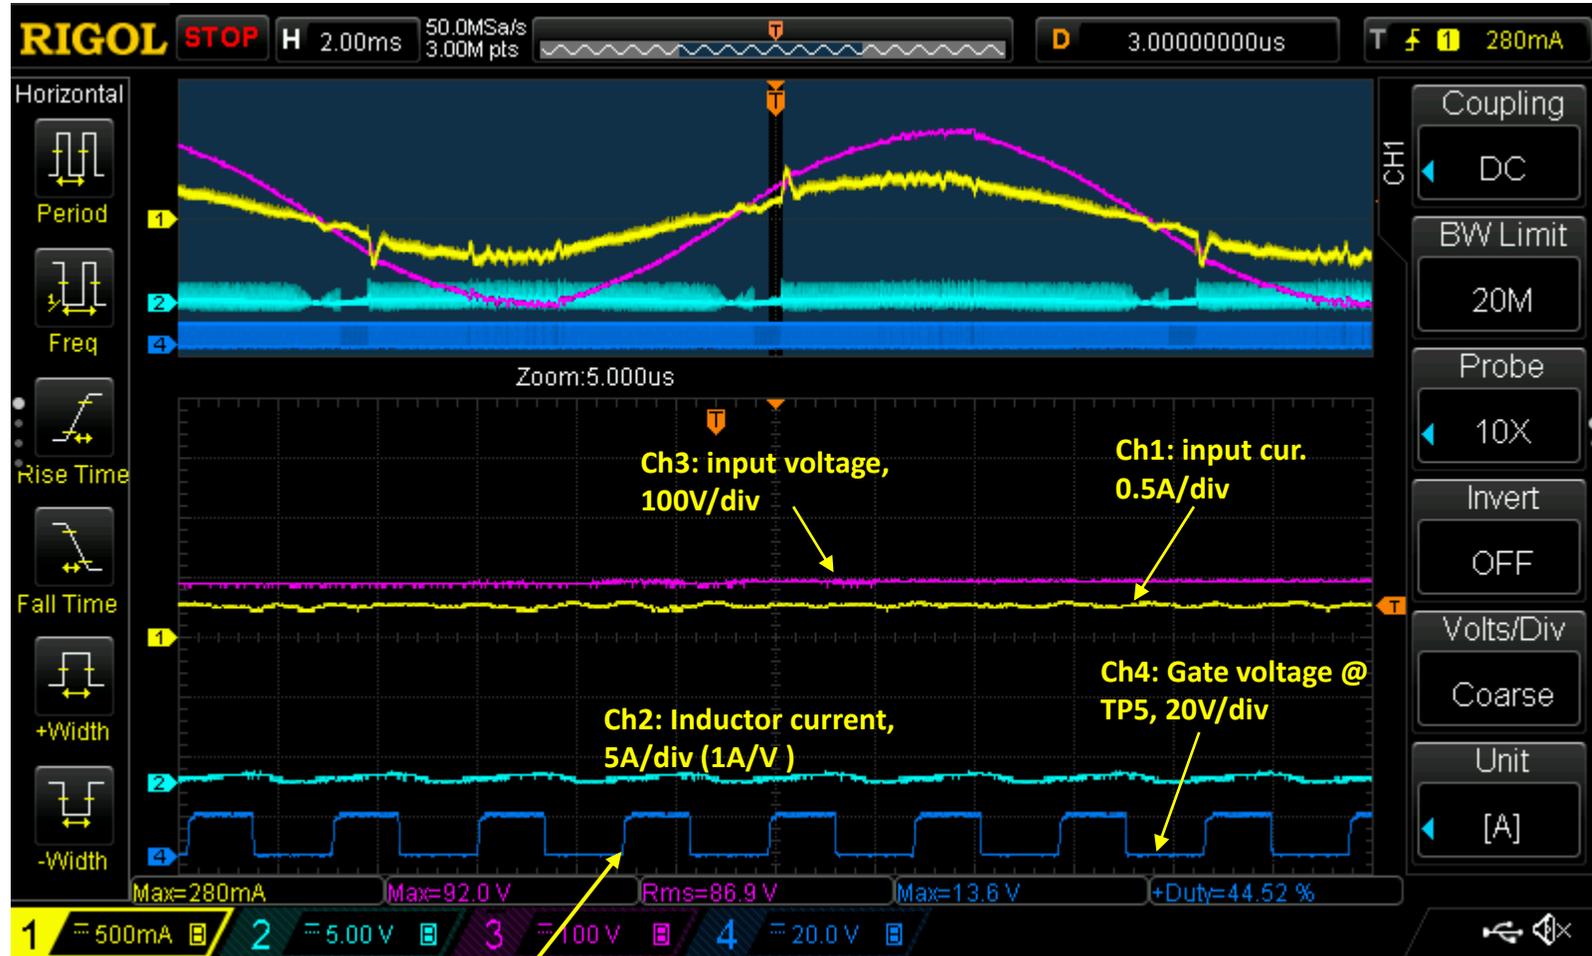
With original inductor and 60W output power, distortions at slightly different locations started at even lower voltage, 180Vac

Switching frequency was reduced to fsw/s , duty cycle was ~50% prior to current spike
