UCC28513 questions, Alex W., 11/17/2022

- The boost stage design is based on UCC28513. The PFC stage works well up to 200-220Vac input. Above this voltage range there are significant distortions at the points where sinusoidal input voltage reaches to its positive and negative peaks
- Output voltage is 385Vac
- Input voltage range is 85-264Vac; 50/60Hz
- The load on DC link output is 120W max
- Boost stage switching frequency is 277kHz
- Verified that the Vcc aux supply and Vref are stable
- Observed that the AC ripple on DC link goes up at around 200Vac but not sure if this is the reason or the result
- Observed that the duty cycle is about 70% at the peak sine wave at 85Vac but drops down to ~15% at the peaks of 220Vac at which point I start get distortions on the input current.
- The provided test results are at ~30W output power. It was observed that changing the load did not affect the behavior at around 220Vac.

UCC28513 questions to TI, Alex W., 11/17/2022

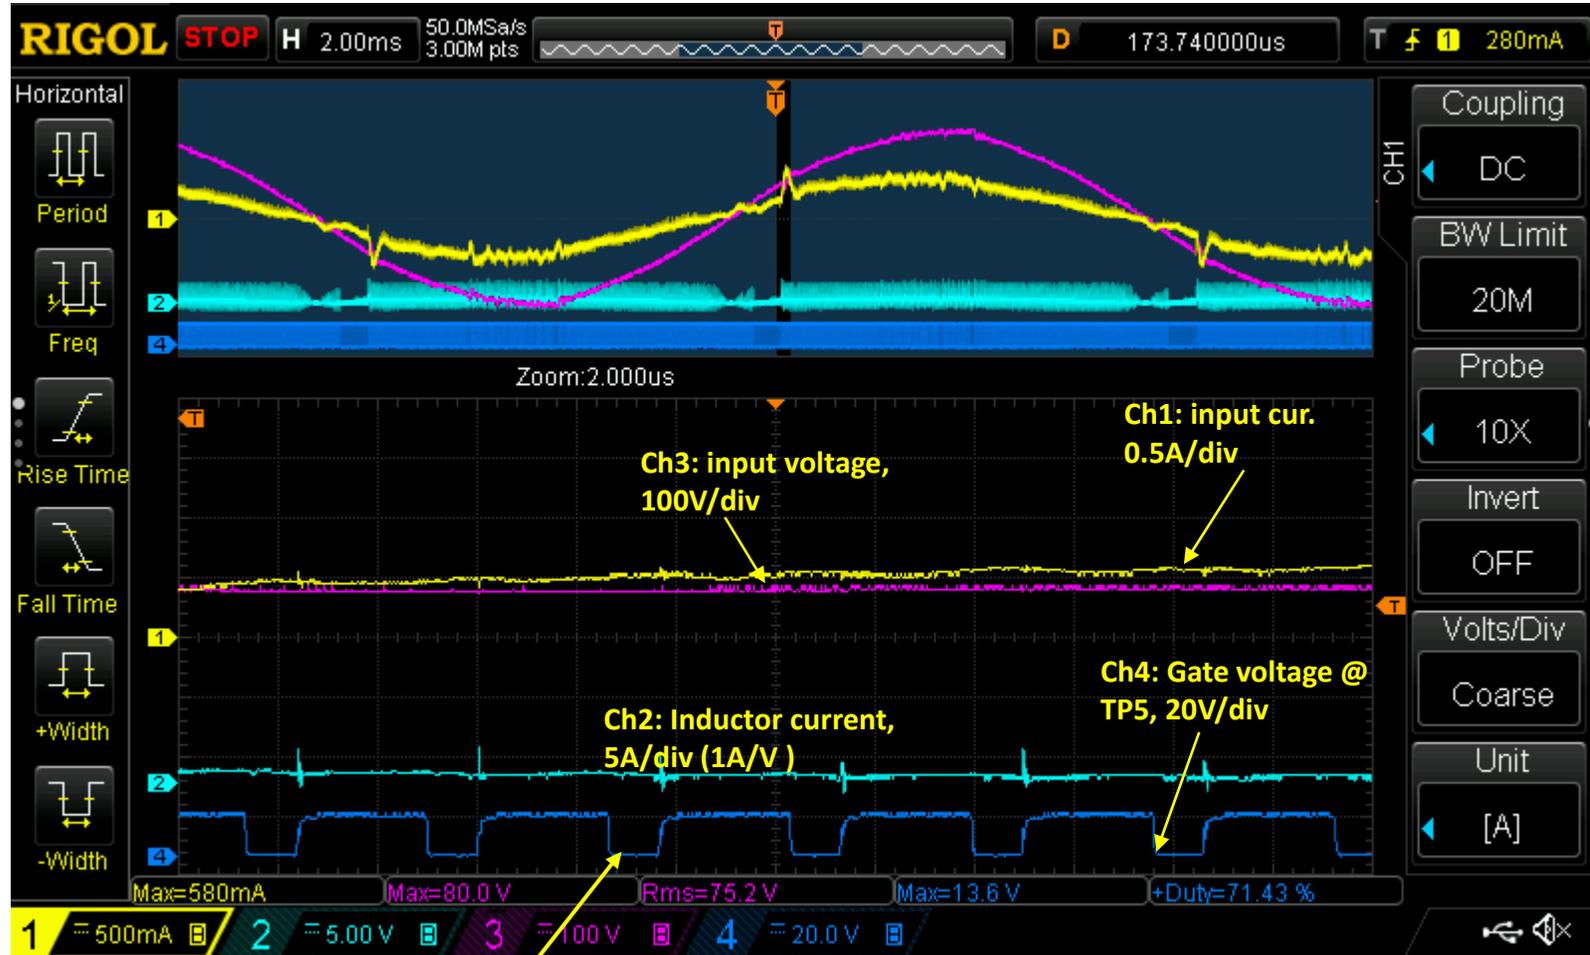
With original inductor and 60W output power, distortions at slightly different locations started at even lower voltage, 180Vac

Switching frequency was increased back to fsw; at which point current spike was observed, duty cycle was about 70%

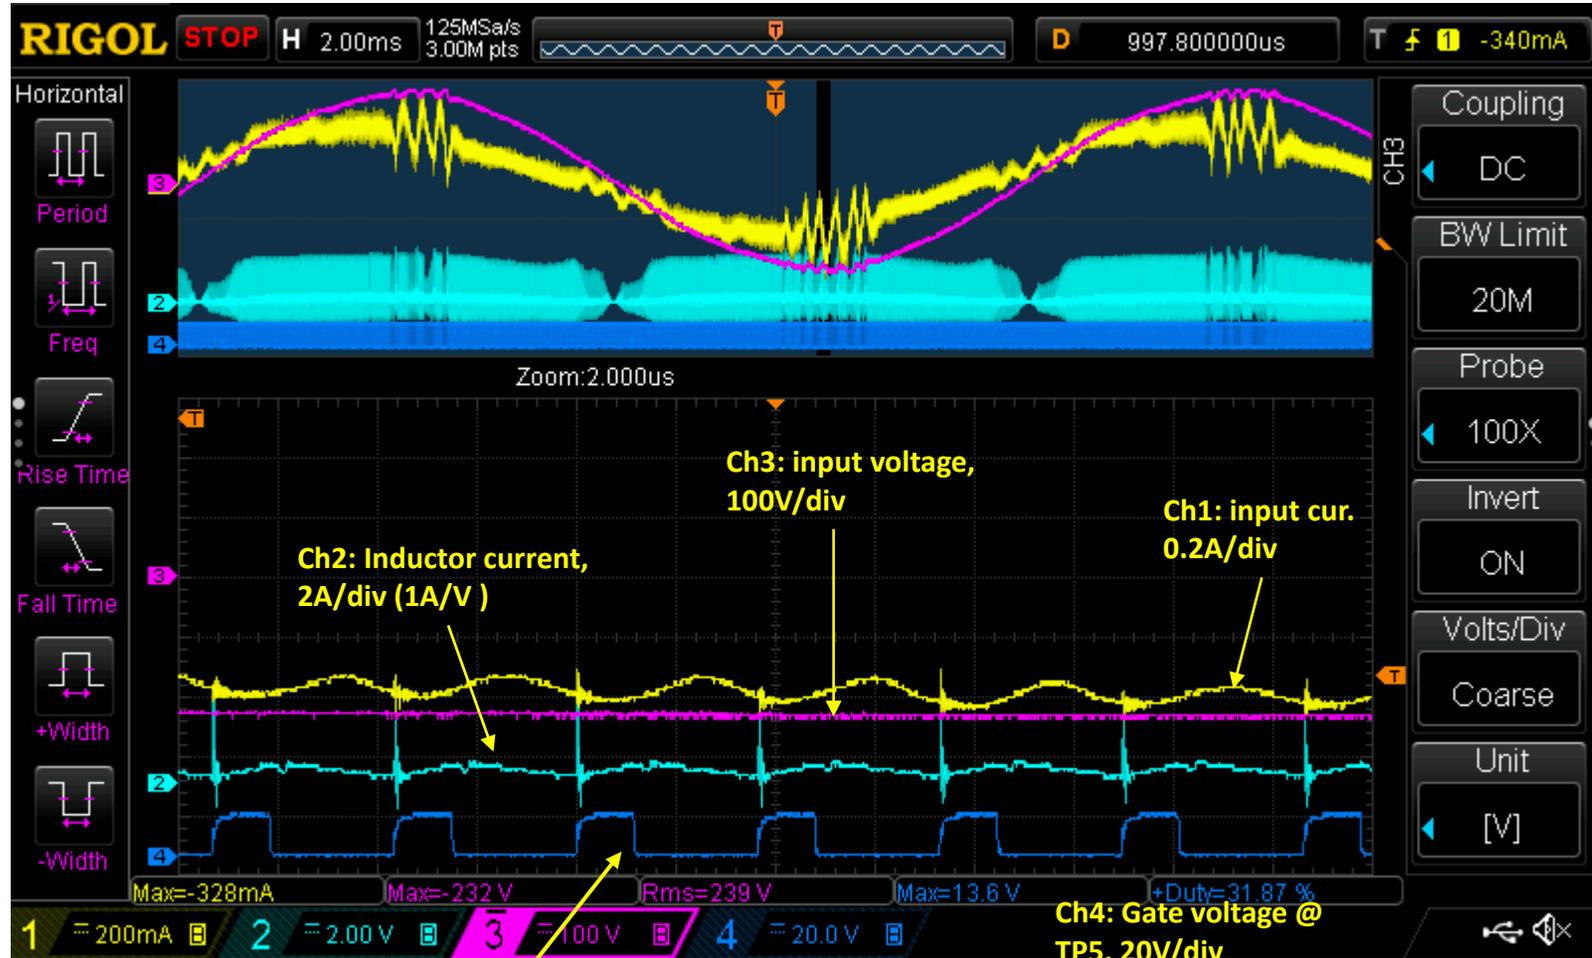
With original inductor, 30W output power and lac connection moved to input of rectifier, major distortions at 180Vac

Switching frequency was normal and duty cycle was about 32% (notice that the on-time was constant)

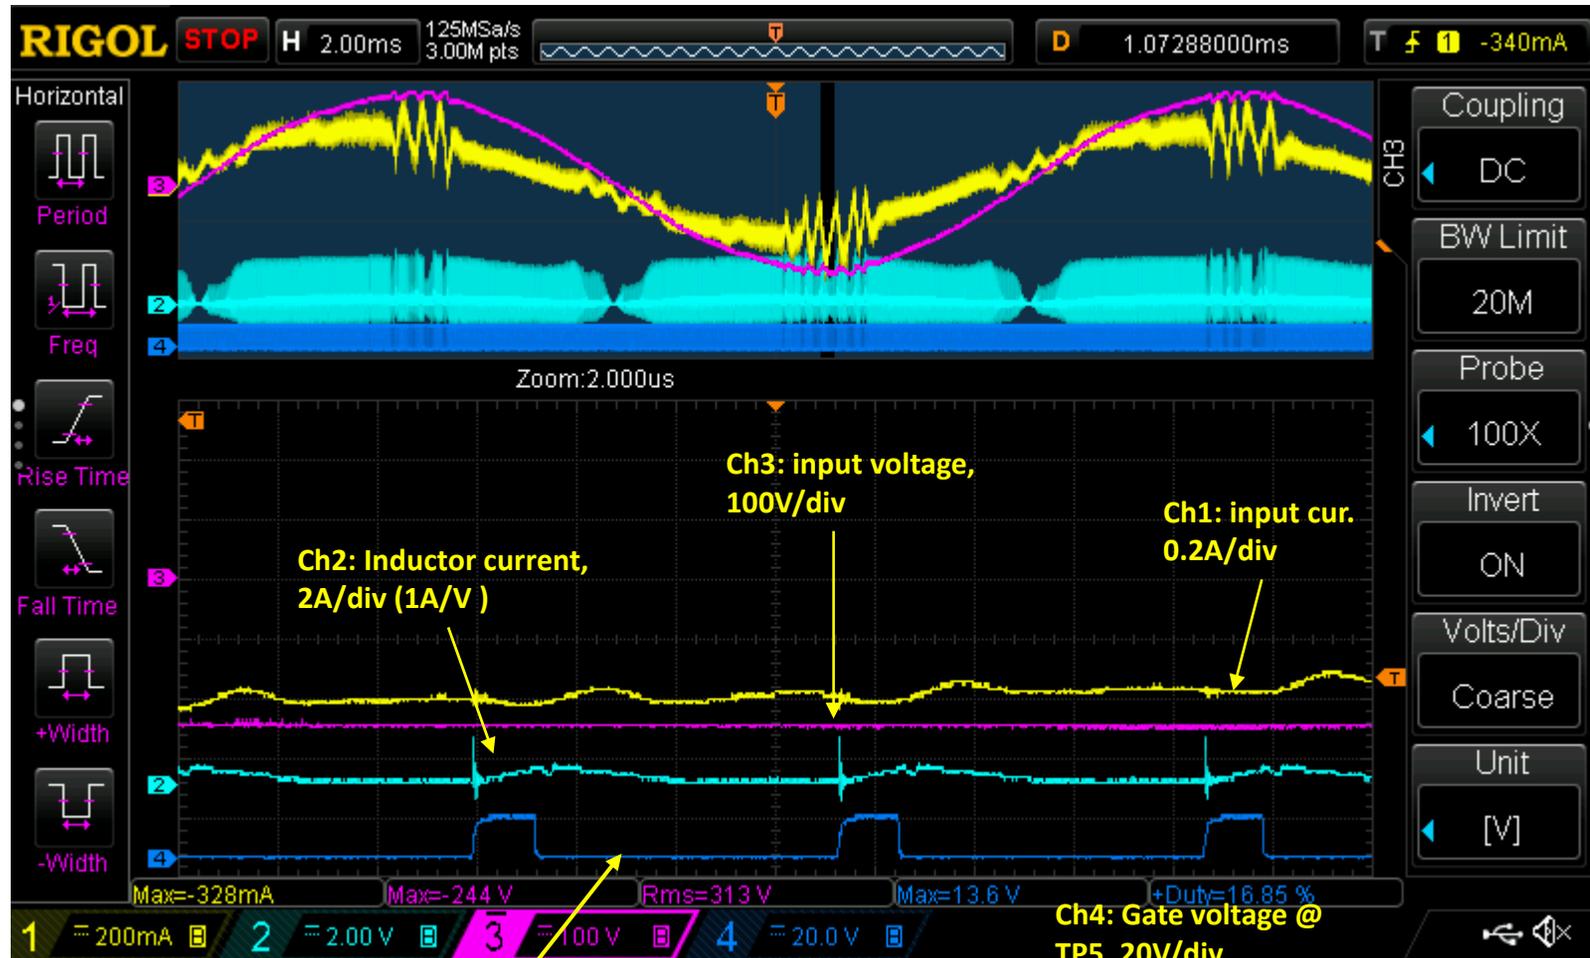
With original inductor, 30W output power and lac connection moved to input of rectifier, major distortions at 180Vac

Switching frequency was reduced to $f_{sw}/2$ and duty cycle was about 16% (notice that the on-time was constant)

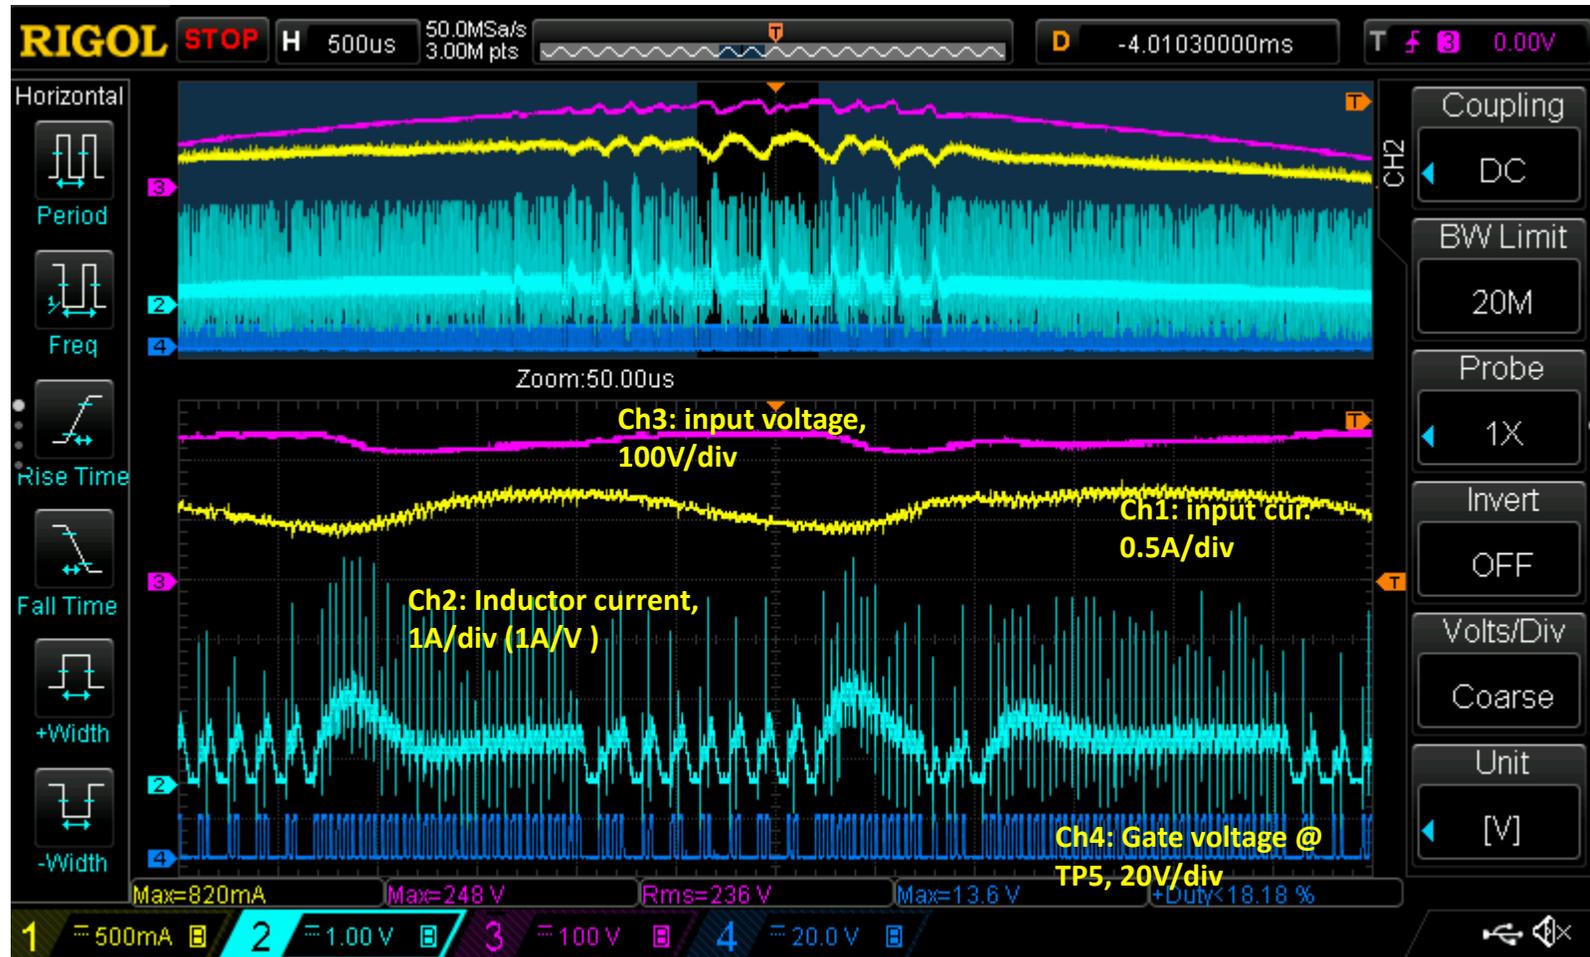
With original inductor, 60W output power and lac connection moved to input of rectifier, major distortions at ~180Vac

Same phenomenon observed; switching frequency was reduced and then increased, at which time current spike was observed
