- The boost stage design is based on UCC28513. The PFC stage works well up to 200-220Vac input. Above this voltage range there are significant distortions at the points where sinusoidal input voltage reaches to its positive and negative peaks
- Output voltage is 385Vac
- Input voltage range is 85-264Vac; 50/60Hz
- The load on DC link output is 120W max
- Boost stage switching frequency is 277kHz
- Verified that the Vcc aux supply and Vref are stable
- Observed that the AC ripple on DC link goes up at around 200Vac but not sure if this is the reason or the result
- Observed that the duty cycle is about 70% at the peak sine wave at 85Vac but drops down to ~15% at the peaks of 220Vac at which point I start get distortions on the input current.
- The provided test results are at ~30W output power. It was observed that changing the load did not affect the behavior at around 220Vac.

### **Questions:**

1. Based on the design values, what could potentially cause the distortions at the peak of sine waves at and above ~ 200Vac?
2. Fig. 36 on data sheet talks about max capacitance vs min duty cycle. What capacitor is referred in Fig 36?

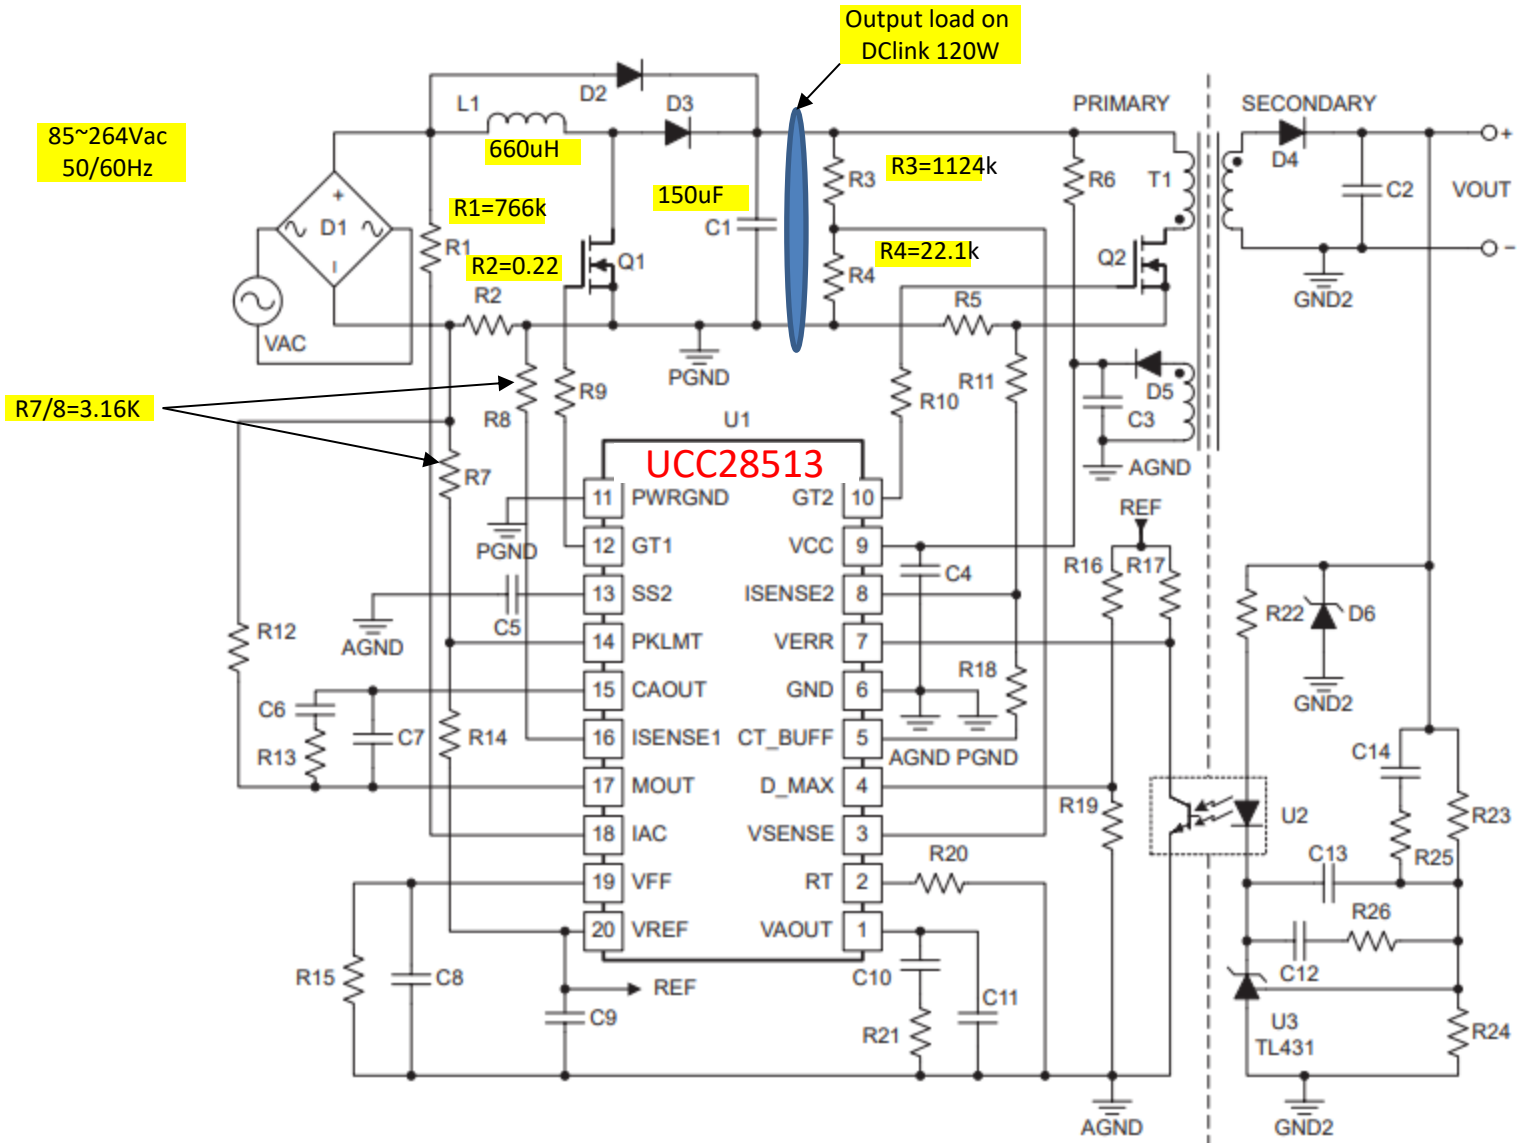
RefDes on data sheet	RefDes in design	values
R1	R47+R50	766K
R2	R43	0.22
R8/R12	R4/R9	3.16K
R3	R44+R49	1124K
R4	R60	22.1k
C1	C32	150uF
L1	L2	660uH
R13	R10	15.8K
C6	C6	680pF
C7	C8	150pF
R15	R11	30.1K
C8	C9	4.7uF
C10	C1	1.5uF
C11	C2	150nF
R21	R1	48.7K
R14	R13	10K
R7	R5	1.18K
C9	C4	1uF

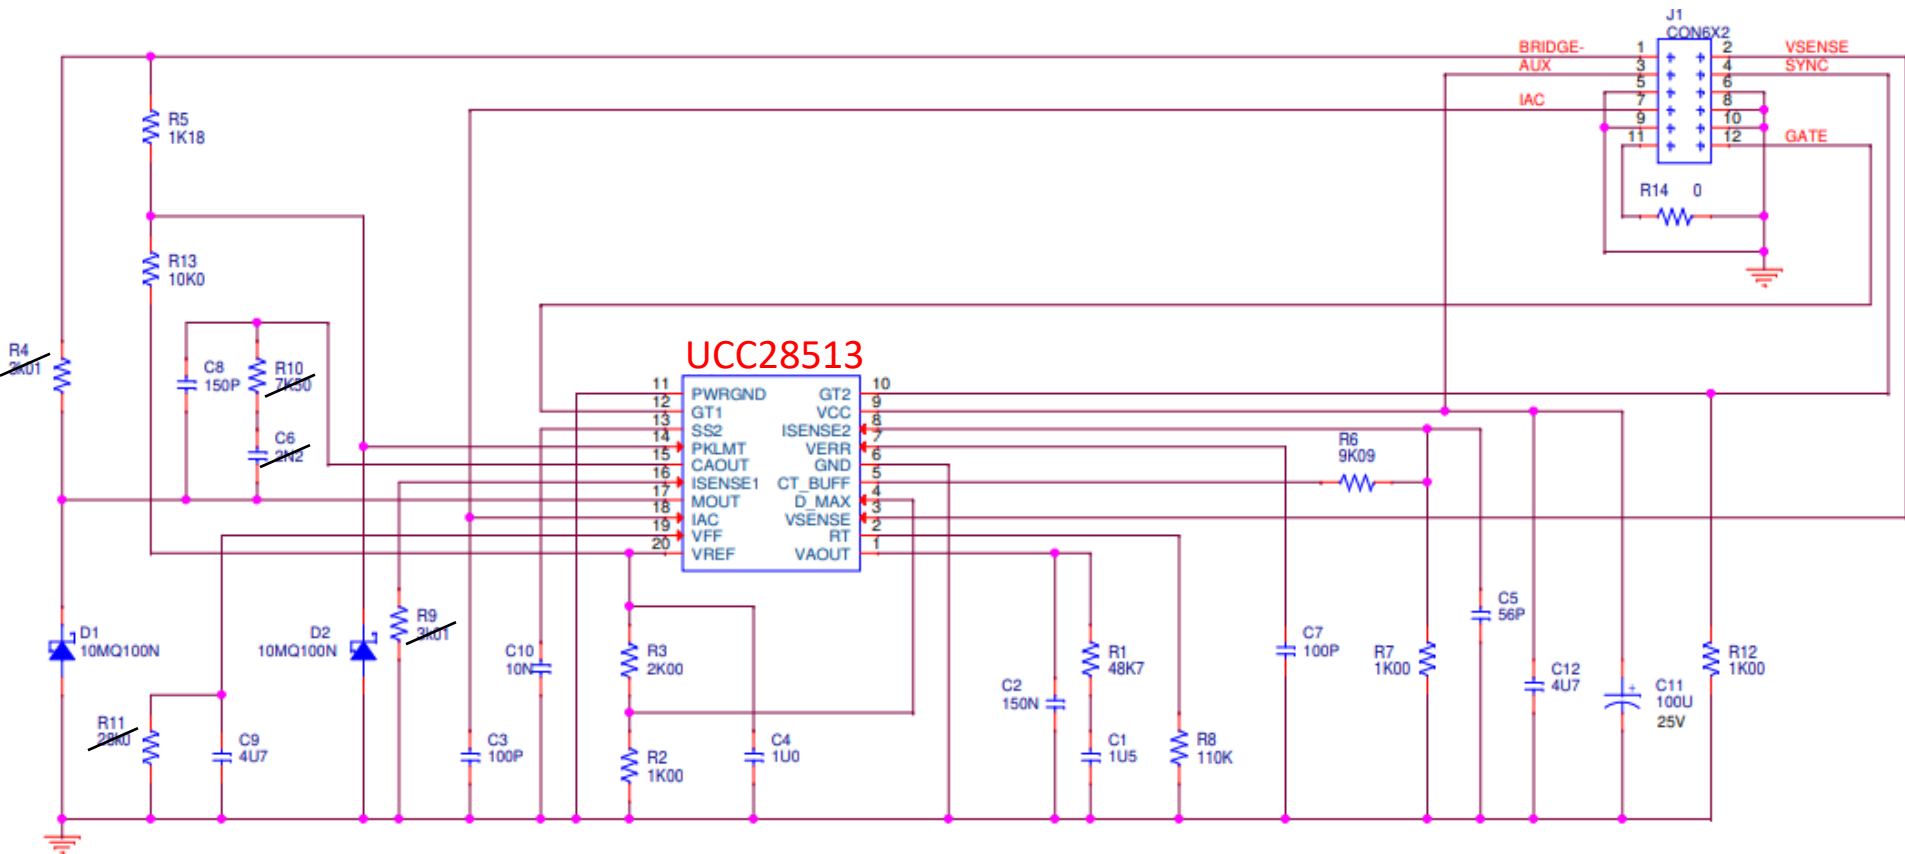
RefDes on data sheet	RefDes in design	values
R8/R12	R4/R9	3.16K
R13	R10	15.8K
C6	C6	680pF
R15	R11	30.1K

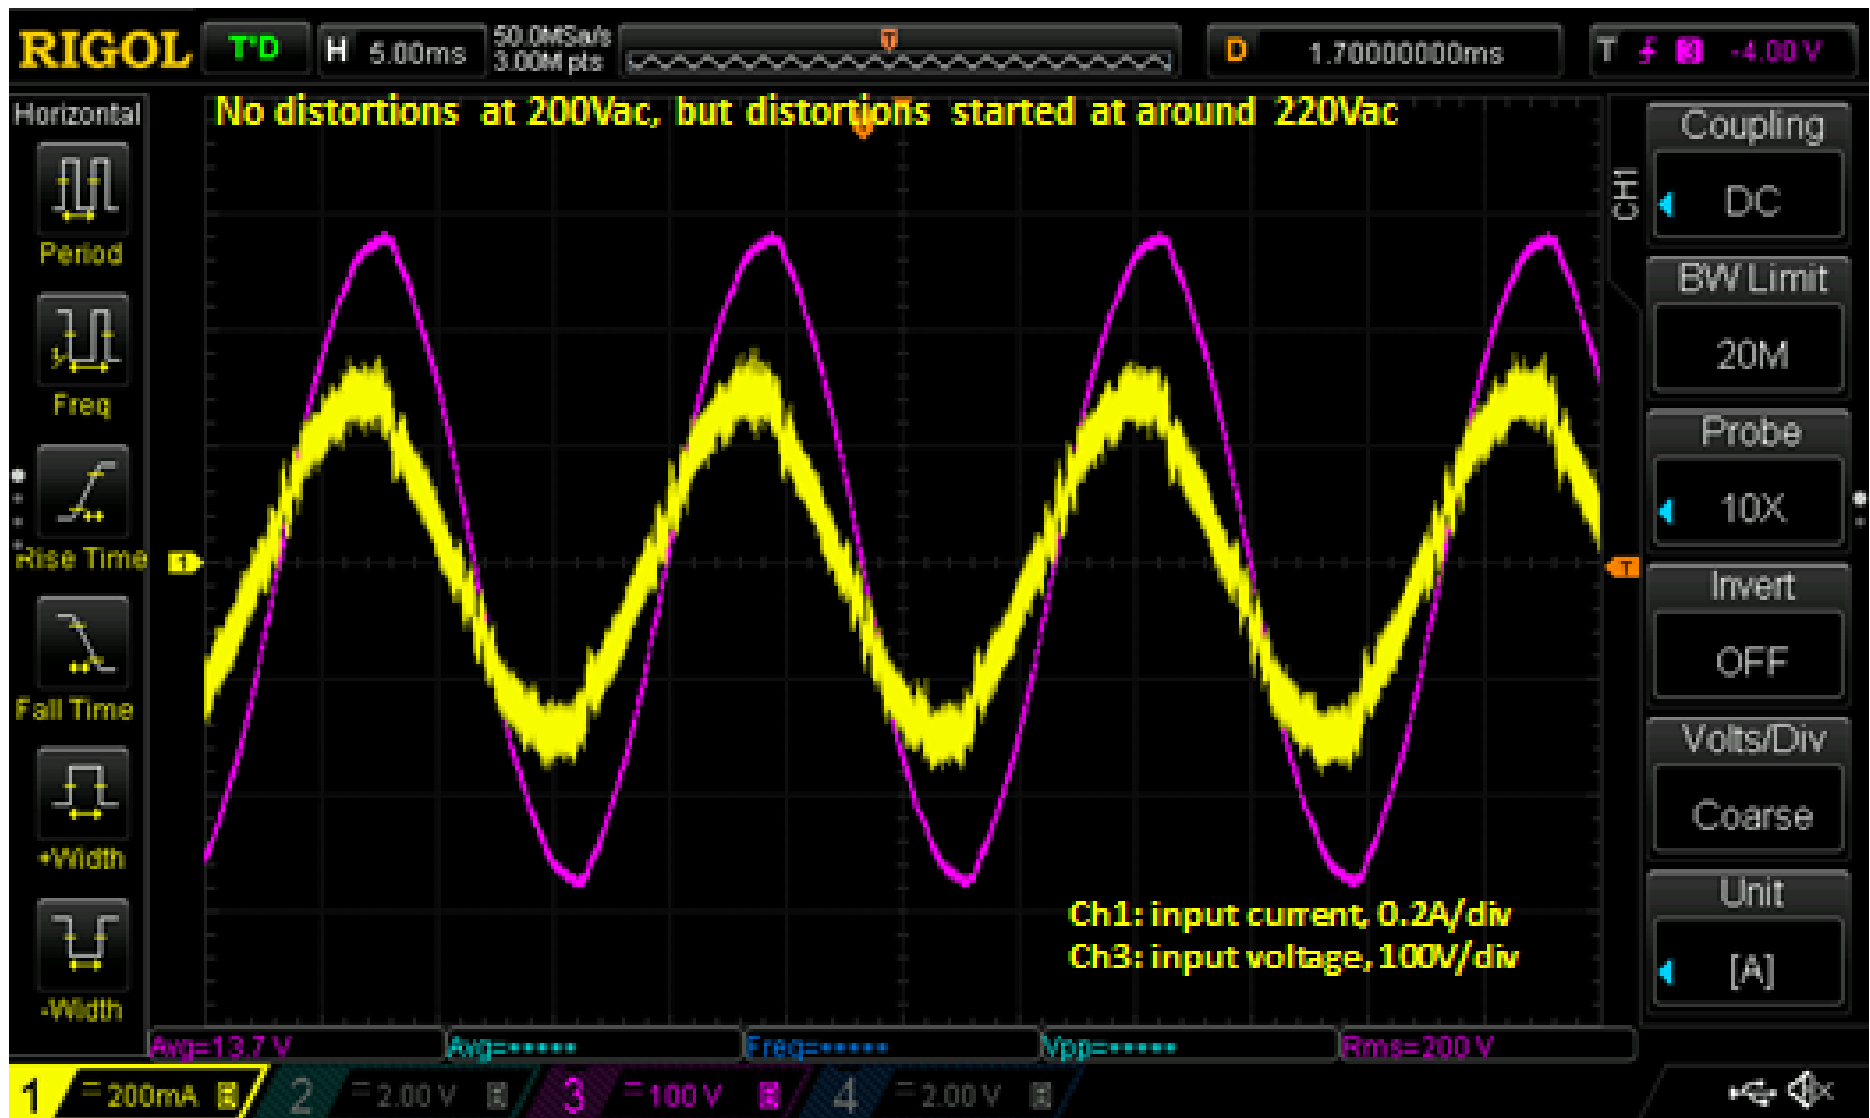
No distortions at 200Vac input, displacement between current and voltage is probably caused by the input capacitors on EMI filter

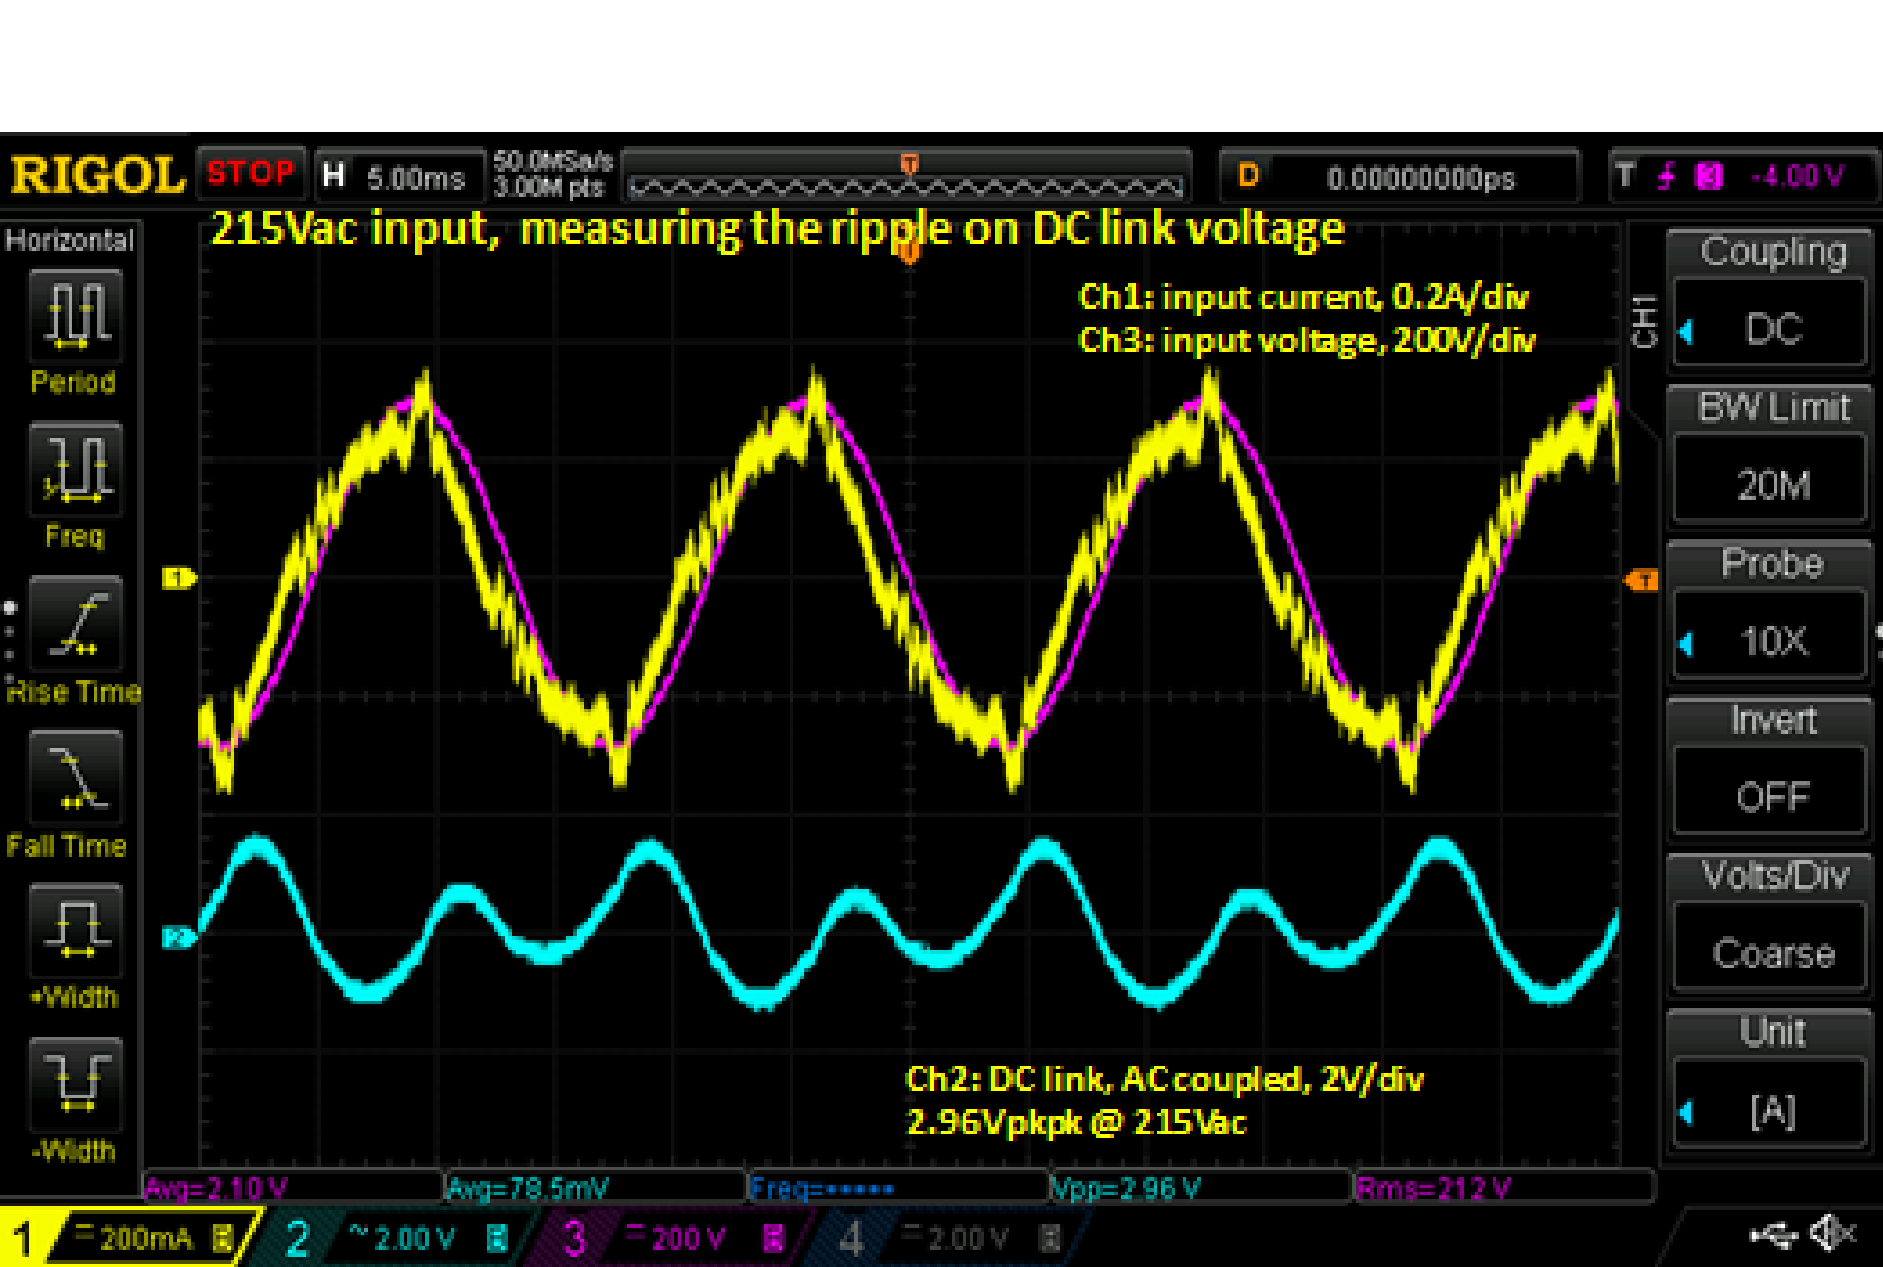
### 200Vac input, measuring the ripple on DC link voltage

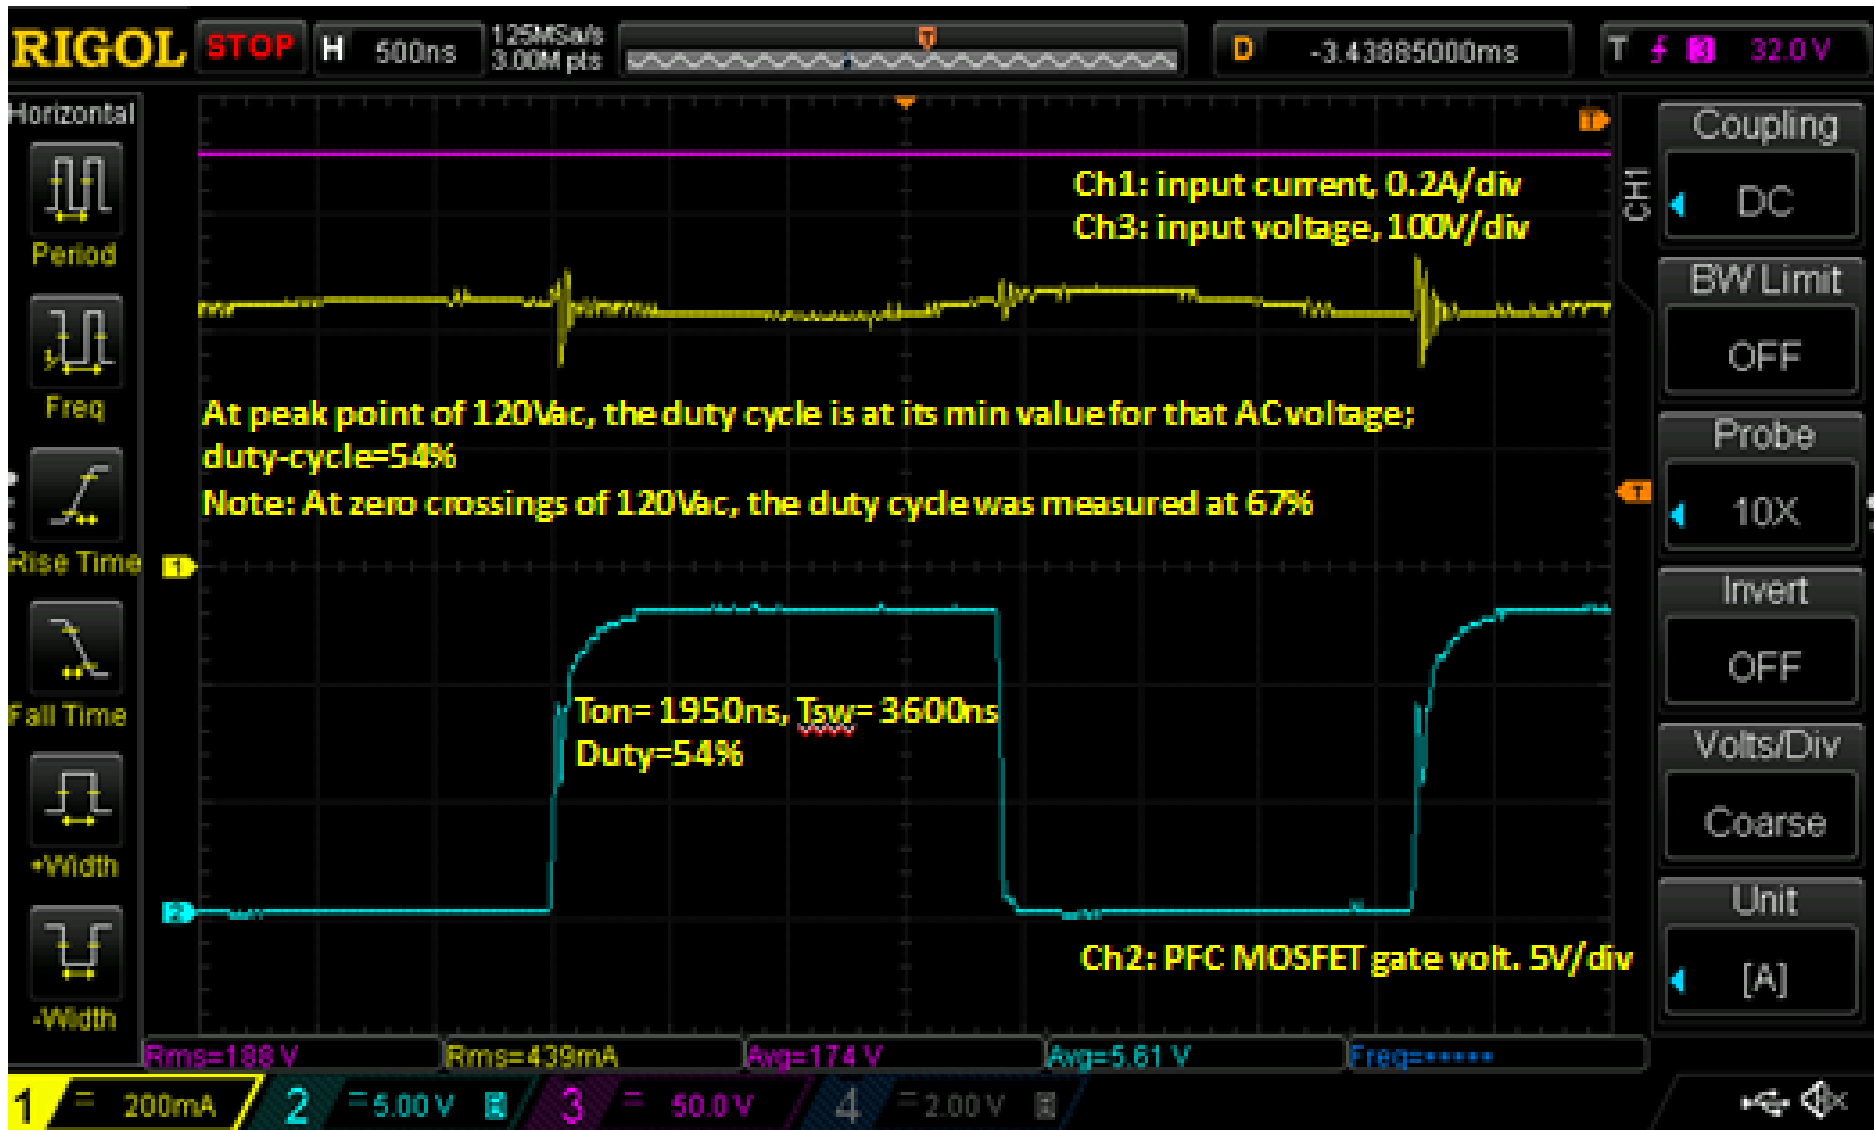
At the peak of sinewaves at 120Vac, the duty cycle of boost MOSFET is about 54%

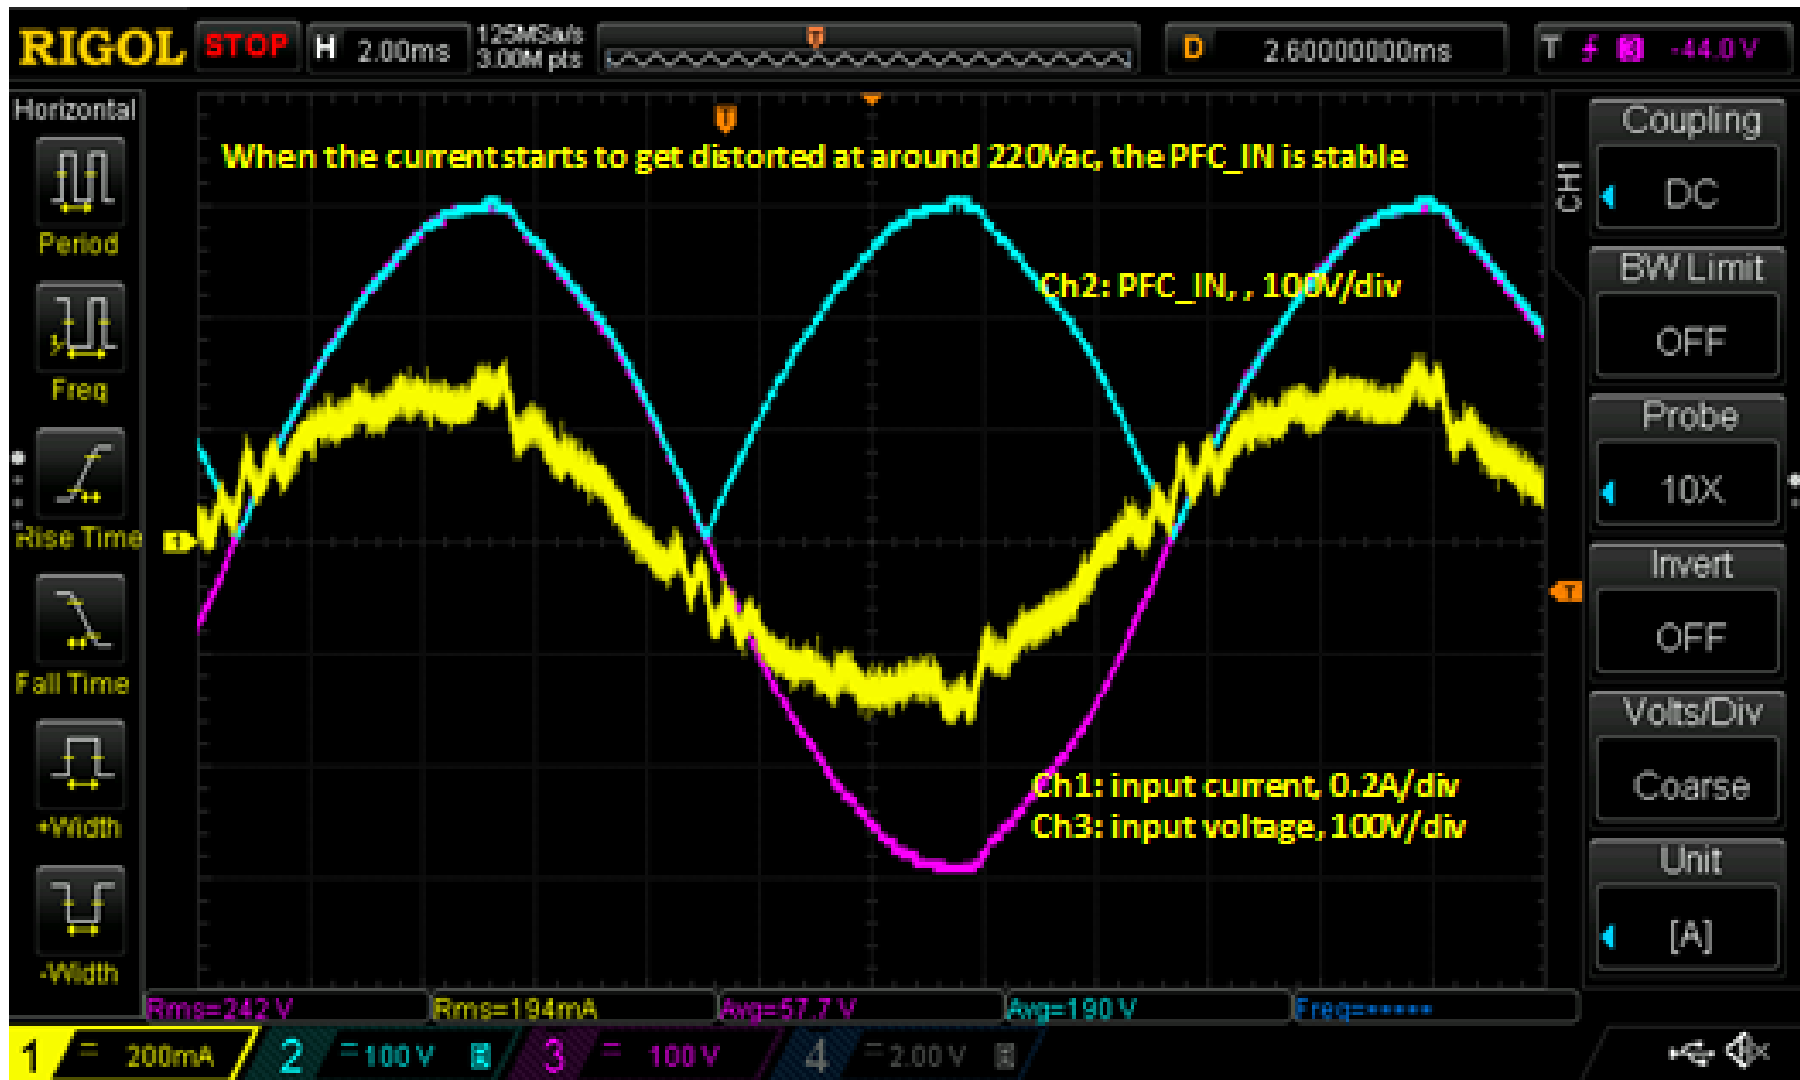
At 220Vac when distortions starts, the rectified input voltage (used for Vff) is shown below

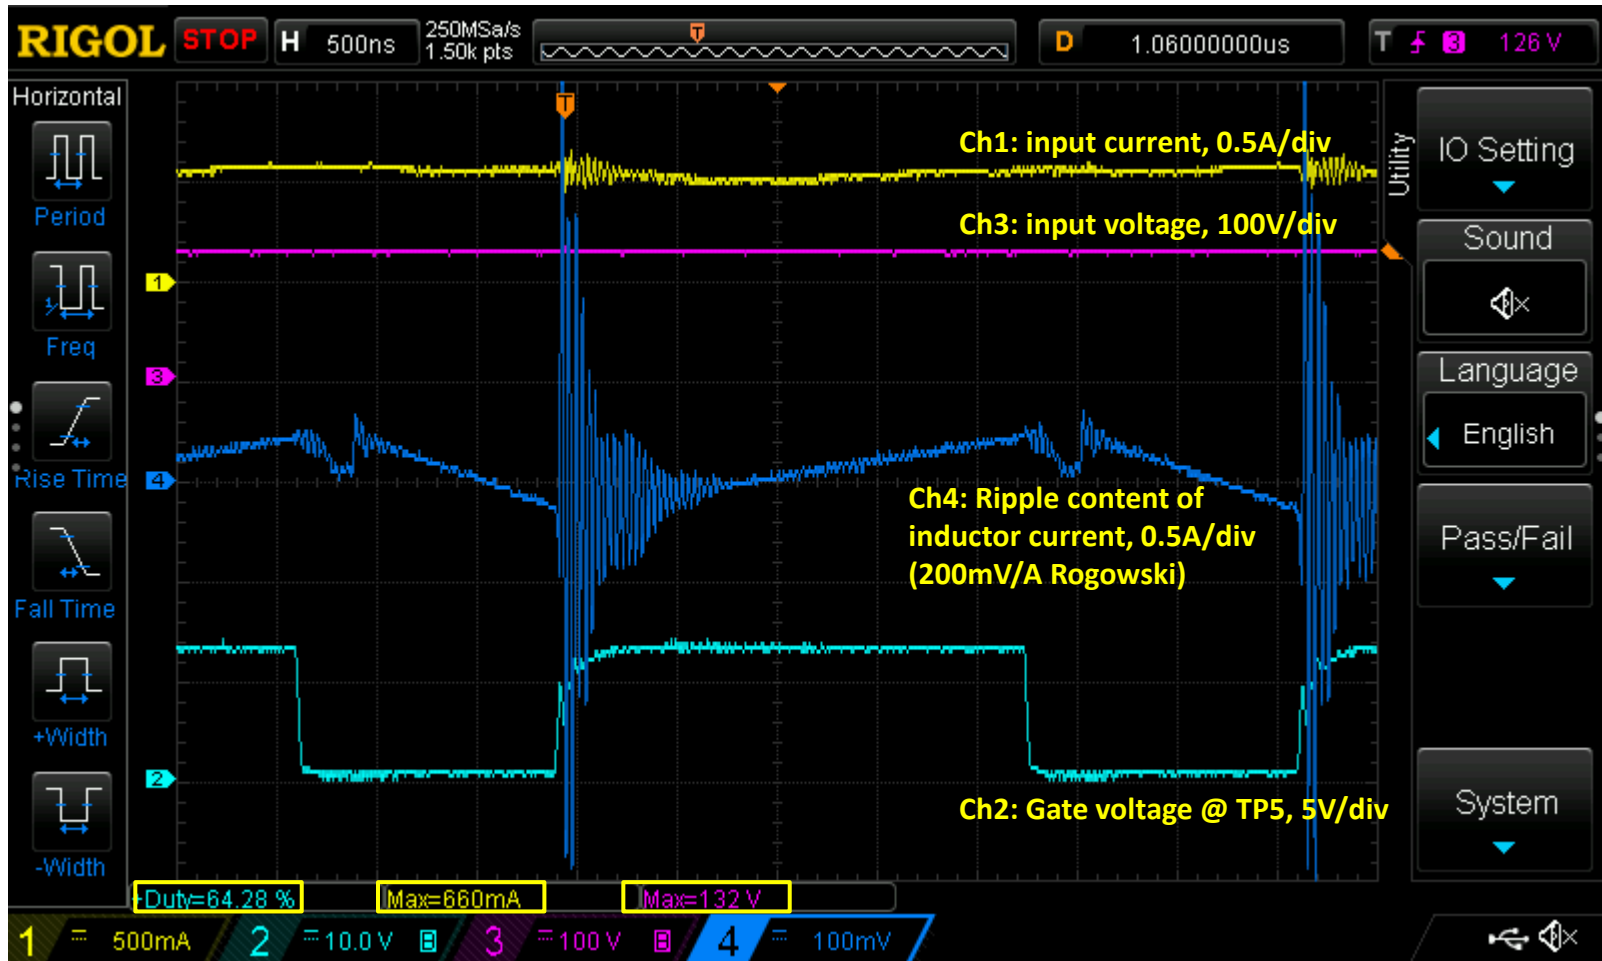
Ch4: Current probe is Rogowski CWTUM-015-B, which can measure high frequency only.

At the peak of 85Vac input voltage and ~25W external load, the instantaneous value of input voltage is 132V, peak input current is 660mA, duty cycle = 64.28%

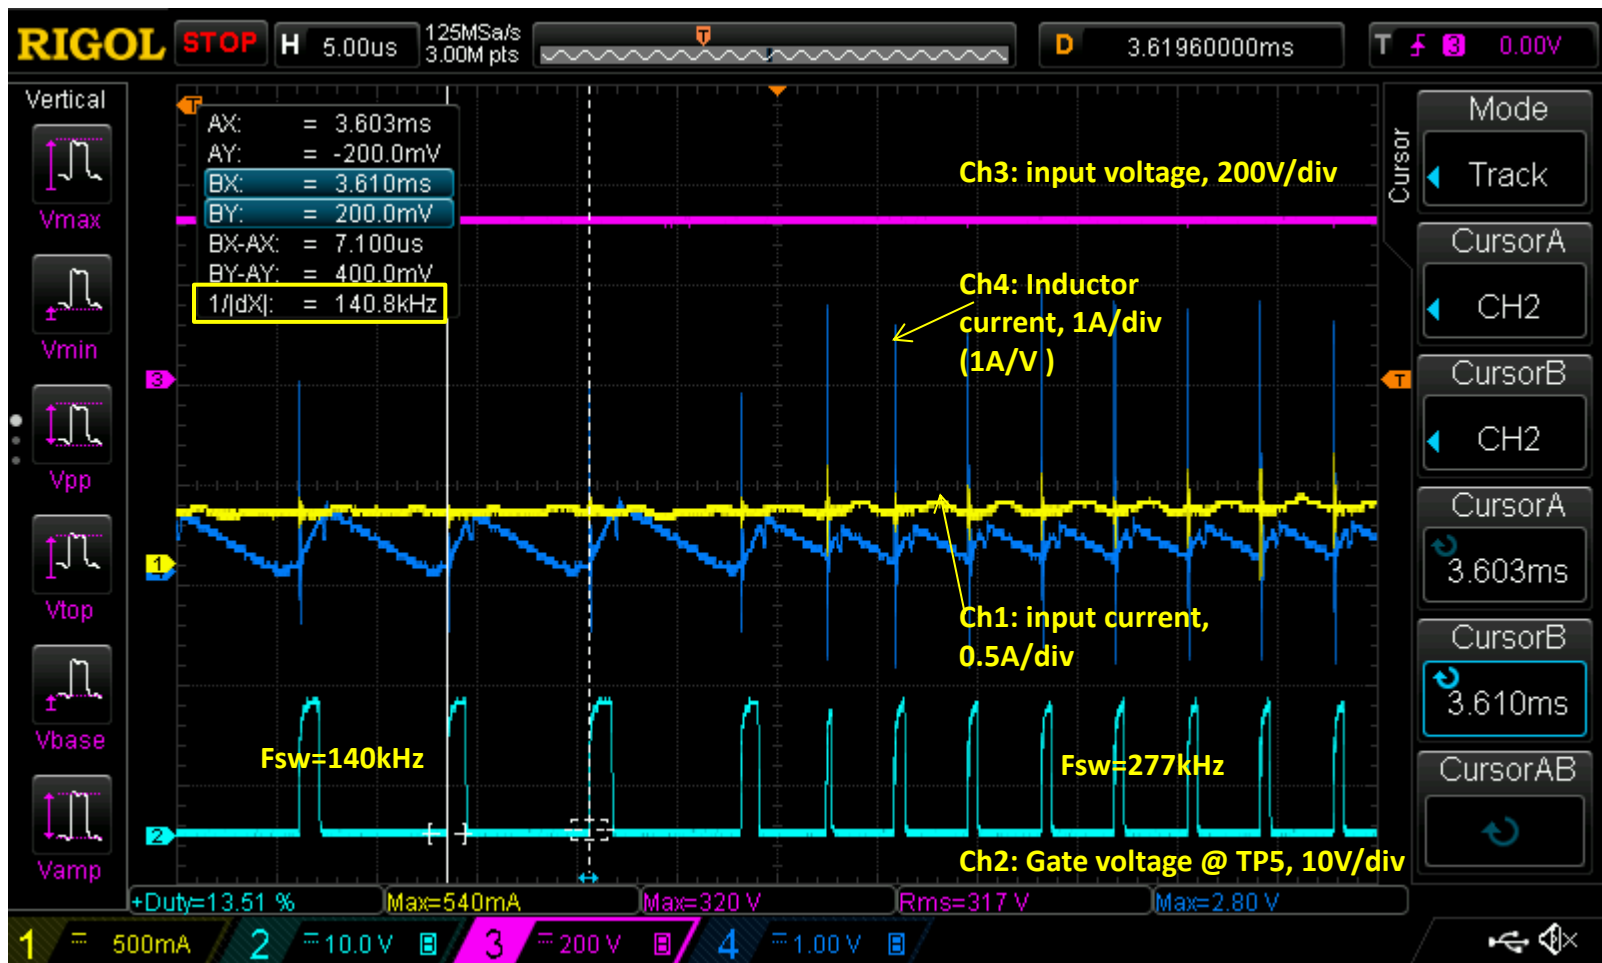
At ~230Vac input voltage and ~25W external load, distortions observed.

At the positive peaks of input voltage, the switching frequency is reduced to about  $\frac{1}{2}$  and this results in “flat top” on the current waveform. After that the switching frequency is raised and around that time the current surge is observed

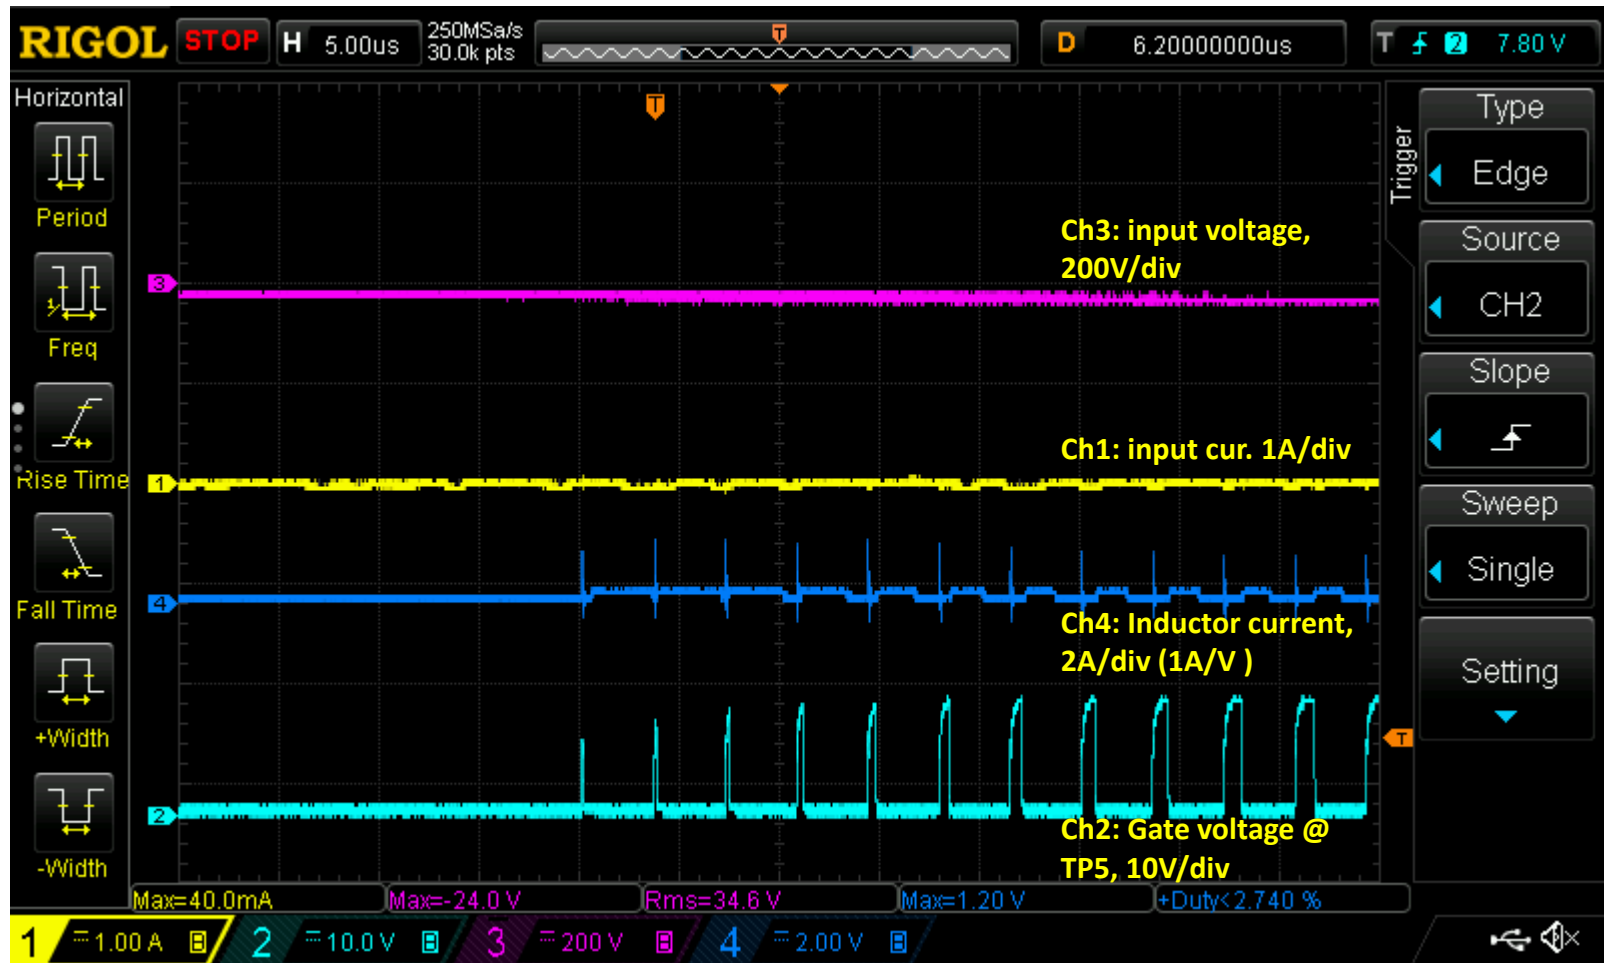
**At the time when PFC stage starts operating, it seems like the ON time pulse-width starts from zero and increases slowly**

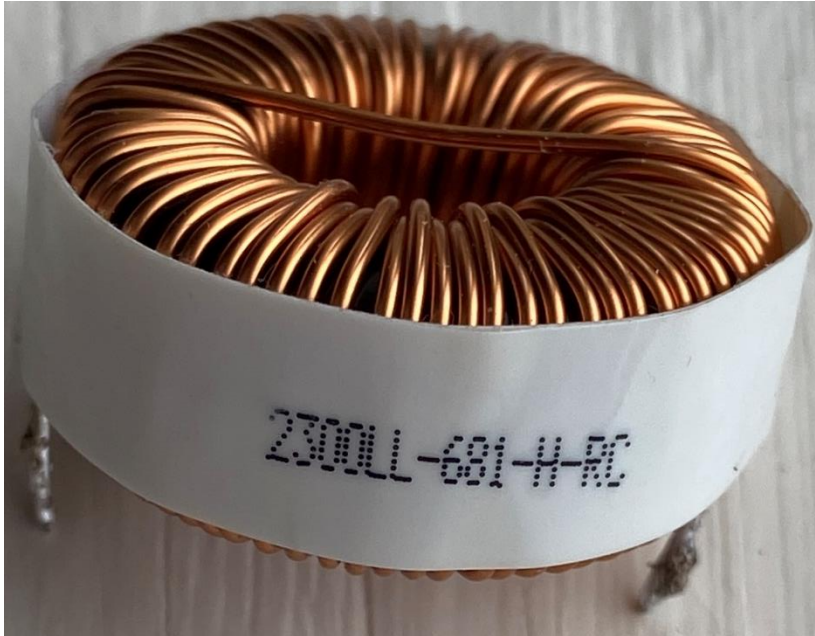
**Trying out with PFC boost inductors that are built by using toroid cores with no overlapping windings**

**Inductor #1:** Bourns PN: 2300LL-681-H-RC, 680uH  
Built by using toroid core, single layer winding.  
However, some amount of winding overlapping is visible.

- 1) Two different inductors with no or minimal winding overlapping are tried out. Current distortions at high voltages were observed in both cases.
- 2) Original inductor has overlapping windings and new ones do not. Even though the winding-to-winding capacitance is not measured, it is assumed that a single-layer toroid inductor would result in the lowest inter-winding capacitance.
- 3) Is there any practical way to measure the inter-winding capacitance?
- 4) Is there any rule of thumb as to how much inter-winding capacitance would be too much?

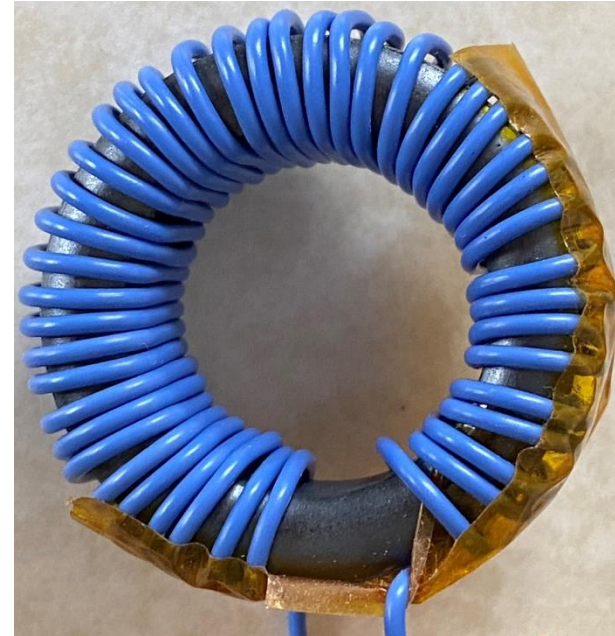
**Inductor #2:** Homemade by using toroid core  
Würth PN: 7427015 and 43 turns of single layer  
winding.  
Inductance measured at 1.39mH @ 300kHz.

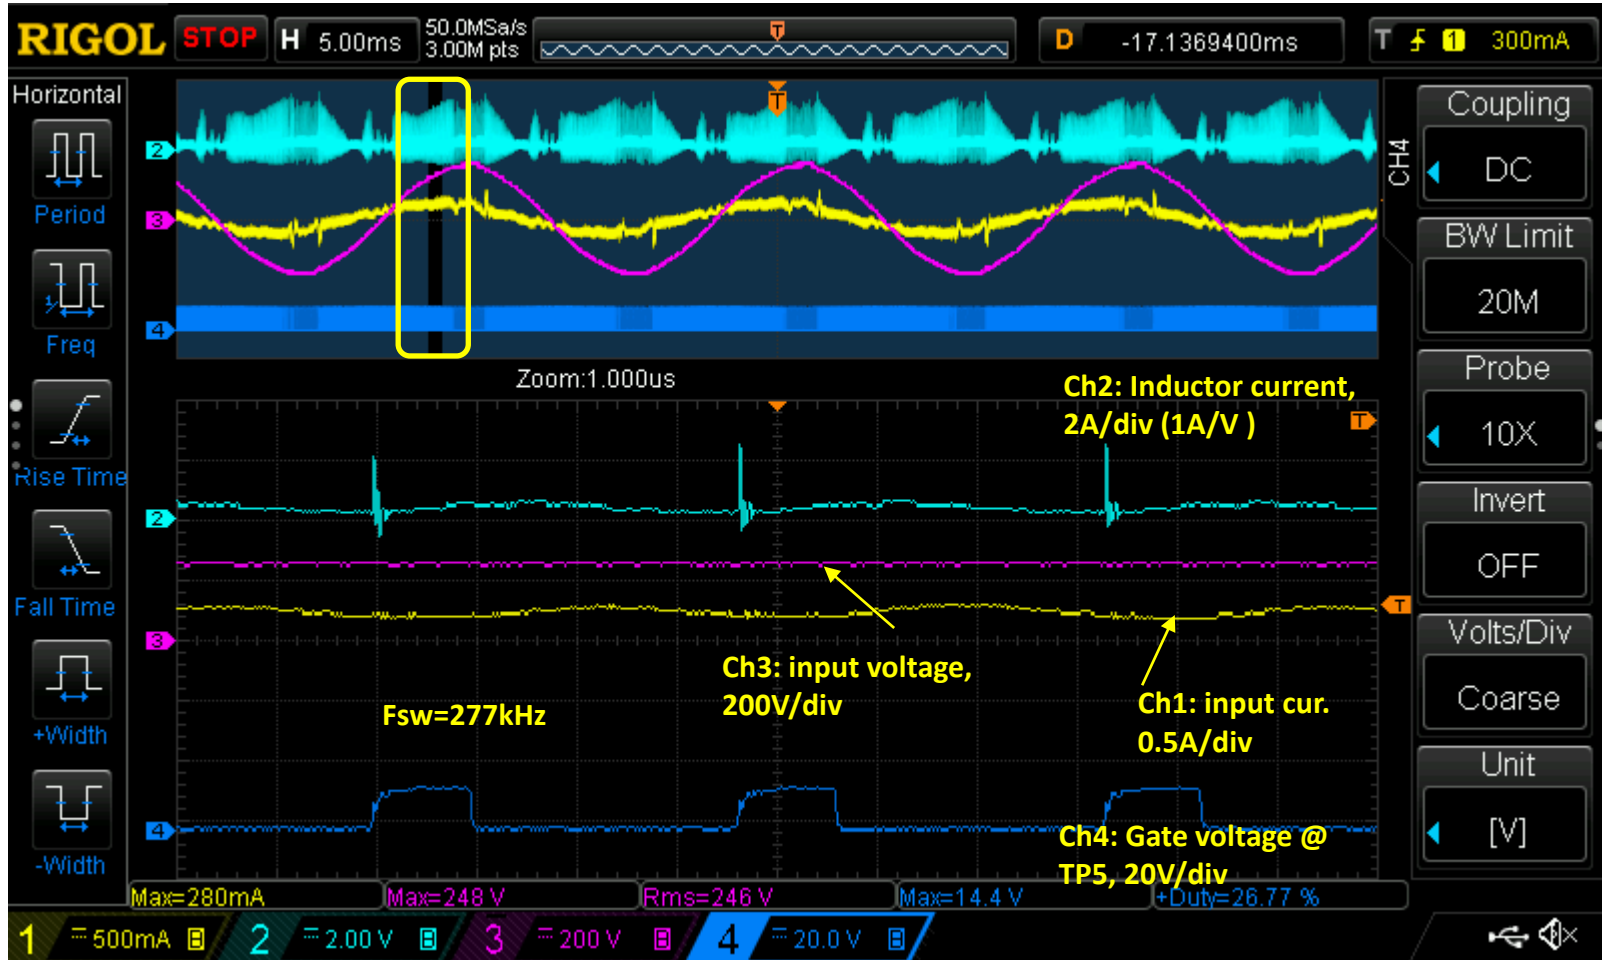
Original boost inductor (680uH), 10nF cap on PKLMT pin14 to GND, see slide 94 for modifications

Distortions start at around 220Vac; zooming into time just before input voltage reaches its peak region

Notice that the switching frequency is reduced to 1/3<sup>rd</sup> at the peak of input voltage and then changes back to F<sub>sw</sub> and current distortions are observed during the transitioning times

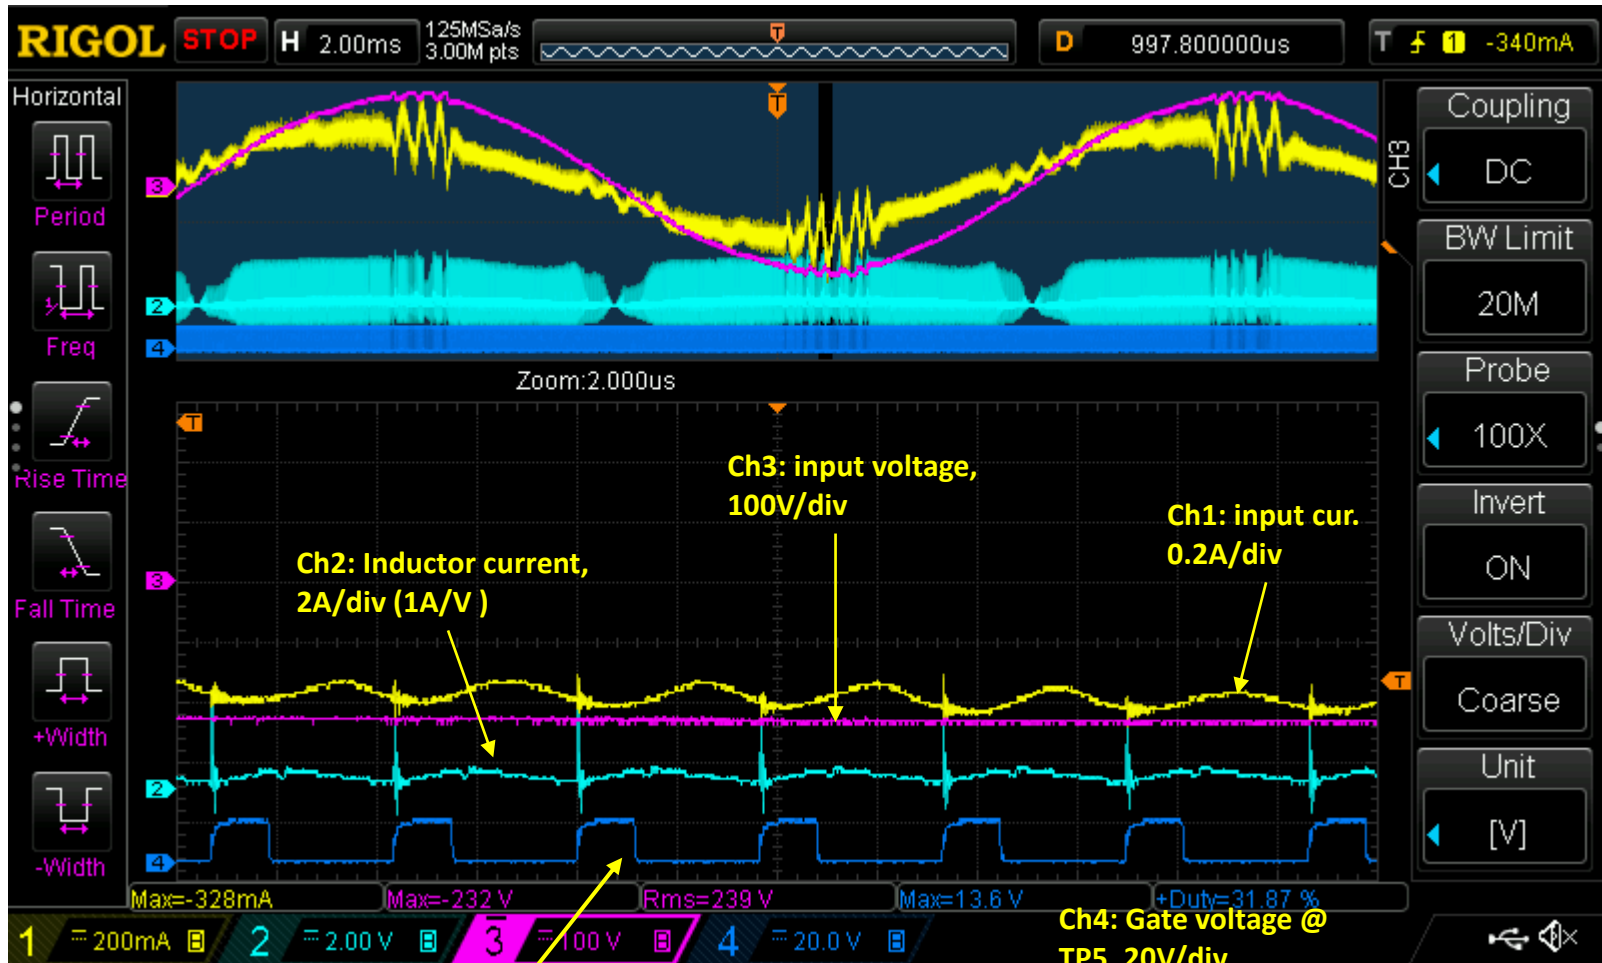
Original boost inductor (680uH), 10nF cap on PKLMT pin14 to GND, see slide 107 for modifications

With original inductor, 30W output power and lac connection moved to input of rectifier, major distortions at 180Vac

Switching frequency was normal and duty cycle was about 32% (notice that the on-time was constant)

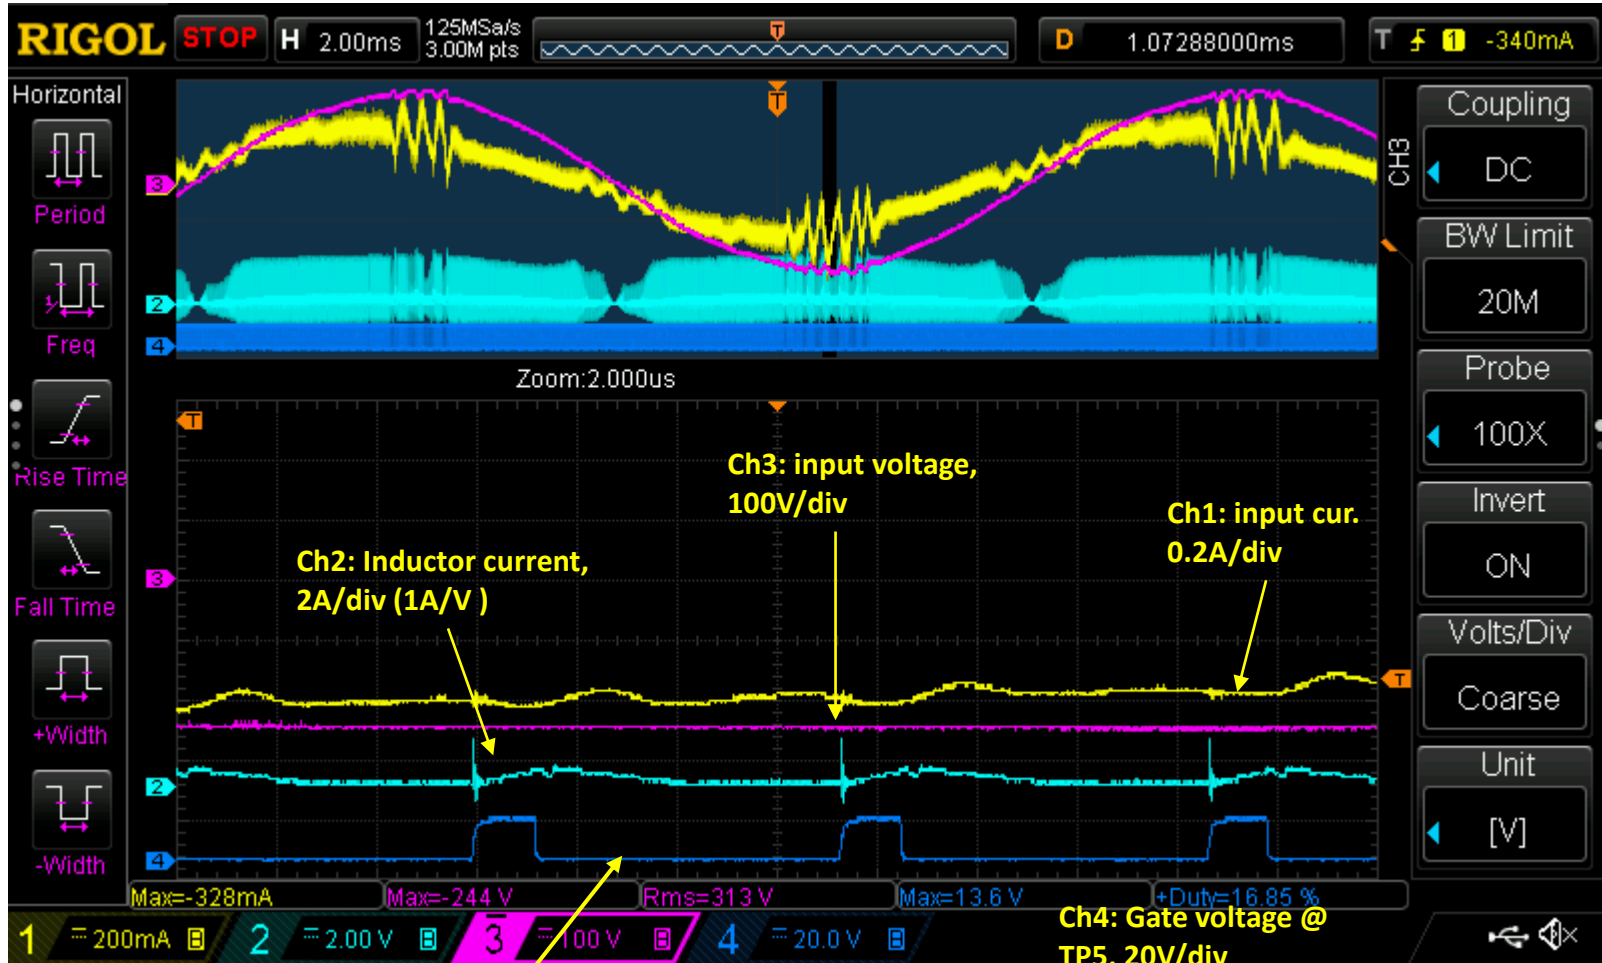
Original boost inductor (680uH), 10nF cap on PKLMT pin14 to GND, see slide 107 for modifications

With original inductor, 30W output power and lac connection moved to input of rectifier, major distortions at 180Vac

Switching frequency was reduced to  $f_{sw}/2$  and duty cycle was about 16% (notice that the on-time was constant)
