- The boost stage design is based on UCC28513. The PFC stage works well up to 200-220Vac input. Above this voltage range there are significant distortions at the points where sinusoidal input voltage reaches to its positive and negative peaks
- Output voltage is 385Vac
- Input voltage range is 85-264Vac; 50/60Hz
- The load on DC link output is 120W max
- Boost stage switching frequency is 277kHz
- Verified that the Vcc aux supply and Vref are stable
- Observed that the AC ripple on DC link goes up at around 200Vac but not sure if this is the reason or the result
- Observed that the duty cycle is about 70% at the peak sine wave at 85Vac but drops down to ~15% at the peaks of 220Vac at which point I start get distortions on the input current.
- The provided test results are at ~30W output power. It was observed that changing the load did not affect the behavior at around 220Vac.

### **Questions:**

1. Based on the design values, what could potentially cause the distortions at the peak of sine waves at and above ~ 200Vac?
2. Fig. 36 on data sheet talks about max capacitance vs min duty cycle. What capacitor is referred in Fig 36?

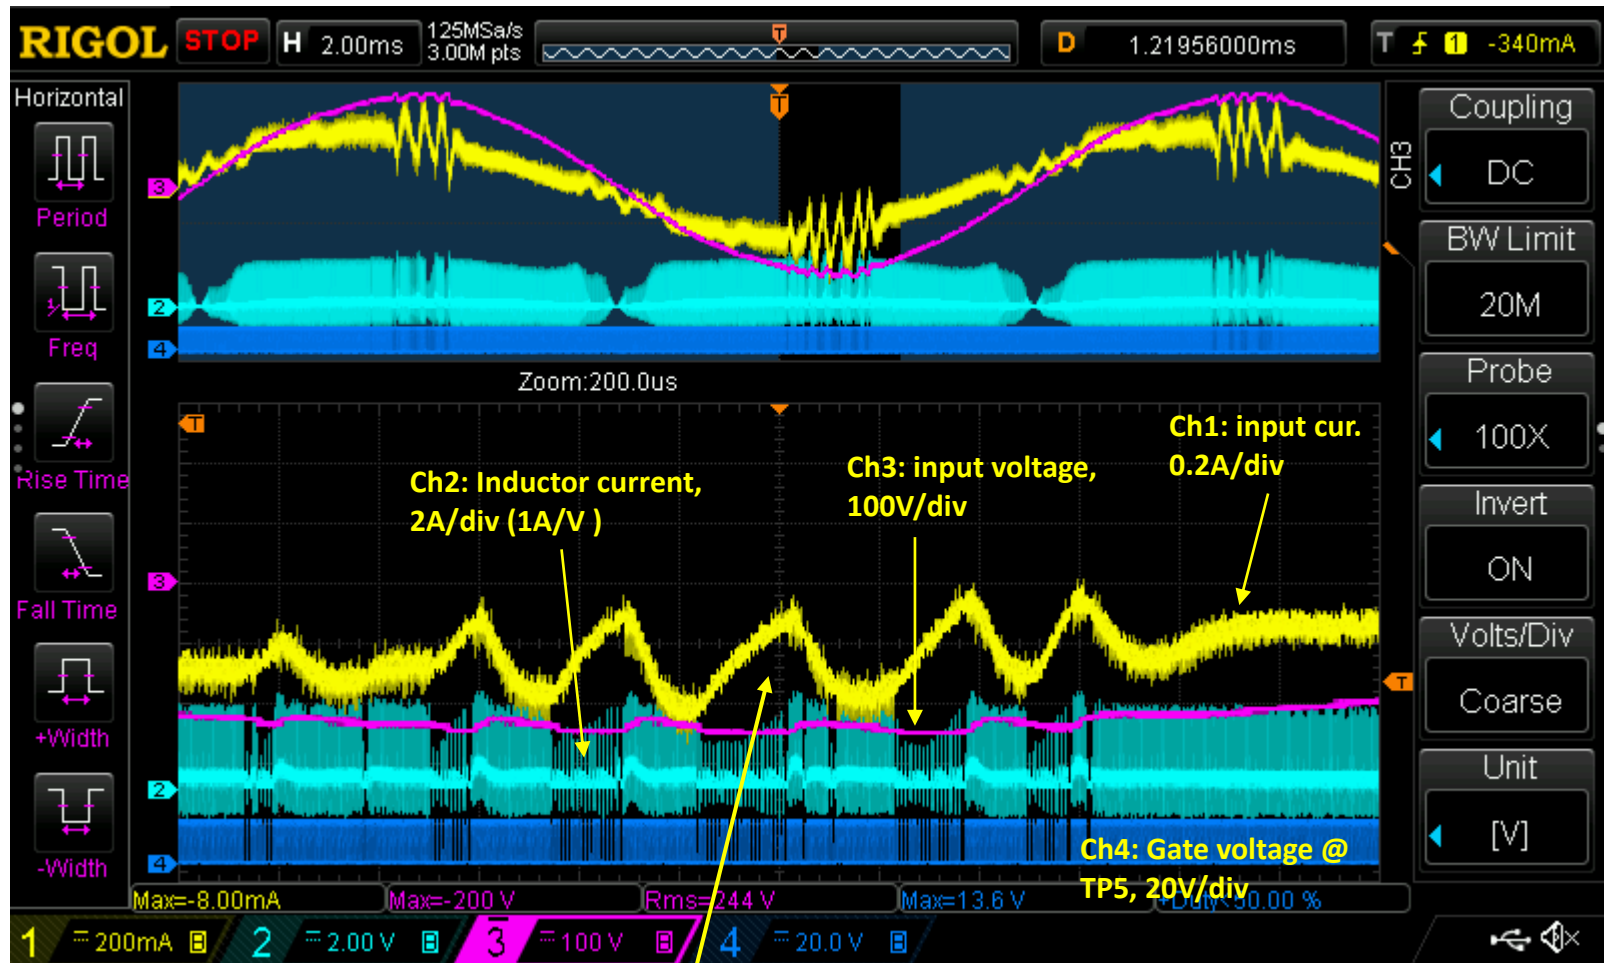
Original boost inductor (680uH), 10nF cap on PKLMT pin14 to GND, see slide 107 for modifications

With original inductor, 30W output power and lac connection moved to input of rectifier, major distortions at 180Vac

About 3.3kHz current oscillations

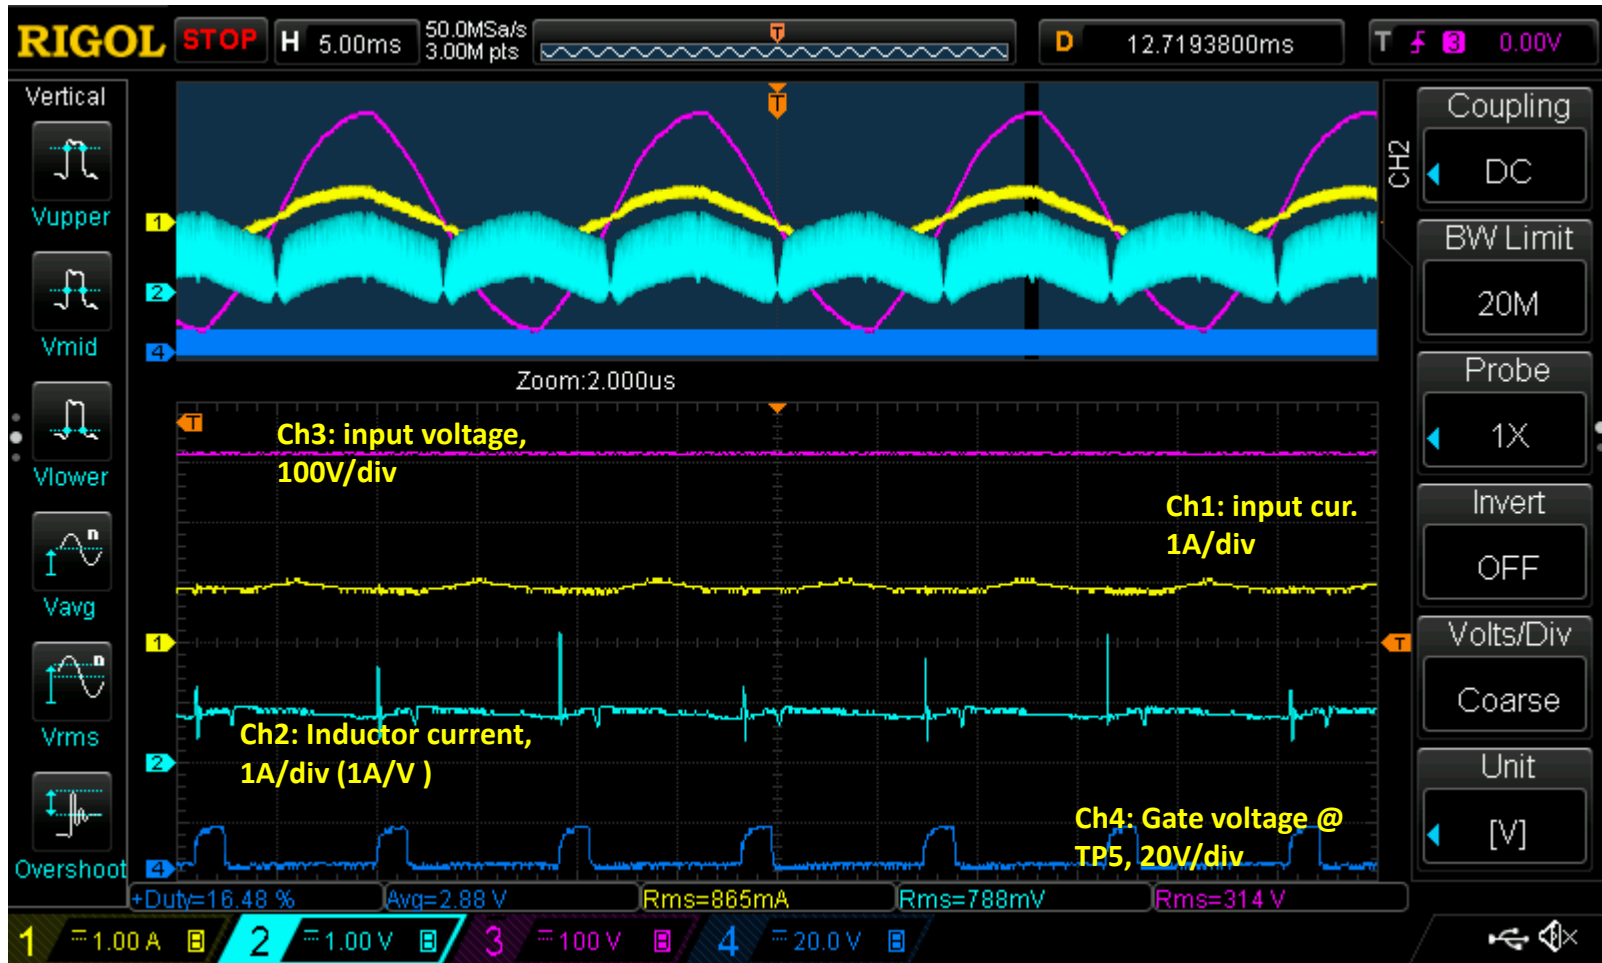
**2pc of original boost inductors in series (1.36mH total)**, 10nF cap on PKLMT pin14 to GND, see slide 107 for modifications

With 2x original inductor, 120W output power, no distortions at 220Vac, no pulse dropping,  $V_{dc\_out}=380V$

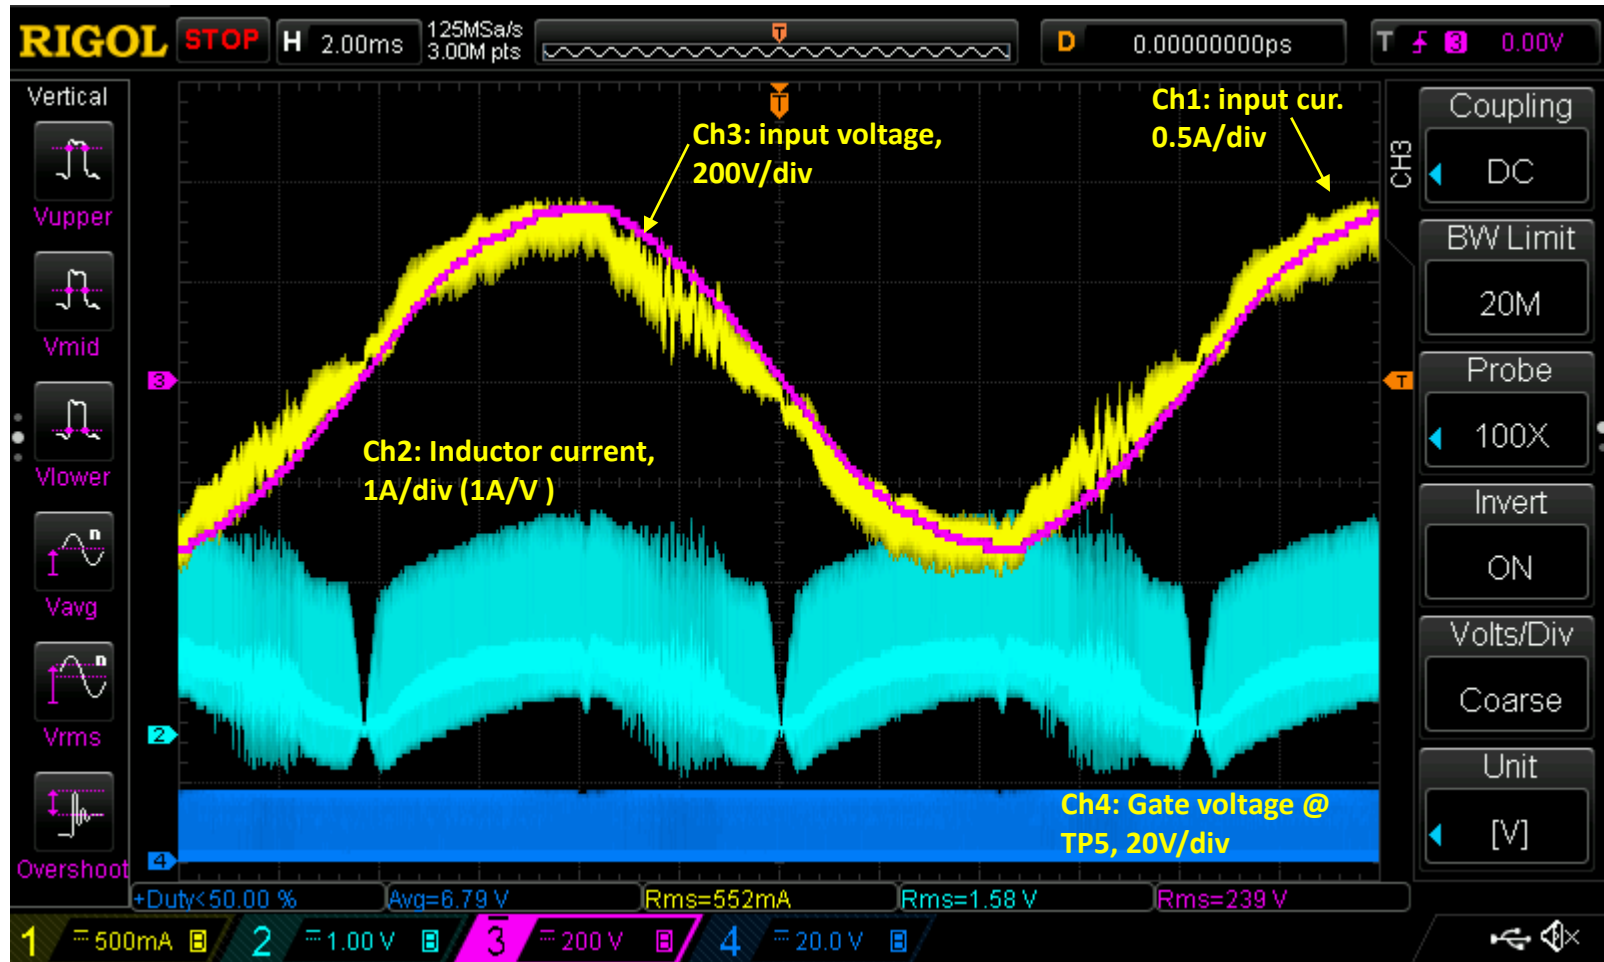
**2pc of original boost inductors in series (1.36mH total)**, 10nF cap on PKLMT pin14 to GND, see slide 107 for modifications

With 2x original inductor, 120W output power, no major distortions at 240Vac, however it appears like the distortions begin to start,  $V_{dc\_out}=380V$

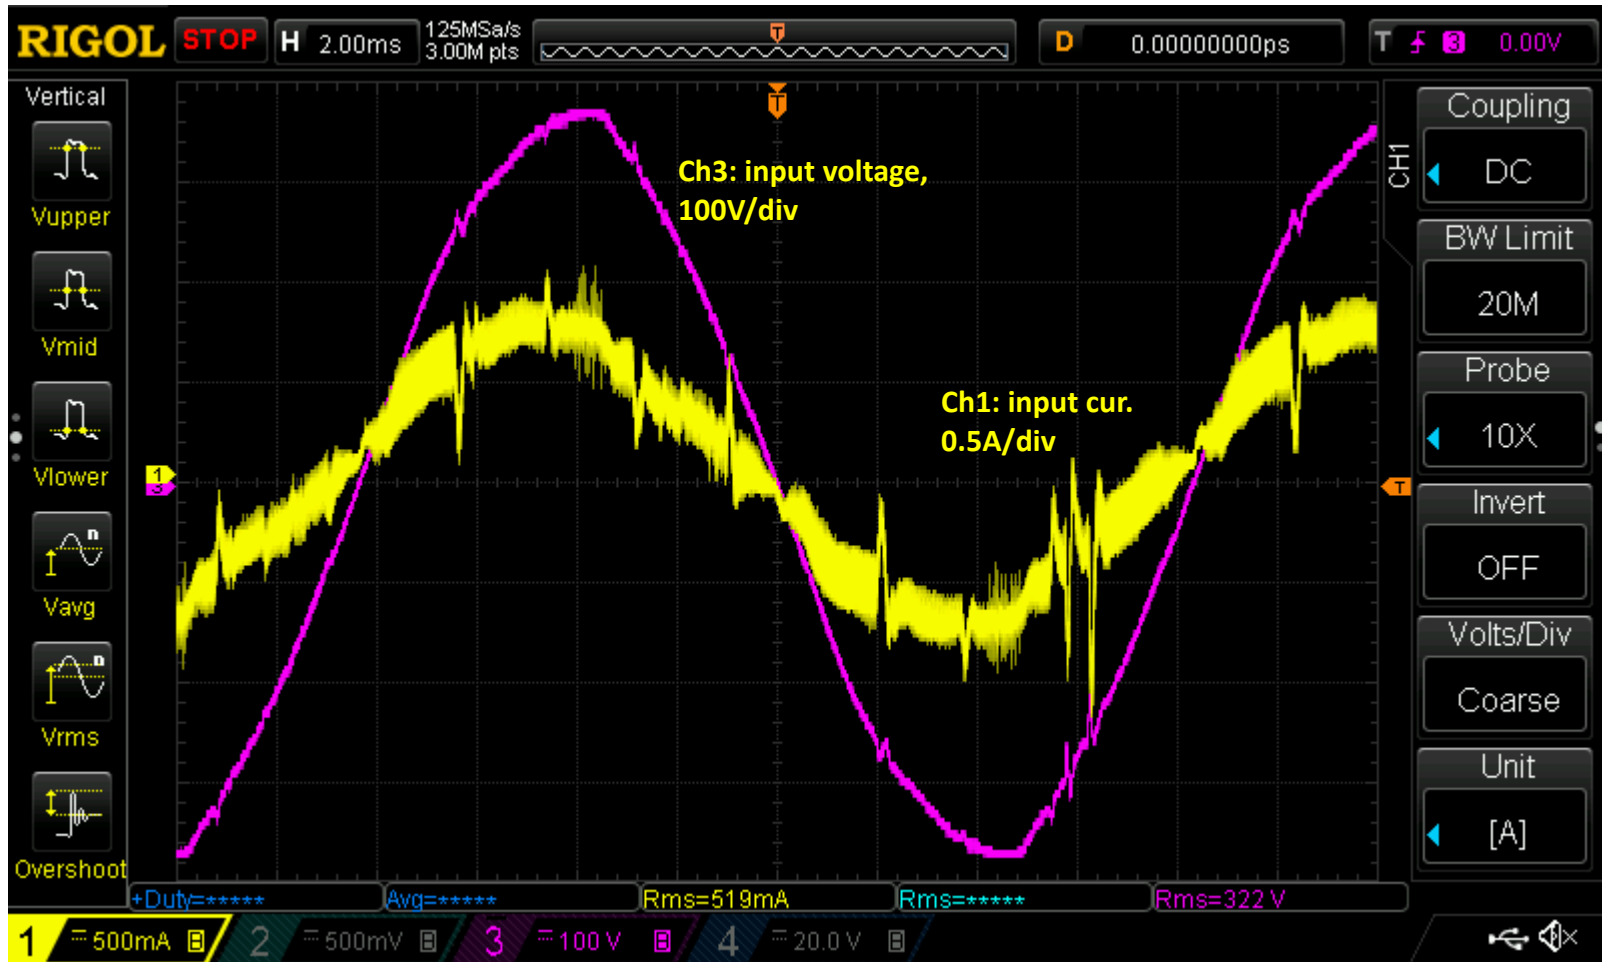
With 2x original inductor, 120W output power, when DMM is connected to pin 19 for Vff, more distortions observed at 265Vac, Vdc\_out=380V

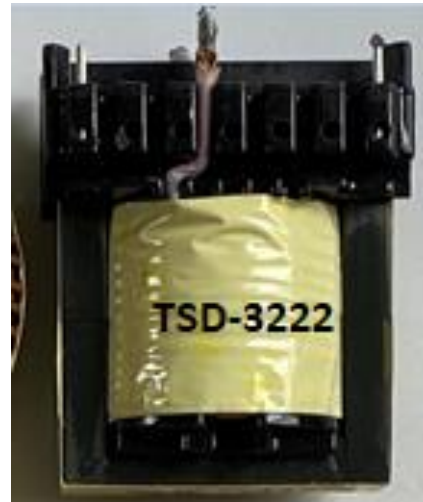
- 10nF cap added from PKLMT pin14 to GND on PFC card.
- PFC inductor (L2) is replaced with TSD-5033 (w/o base)
- Sense resistor on PSB (R43) part number: MOSX5CR47J

Old PFC inductor (L2) w/  
overlapping windings  
625uH @ 4.8A

- By removing L1, Q5, Q6 on PSB, only the PFC stage was tested w/o secondary stage power supply board
- By using larger toroidal inductor, the current distortions observed earlier were mostly eliminated
- Turn-on current spikes were reduced, this is visible in inductor current measurements
- At min load from 85Vac-265Vac, good DC-link regulation was achieved
- At max output load and low AC voltage, the DC-link voltage was less than the set point of 390V

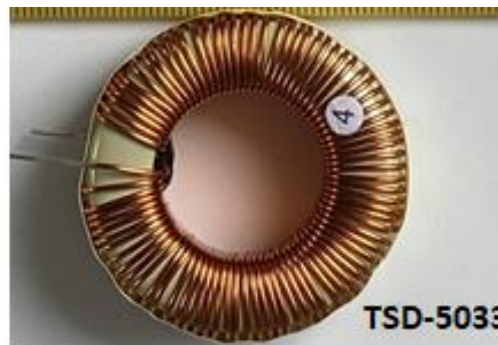
New toroidal PFC inductor  
(L2) w/o overlapping  
windings  
750uH @ 8A

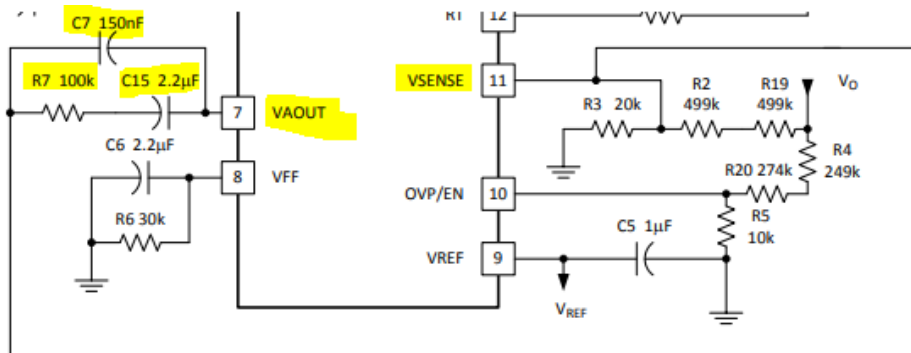
UCC3817 voltage feedback circuit shown for reference

Changed to 100K per slides 162/163
