UCC28513 questions, Alex W., 11/17/2022

- The boost stage design is based on UCC28513. The PFC stage works well up to 200-220Vac input. Above this voltage range there are significant distortions at the points where sinusoidal input voltage reaches to its positive and negative peaks
- Output voltage is 385Vac
- Input voltage range is 85-264Vac; 50/60Hz
- The load on DC link output is 120W max
- Boost stage switching frequency is 277kHz
- Verified that the Vcc aux supply and Vref are stable
- Observed that the AC ripple on DC link goes up at around 200Vac but not sure it this is the reason or the result
- Observed that the duty cycle is about 70% at the peak sine wave at 85Vac but drops down to ~15% at the peaks of 220Vac at which point I start get distortions on the input current.
- The provided test results are at ~30W output power. It was observed that changing the load did not affect the behavior at around 220Vac.

### UCC28513 questions to TI, Alex W., 11/17/2022

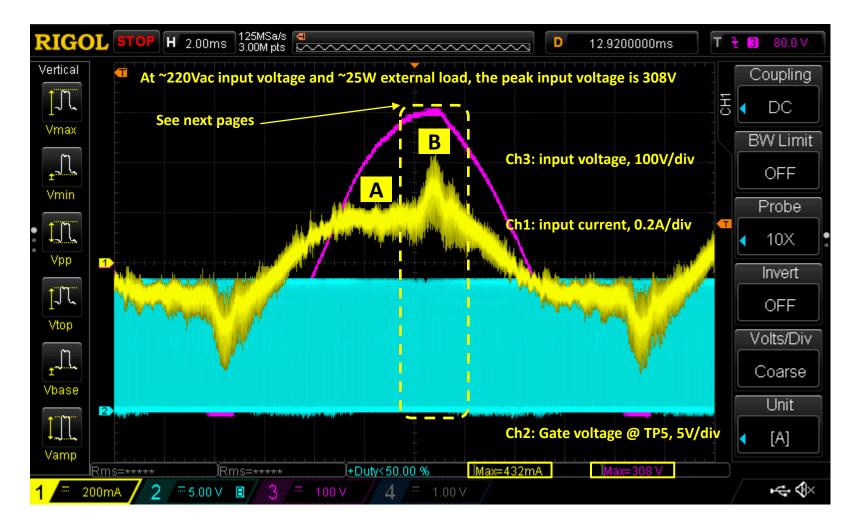
In addition, a  $100m\Omega$  and  $20m\Omega$  sense resistor was connected in series with inductor and the voltage across the resistor was measured with a differential probe. However, doing so resulted in further instability and distortion and therefore abandoned.

Ch1: Current probe is Fluke 80i-110S, which has limited bandwidth and is used to measure 60Hz input current

Ch4: Current probe is Rogowski CWTUM-015-B, which can measure high frequency only.

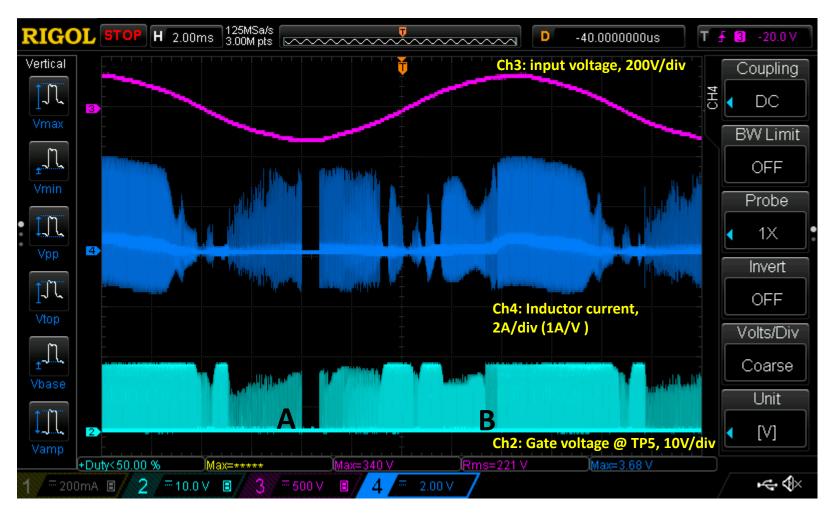
Ch1: Fluke 80i-110S, which has limited bandwidth

Ch4: Tek TCPA300 w/ TCP312 Current probe

At ~230Vac input voltage and ~25W external load, distortions observed.

- 1) Location A: While the supply voltage ramps up toward the negative peak, the switching frequency is reduced significantly and then MOSFET shuts down for a while at the negative peak. It seems like the inductor current is relatively small and this may not be current limit initiated turn off.
- 2) Location B: While the supply voltage ramps up toward the positive peak, the switching frequency is reduced by about 50%. It is observed this corresponds to "flat top" on supply current. At around the peak of supply voltage, the switching frequency suddenly snaps back to normal frequency and this corresponds to surge in peak of the supply voltage. It is not clear if this phenomenon is caused by activation of current limit.
- 3) Adding an other 68nF cap after rectifier did not improve the issue
- 4) Adding 100nF cap across R5 (R7 on data sheet) did not improve the issue

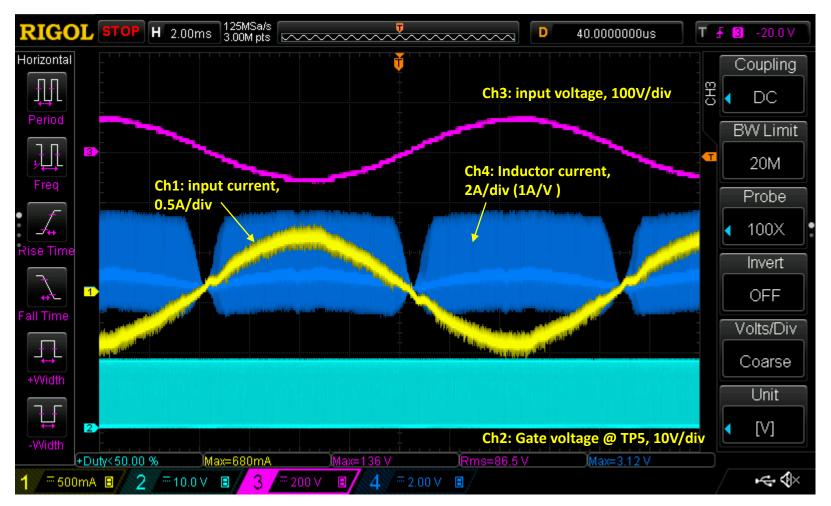
At ~85Vac input voltage and ~25W external load, no major distortions observed

РСВ	RefDes on datasheet	RefDes in design	12/11/2022 Fci=44kHz, Gci=5.6	12/25/2022 Fci=11kHz, Gci=1.6
PSB- 04	R1	R47, R50	383K	383K
	R2	R43	0.44	0.44
	L1	L2	660uH	660uH
PFC- 03	R8, R12	R4, R9	2.74K	2.74К
	R13	R10	15.8K	4.7K
	C6	C6	233pF (200p//33p)	3.3n
	С7	C8	33pF	150pF
	R15	R11	30.1K	30.1K
	C8	С9	4.7uF	4.7uF
	C10	C1	1.5uF	1.5uF
	C11	C2	150nF	150nF
	R21	R1	48.7K	48.7K
	R14	R13	10K	10К
	R7	R5	1.50K (3.3K//2.74K) +100pF	1.50K (3.3K//2.74K <b>) + 100pF</b>
	С9	C4	1uF	1uF

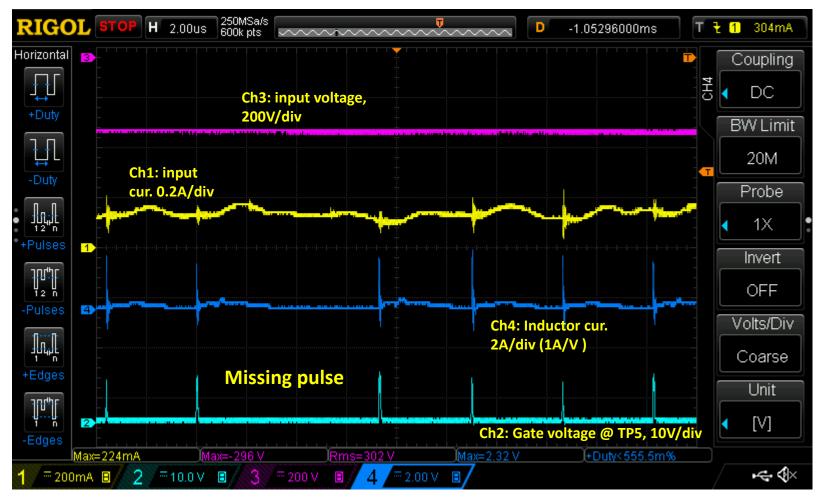
At ~230Vac input voltage, <u>C46=100nF</u>, location A; ON times gets very small & pulses start to drop Ch4: Tek TCPA300, Ch1: Fluke 80i-110S
