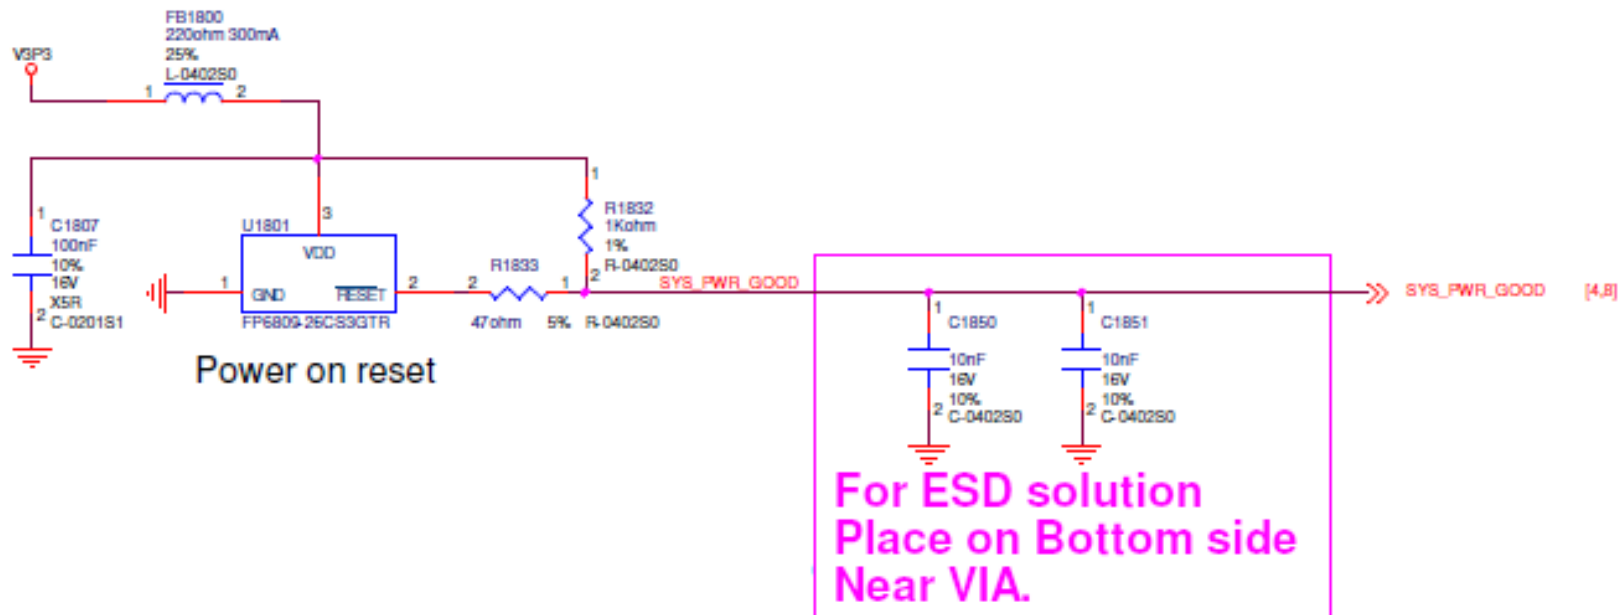
- At first, we remove R1832 and R1833 in above circuit
- We measure three voltage waveform:
  - **CH3: VDD**
  - **CH4: /RESET**
  - **CH1: SYS\_PWR\_GOOD**
- Then we plug in AC adaptor, you can see TPS3809 reset signal different testing result

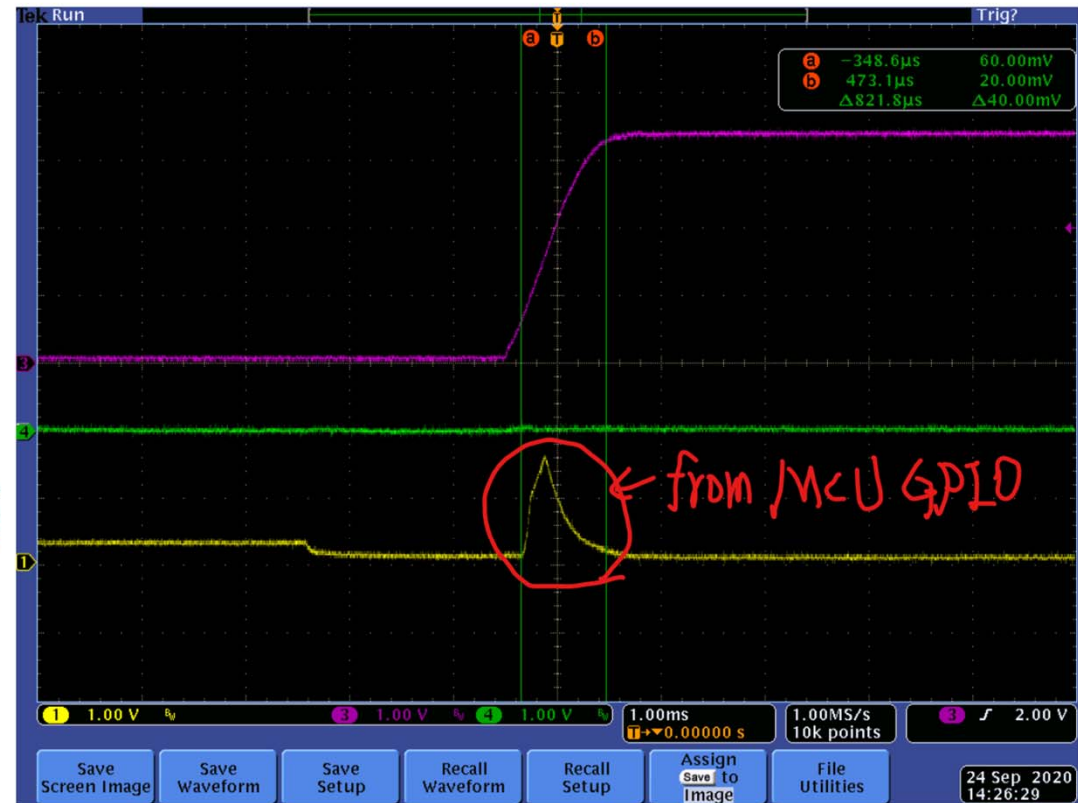
- In above figure, we zoom in the power on state. We can see there is **voltage pulse** induce from MCU

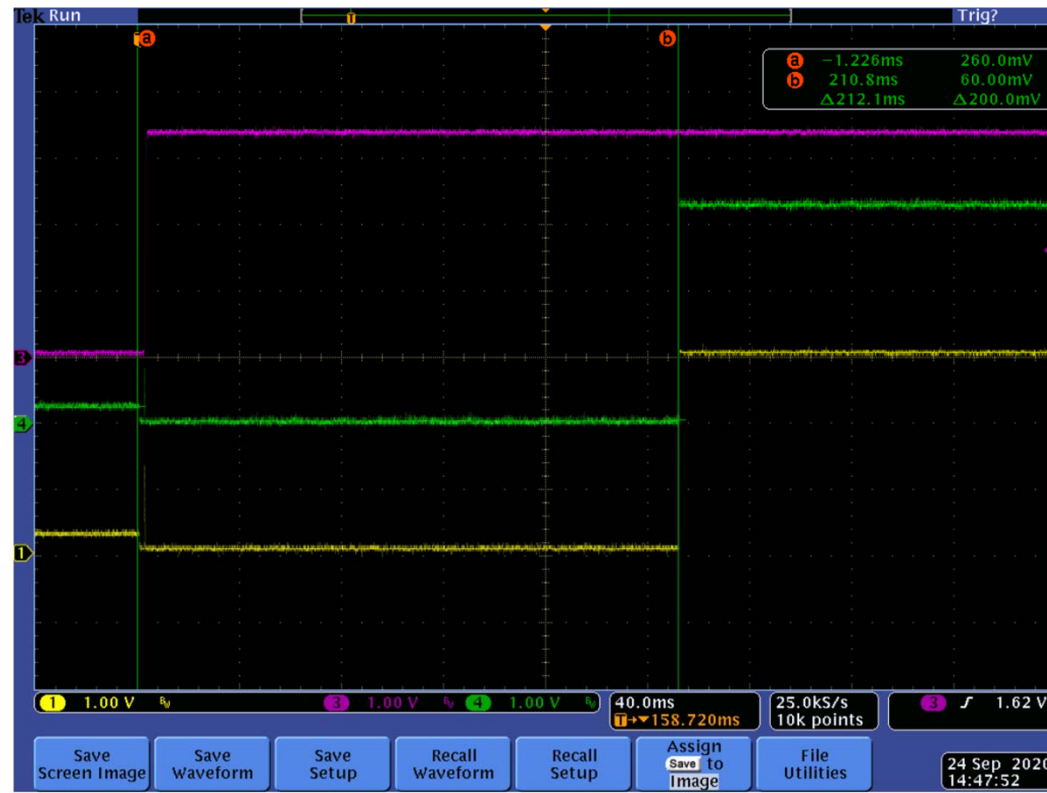
We remove R1832 still and mount  
**R1833=1kohm**

- In above figure, we can see TPS3809 RESET signal is correct with 1kohm series resistor
