Titolo P01_19_S01_E01 ASSP BASE BOARD	
		POWER_MUX	
		<Variant Name>	
Data di creazione Progettato <Designer>	Data ultima modifica Thursday, October 03, 2019	Codice PCB <Inspector>	Revisione 1.0
	Rilasciato <Supervisor>		Foglio 17 di 17
FORMATO A3			
RISERVATO - CONFIDENTIAL. Questo documento è di proprietà della società PAC s.r.l. che se ne riserva tutti i diritti.

Test configuration :

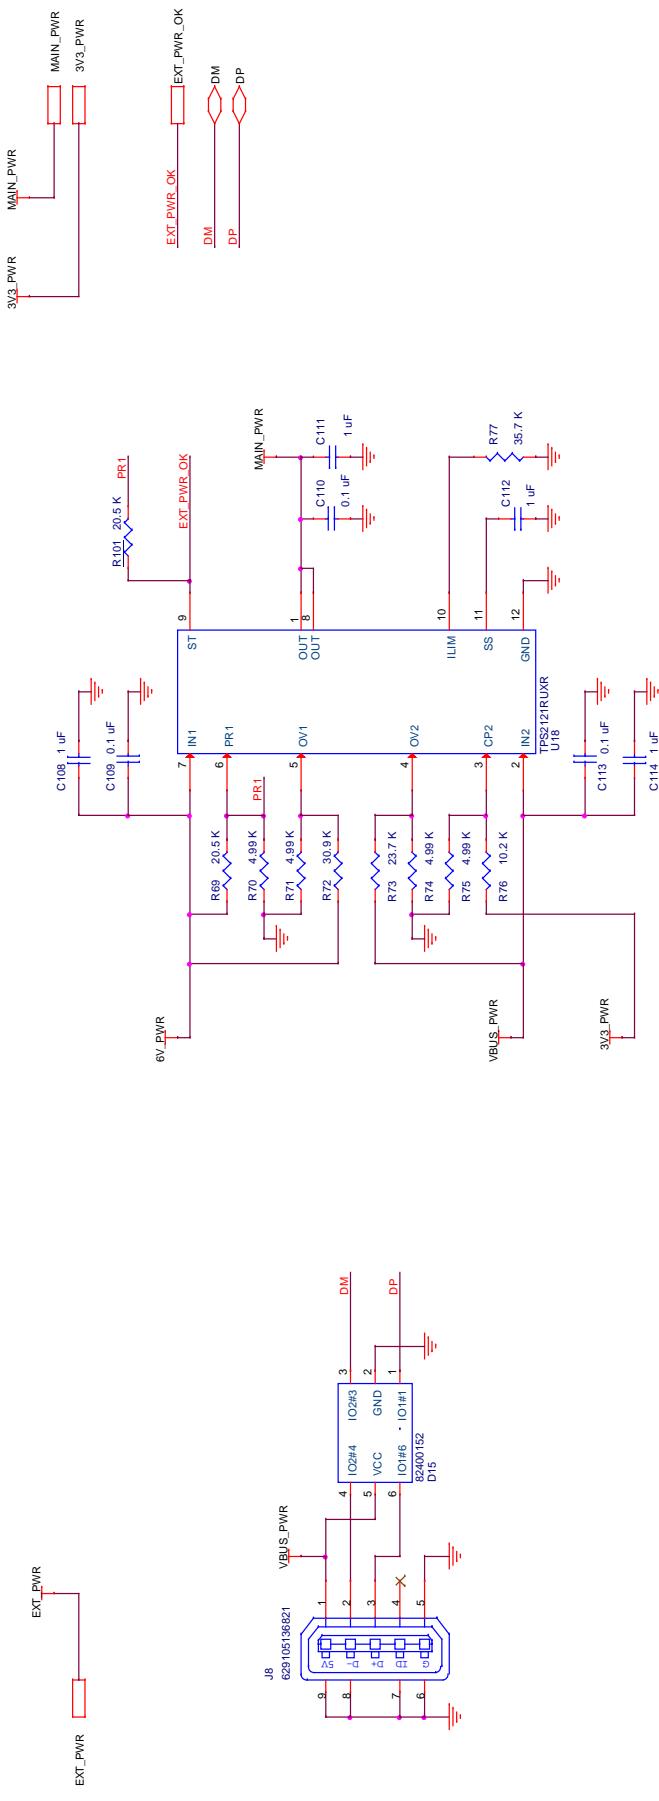
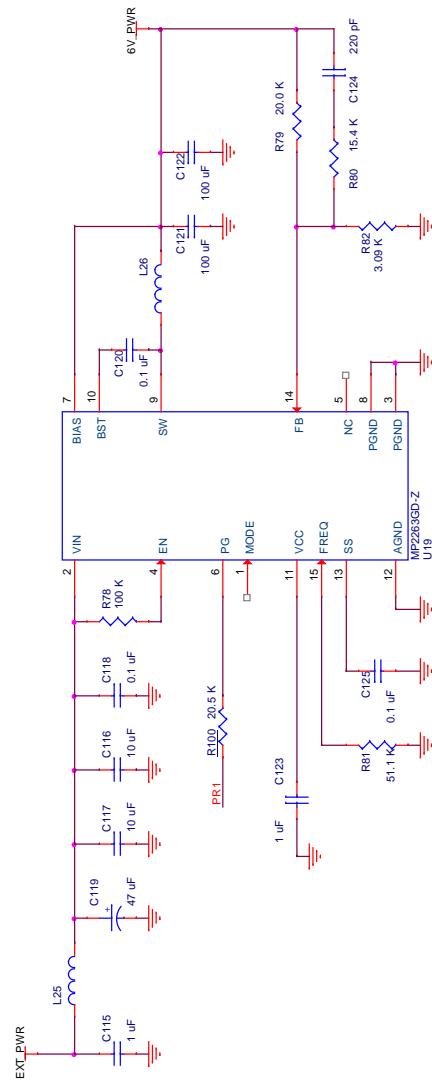
- VBUS_PWR always present at 5V
- 3 Ohm load resistive load on MAIN_PWR (2A @6V)
- 450 uFelectrolytic capacitance on MAIN_PWR (not shown on schematics)
- EXT_PWR (12V) is rapidly switched ON and OFF to verify output drop
- CP2 is 3.3V derived from the main logic supply which is derived from MAIN_PWR (as described in TIDA-01638)

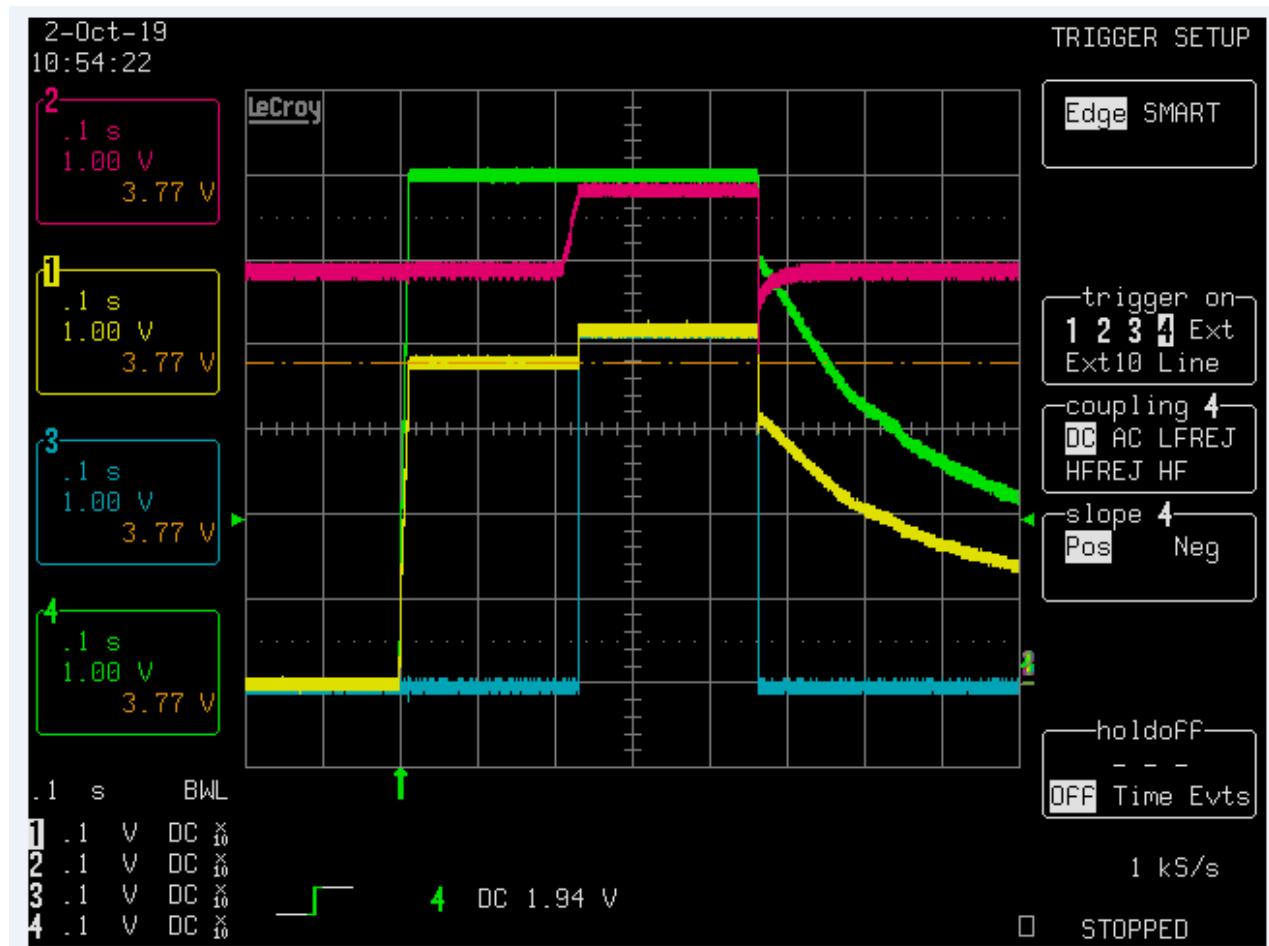
Successful Switchover USB_PWR -> 6V_PWR-> USB_PWR

GREEN TRACE : 6V_PWR (VIN1 on TPS2121)

RED TRACE : MAIN_PWR (output from TPS2121)

YELLOW TRACE : PR1

BLUE TRACE : EXT_PWR_OK (ST on TPS2121)

Note that the step increase in PR1 is due to the positive feedback introduced by the resistor R101 from ST to PR1 required to avoid spurious switching when PR1 is at 3.3V.

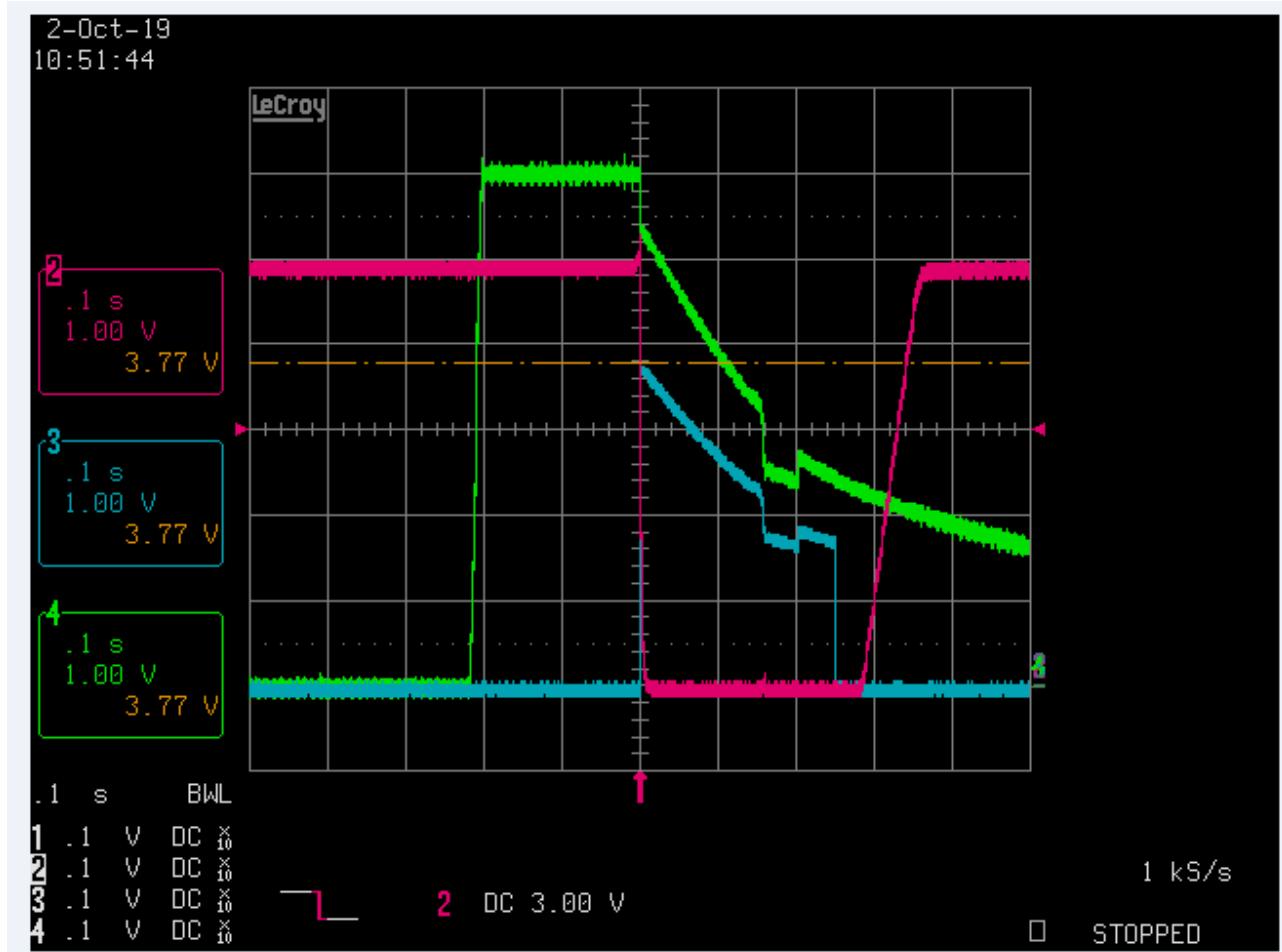
Failed Switchover USB_PWR -> 6V_PWR-> USB_PWR

If the time interval in which 6V_PWR is present is reduced the above situation appears in which :

- Output do not switch to 6V
- The 5V (always present) is not restored at the output of the TPS2121 causing a reset of the device.

This configuration is representative of what happens when unstable power supply.

If the presence of 6V_PWR is shorter than 200 msec the drop in MAIN_PWR do not happen.

It seems that this happen when the 6V_PWR is removed close to the ST rising edge.

Note also that the 6V_PWR show initially a sharp decrease due to the fact that the load is still connected to VIN1 and discharge the capacitors on 6V_PWR. When ST rises the slope in 6V_PWR decreases meaning that the load is no more connected to VIN1

I also tried to use resistor R100 instead of R101 but the behaviour is the same

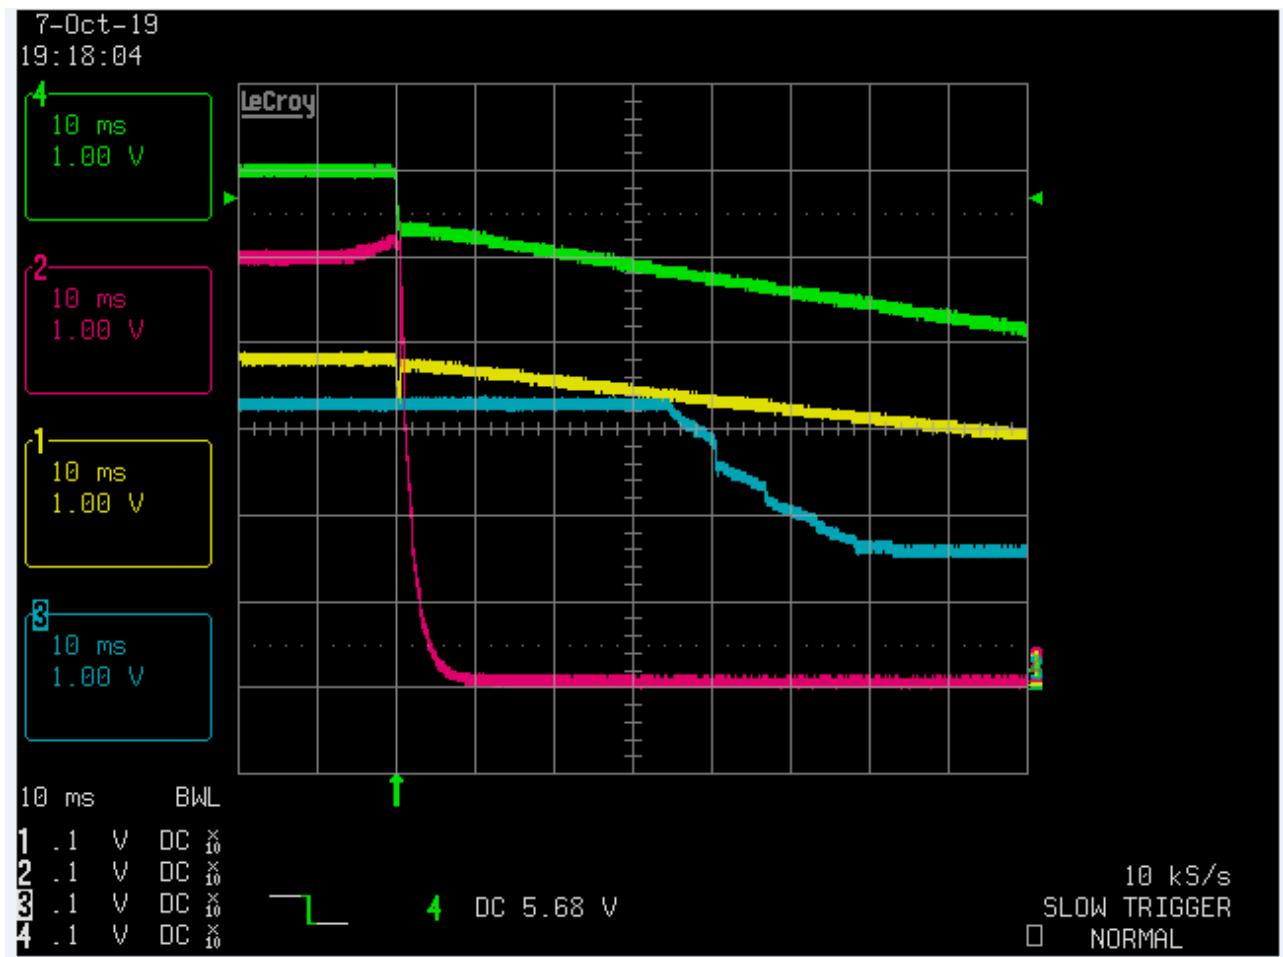
Other tests of failed switchover

GREEN TRACE : 6V_PWR (VIN1 on TPS2121)

RED TRACE : MAIN_PWR (output from TPS2121)

YELLOW TRACE : PR1

BLUE TRACE : CP2

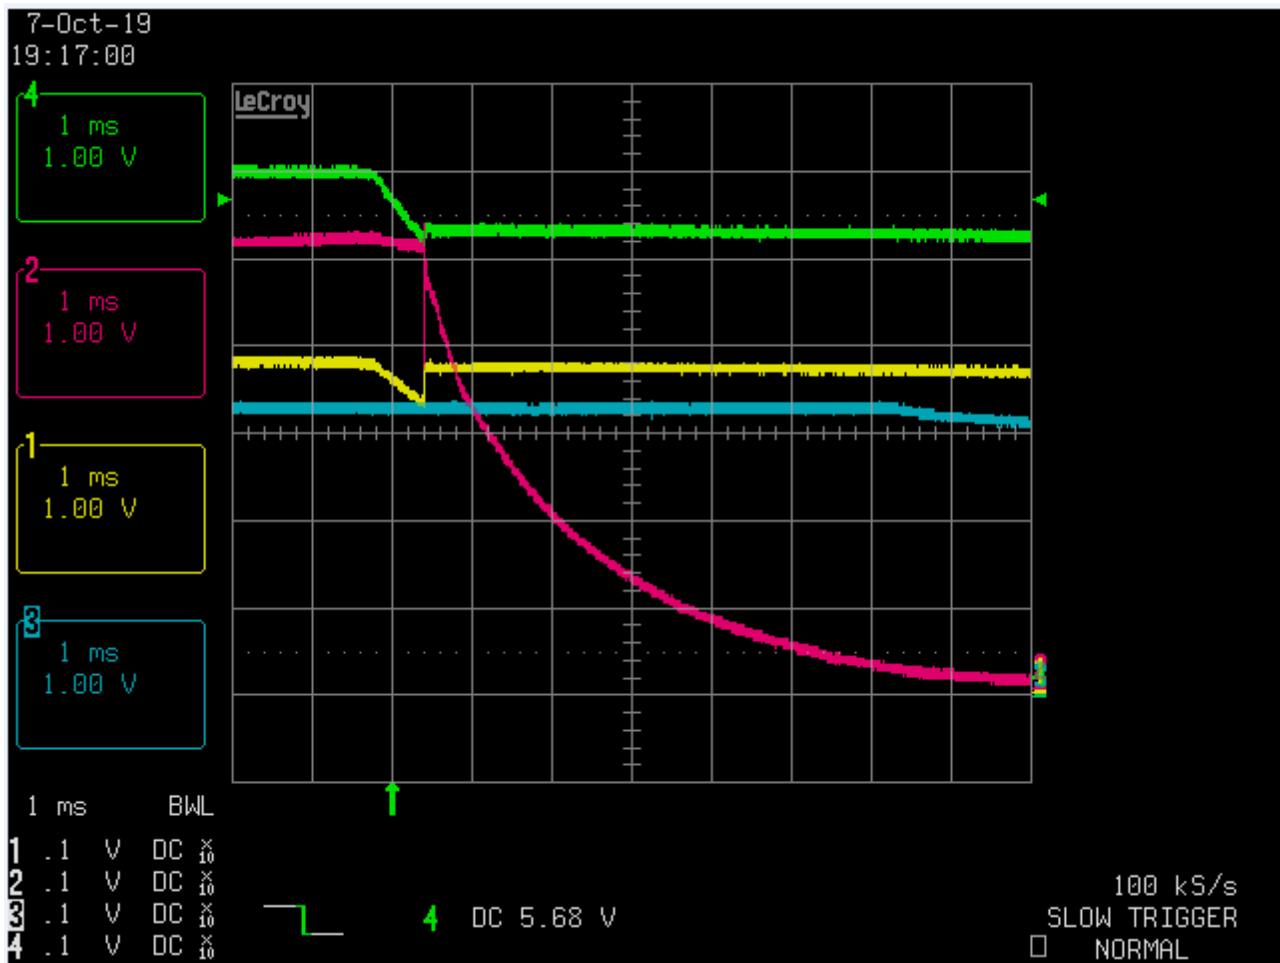
GREEN TRACE : 6V_PWR (VIN1 on TPS2121)

RED TRACE : MAIN_PWR (output from TPS2121)

YELLOW TRACE : PR1

BLUE TRACE : CP2

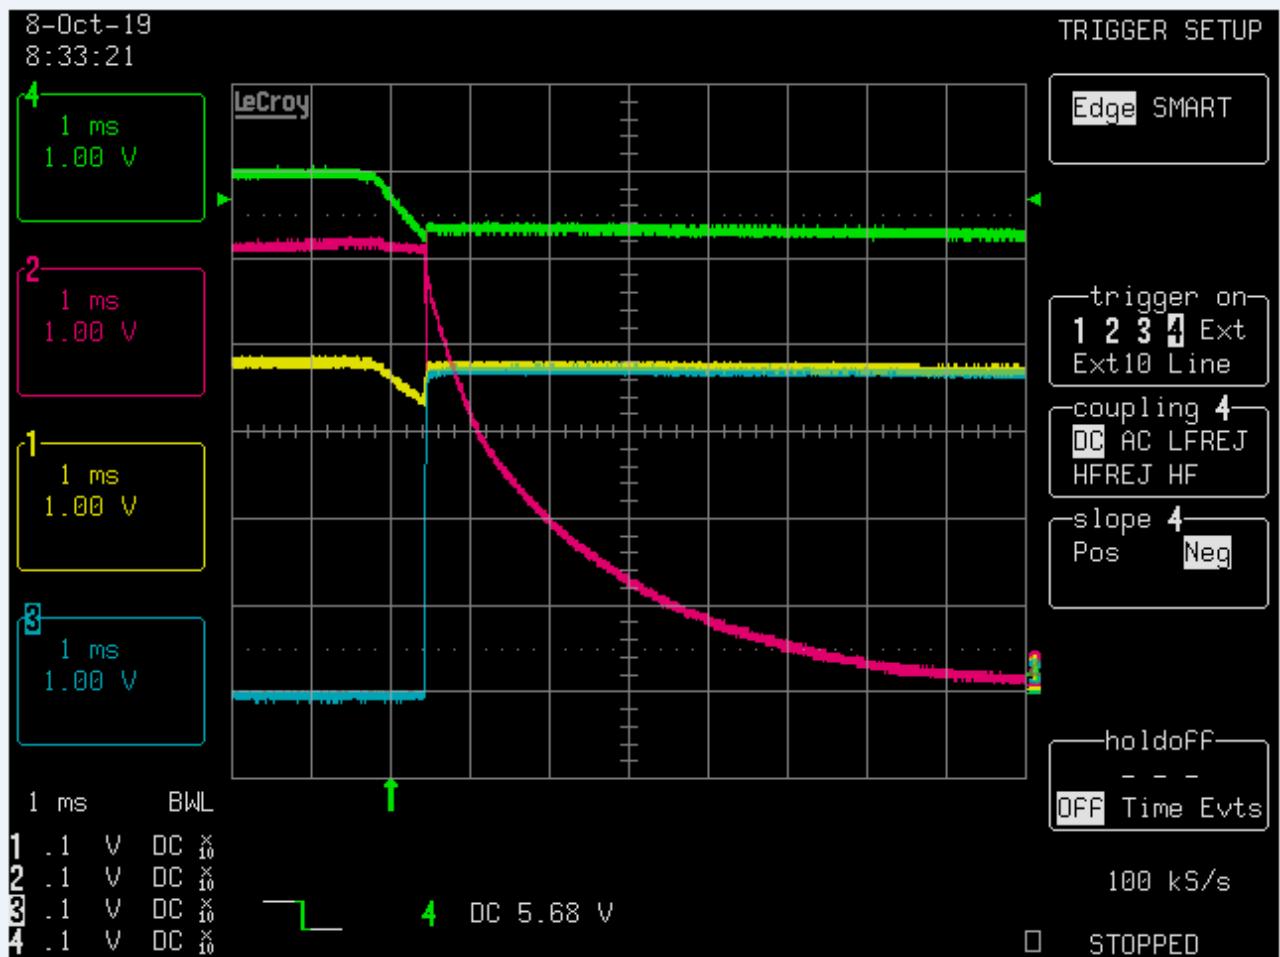
GREEN TRACE : 6V_PWR (VIN1 on TPS2121)

RED TRACE : MAIN_PWR (output from TPS2121)

YELLOW TRACE : PR1

BLUE TRACE : ST
