Vin = +24V, Vopos = +15V, Voneg = -15V, SYNC = 500kHz, 3.3V

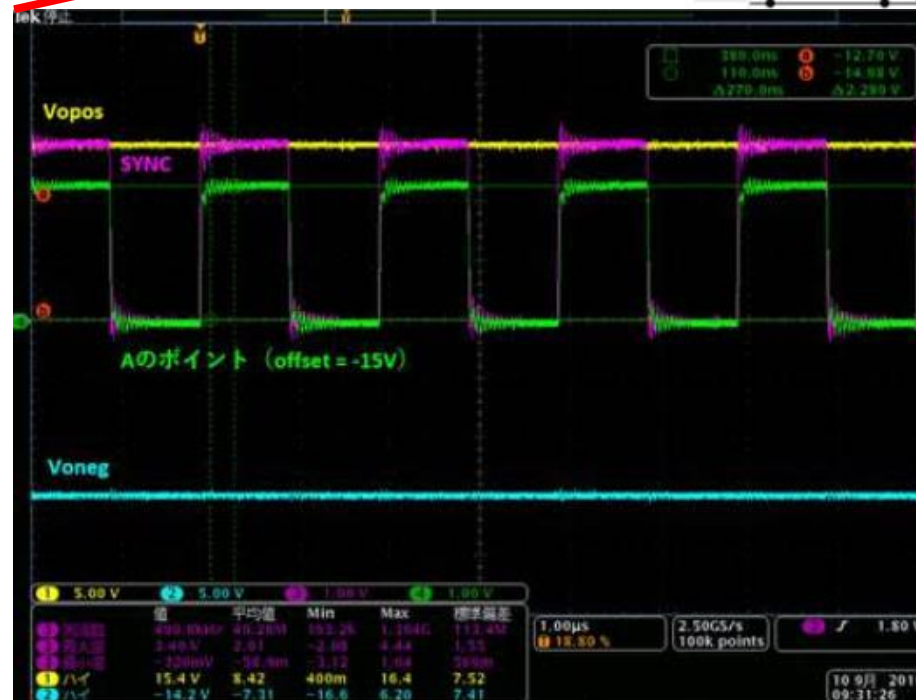
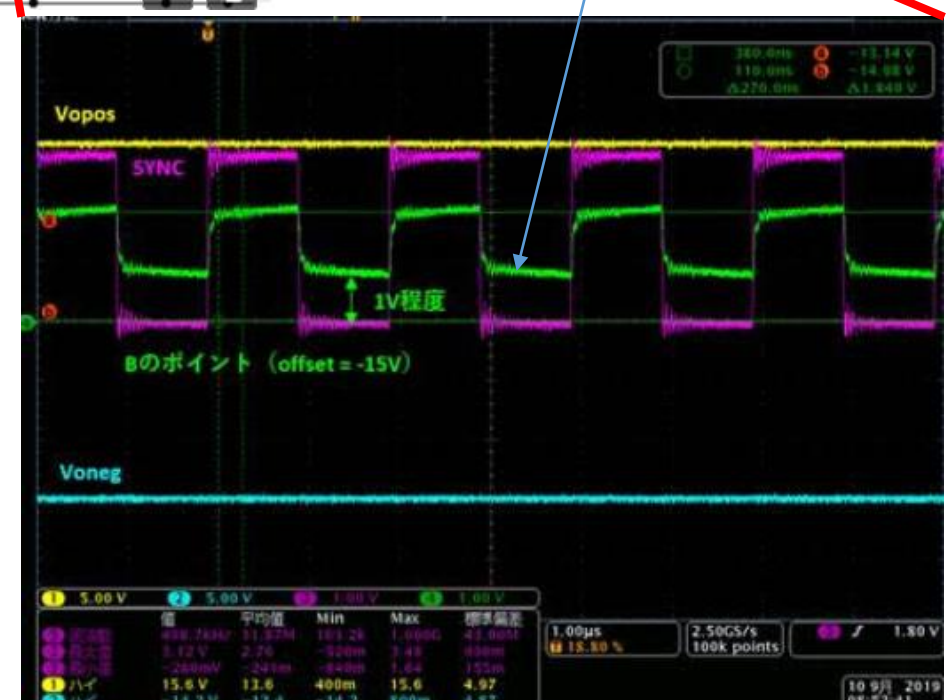
At point B, it operates with an offset of about 1V.
The RT / CLK low threshold is not met.
How can customer improve this?
