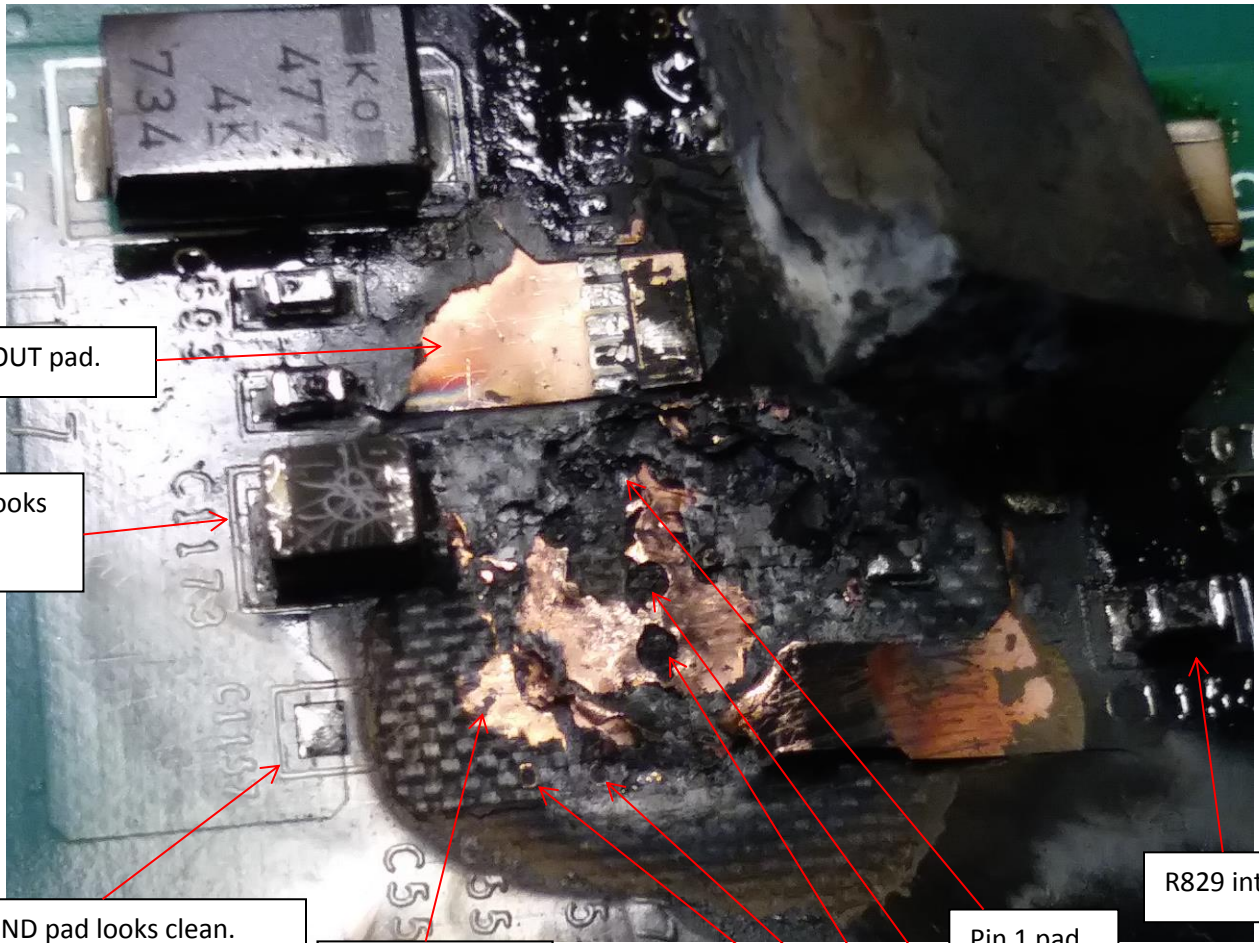
VOUT pad.

CIN, C1173 looks intact.

C1157 GND pad looks clean. Looks like the terminal from the cap was not soldered to the pad.

C1157 12V pad blown off.

12V vias.

Pin 1 pad here.

R829 intact.
