A LITTLE ABOUT THE ATTACHED WAVEFORMS. FIGURES #1 THRU #7 ARE ALL THE SAME SIGNAL. I TRIED TO GIVE YOU THE PICS TTHAT I THOUGHT WWOULD THAT I BELIEVE WOULD DEMONSTRATE THE PROBLEM I AM FACED WITH AND WHICH I HAVE NOT BEEN ABLE TO SOLVE. (I HATE IT).

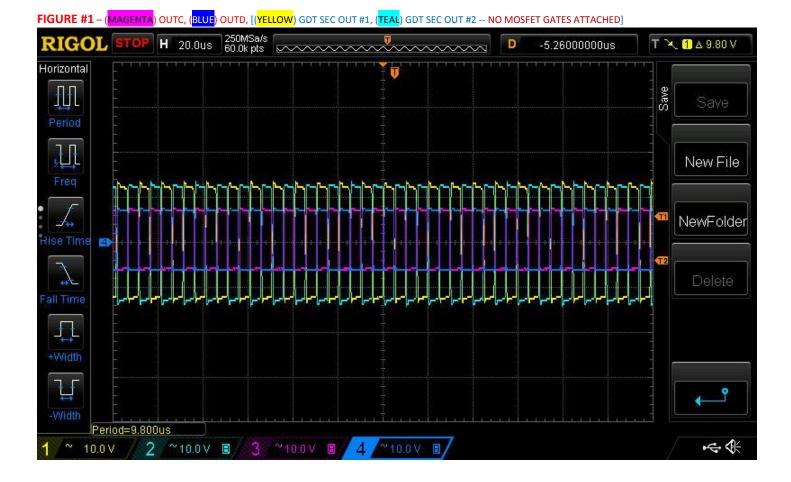
FIGURE #2 – (MAGENTA) OUTC, (BLUE) OUTD, [(YELLOW) GDT SEC OUT #1, (TEAL) GDT SEC OUT #2 -- NO MOSFET GATES ATTACHED

SO, LETS GO STRAIGHT TO THE PROBLEM, WHICH I SEE AS A PROBLEM. NOTICE THE RINGING WHICH PEEKS ITS UGLY, BUT WELL SHAPED RINGING RIGHT IN THE MIDDLE OF THE GDT SEC#1 AND GDT SEC#2 WAVEFORMS? I BELIEVE WHAT SHOULD BE THERE ARE TWO ZERO REFERENCING LINES.

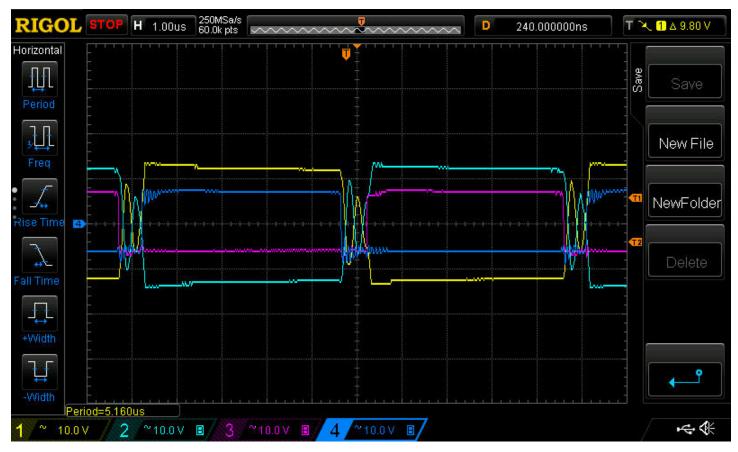
FIGURE #4 – (MAGENTA) OUTC, (BLUE) OUTD, [(YELLOW) GDT SEC OUT #1, (TEAL) GDT SEC OUT #2 -- NO MOSFET GATES ATTACHED

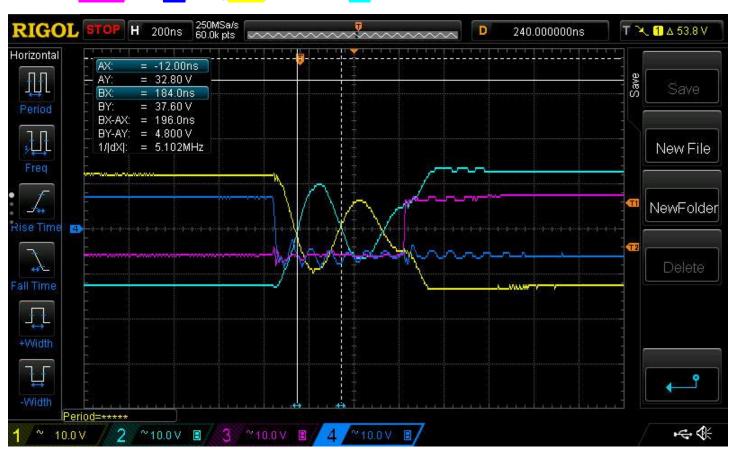
FIGURE #5 – (MAGENTA) OUTC, (BLUE) OUTD, [(YELLOW) GDT SEC OUT #1, (TEAL) GDT SEC OUT #2 -- NO MOSFET GATES ATTACHED

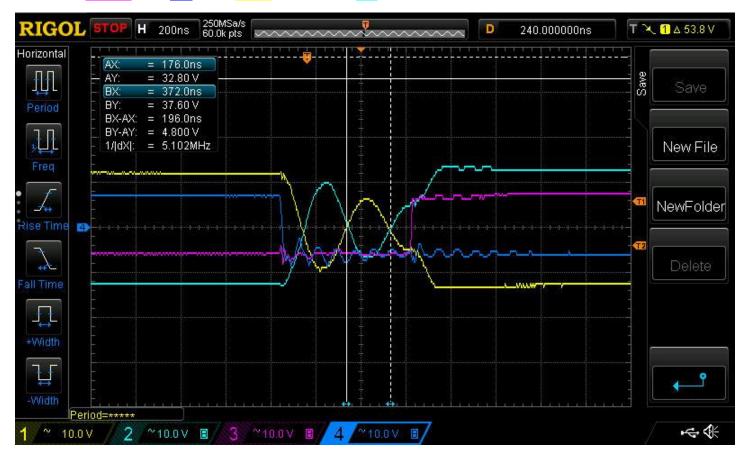
FIGURE #6 – (MAGENTA) OUTC, (BLUE) OUTD, [(YELLOW) GDT SEC OUT #1, (TEAL) GDT SEC OUT #2 -- NO MOSFET GATES ATTACHED
