On the data sheet, DRV8818 (revised January 2016), there seems to be an error on page 9: functional block diagram

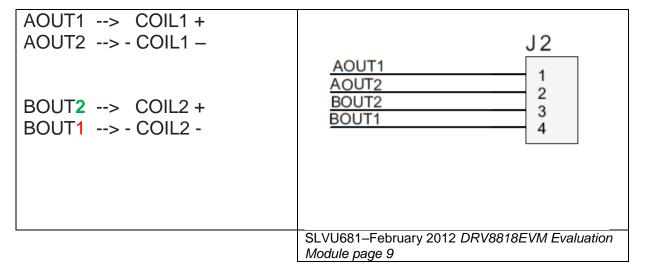
To make sure, your driver is working properly (as also indicated on the DRV8818 EVM for connector J2), the connection is:.

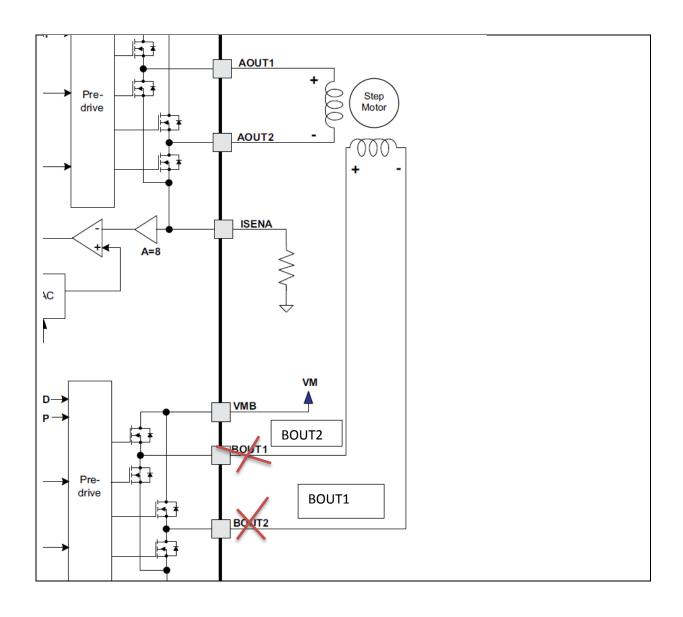
So at last , we would have on page 9 data sheet DRV8818

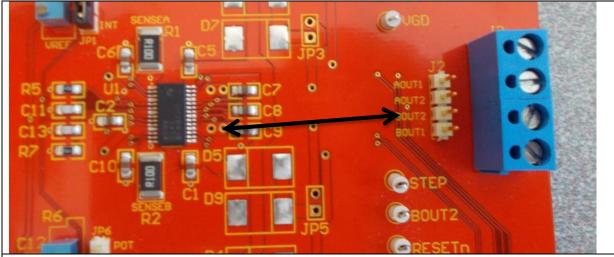
DRV8818 EVM REVB 2/10/2012 Connection between BOUT2 ( pin 18 ) and pin 3 connector J2 checked with multi meter

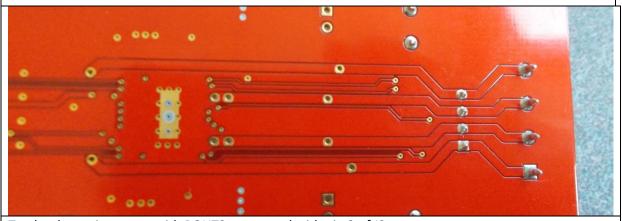
Tracks do not intersect with BOUT2 connected with pin 3 of J2

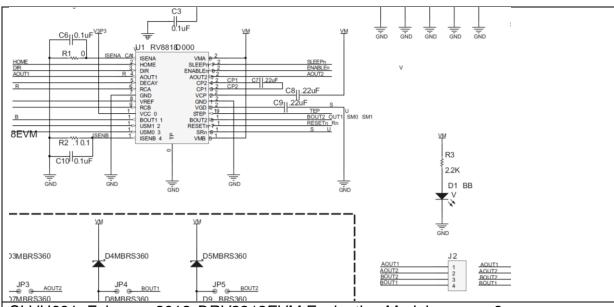
SLVU681–February 2012 *DRV8818EVM Evaluation Module* page 9

→ Schematics in accord with the DRV8818 EVM

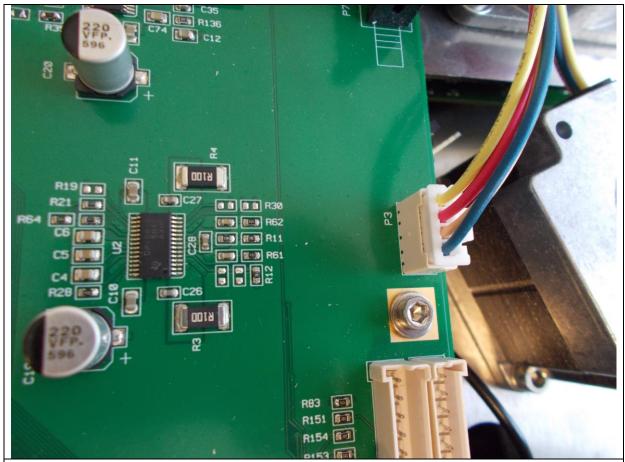
New PARKEON board working perfectly
With a connection between BOUT2 ( pin 18) and RED wire of stepper motor : Coil + (A)
