We are requesting a return and evaluation for a batch of DRV8231DSGR motor driver ICs purchased on **March 13, 2025**.

- **Lot Code (packaging):** 4175249CDA
- **Device Marking:**
31
458
A3D2
- **Quantity:** 642
- **Digi-Key Order Number:** 91523235

Technical Issue Description: DRV8231DSGR – No Output Observed (Marking: 31458A3D2)

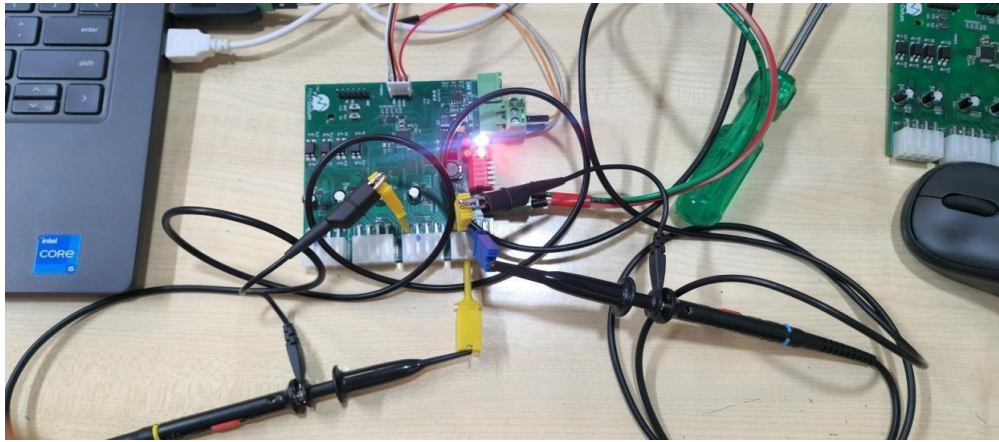
Testing:

To validate the functionality of the DRV8231DSGR IC, the following oscilloscope test configuration was used:

- **Channel Configuration:**
 - **CH1 (Forward Test):** Probe connected to the signal output (OUT1/OUT2), with ground reference connected to system GND
 - **CH1 (Reverse Test):** Same configuration applied, with reversed input conditions to test reverse operation

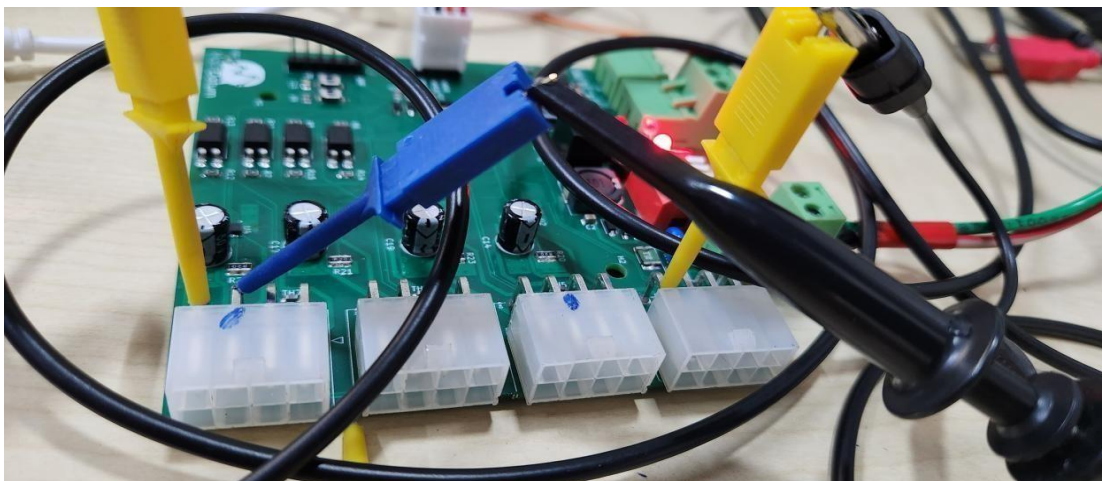
Test Comparison Between Current and Previous IC Batches

The oscilloscope test setup included **four channels** for simultaneous observation and comparison.

- The **marked channel outputs** (highlighted in blue on the white connector) correspond to the **current batch** of DRV8231DSGR ICs, marked **31-458-A3D2**.
- The **unmarked channel outputs** correspond to the **previous batch**, marked **31-428-A62J**.

- Input Supply: 24 VDC
- Input Signal: 40 kHz PWM at 50% duty cycle
- Identical test circuit, PCB, and firmware used for both batches

- The **previous batch (31-428-A62J)** produced the expected PWM output with a voltage swing up to 24V.
- The **current batch (31-458-A3D2)** failed to produce any output under the same conditions.

This confirms that the issue is specific to the current lot and not related to the test setup or methodology.

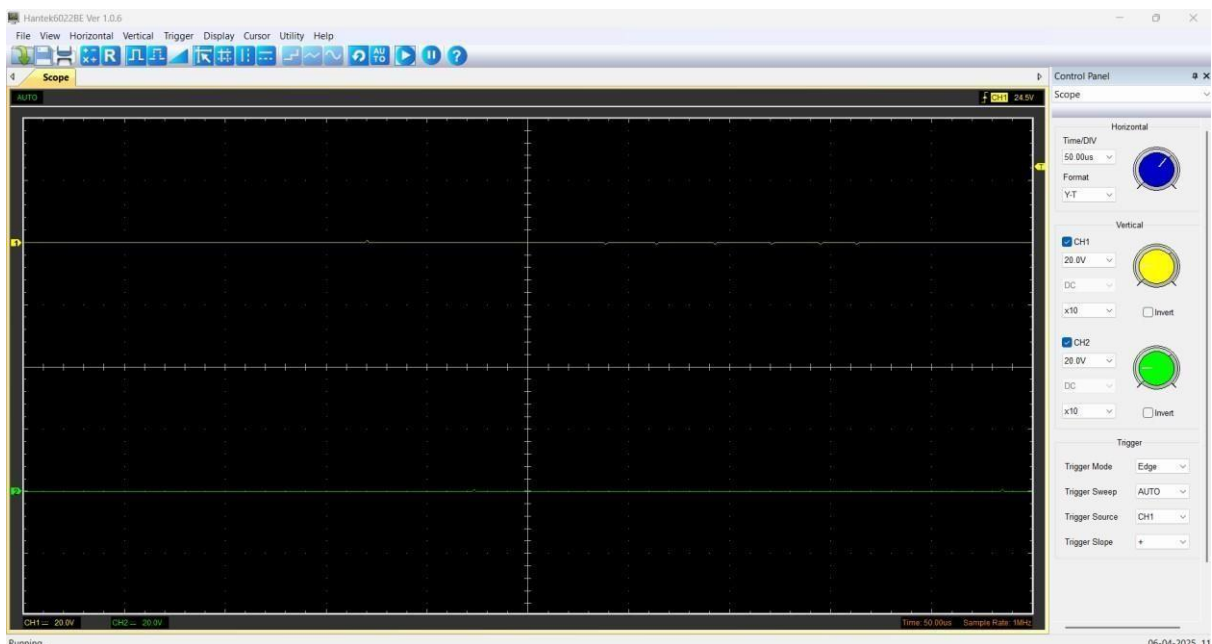
Marking on IC: **31-458-A3D2**.

Despite correct supply and input logic signals, the ICs marked **31458A3D2** do not provide any output at **OUT1** or **OUT2** under the described test conditions.

Please evaluate this batch as potentially defective. We would appreciate a replacement or refund.

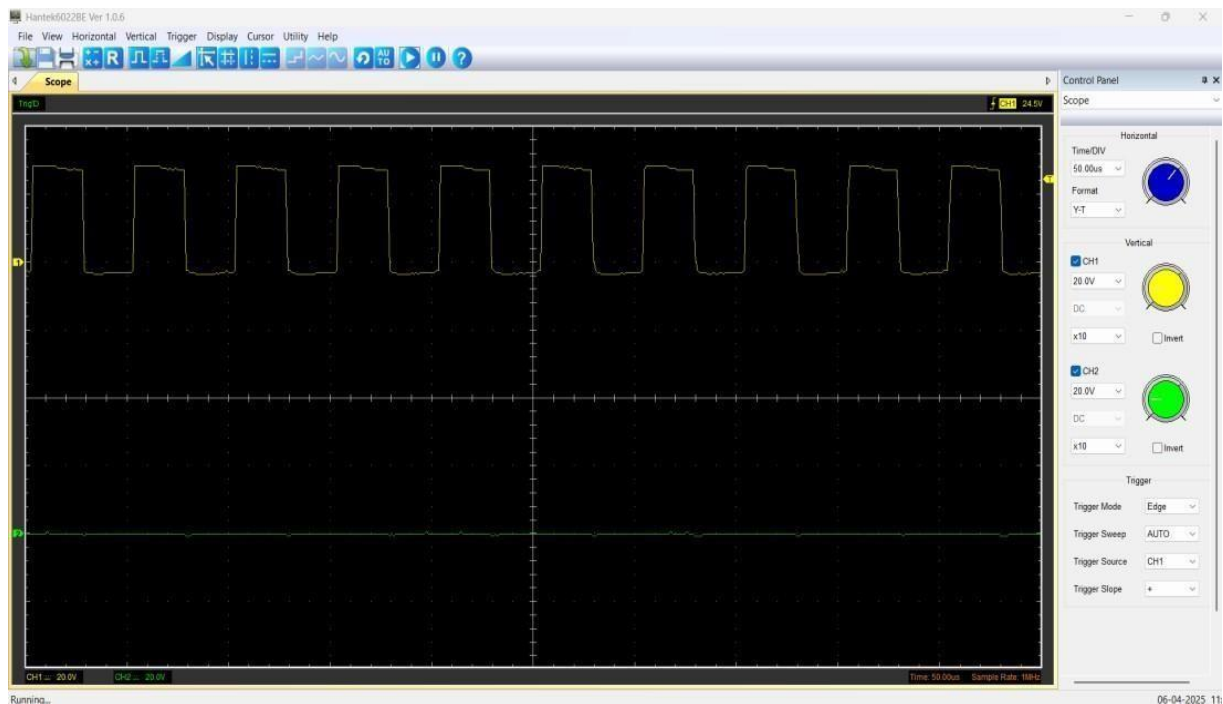
Forward operation

Forward Operation – Working (Marking: 31428A62J)

- **PWM Input:** 20 kHz, 50% duty cycle
- **IN1:** High (PWM applied)
- **IN2:** Low
- **Supply Voltage:** 24 VDC
- **Reference Voltage:** 3.3VDC
- **Expected Result:** PWM output at OUT1/OUT2
- **Observed Result:** Output is as expected – PWM signal is present at OUT1/OUT2

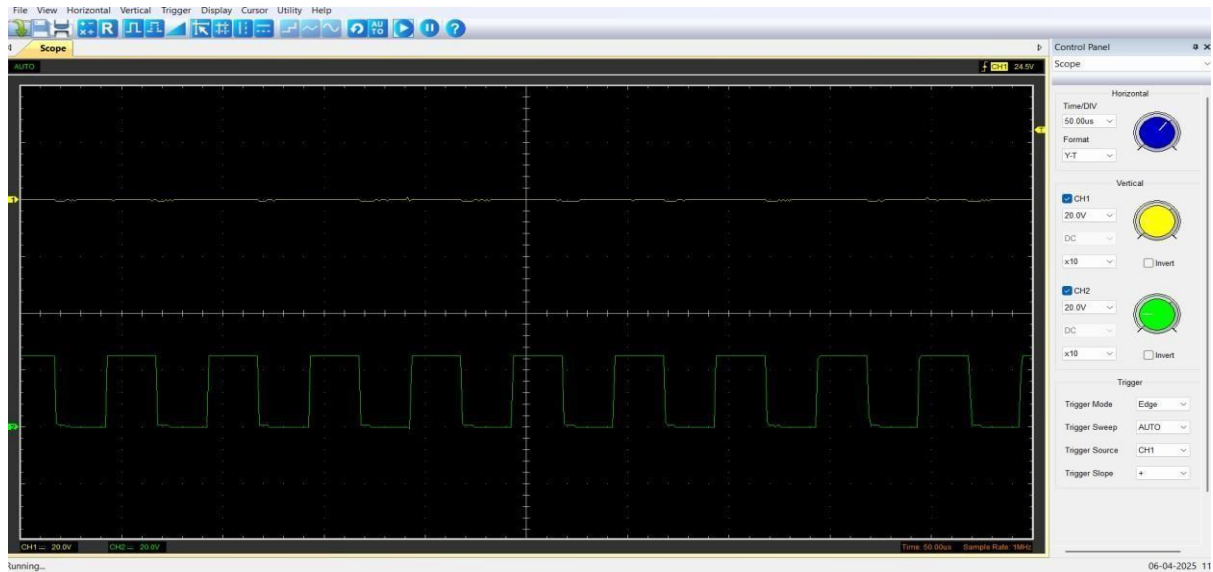
Reverse Operation – Working (Marking: 31428A62J)

- **PWM Input:** 40 kHz, 50% duty cycle
- **IN1:** Low
- **IN2:** High (PWM applied)
- **Supply Voltage:** 24 VDC
- **Expected Result:** PWM output at OUT1/OUT2 (in reverse polarity)
- **Observed Result:** Output is as expected – PWM signal is present at OUT1/OUT2
