Problem: Electrical Failure

SigmaTron Part number: L27-3253

P/N Description: IC, SM, ANALOG DEMUX/MUX

Report date: Feb/13/2026

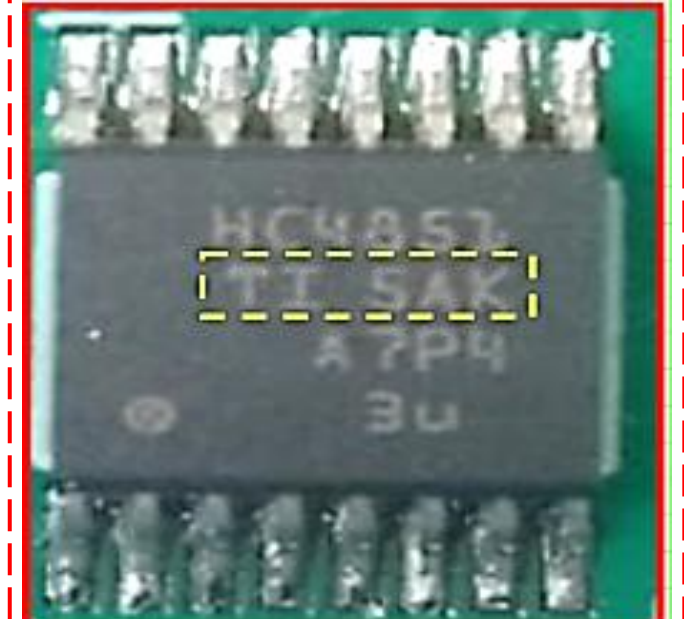
Not acceptable

On January 28, 2026, during the first production shift, a rejection of 131 units of assembly B27-812766-001 (Shop order 665467) was identified due to ICT (In-Circuit Test) failures. Technical analysis confirmed that component L27-3253 (PO 81515800/L1, DC 2540), located at positions U6, U7, and U8, presents an open circuit condition. The failure was validated through manual multimeter measurements by the Electrical Test Engineering team.

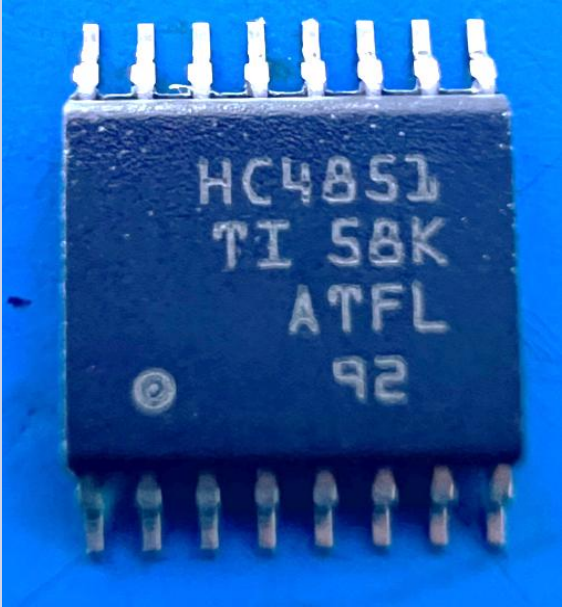
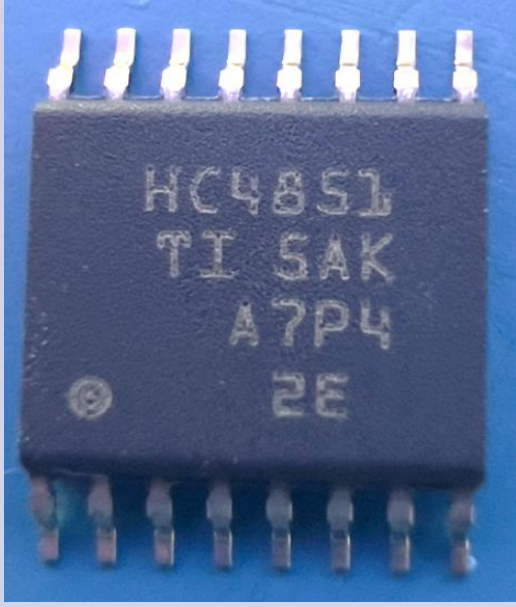
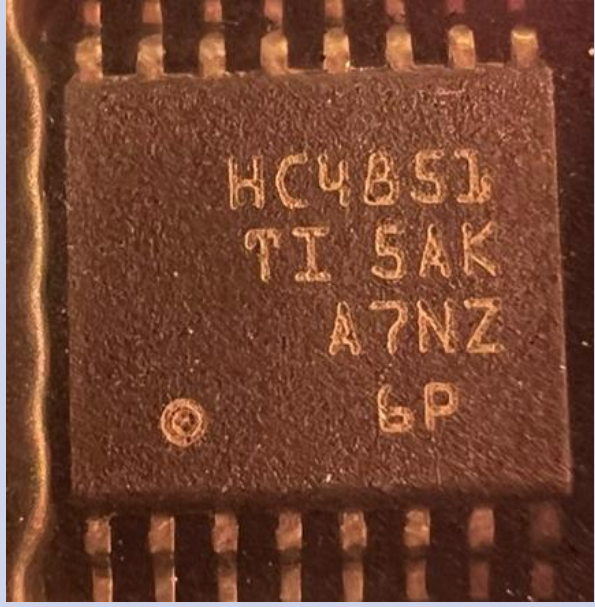
DMR 9254	DMR 9267	DMR 9271
Qty Rejected raw material:	245 pcs (IC's)	1,715 pcs	4,000 pcs
Qty of rejected assembled ICs:	255 pcs	281 pcs	0
Purchase Order:	TJ815196	TJ815158	TJ815362
Date Code:	2533	2540	2540
LOT#	5559180ML5	5683146ML5	5683140ML5
Suspect batch:	TI 58K	TI 5AK	TI 5 AK
Image of IC:

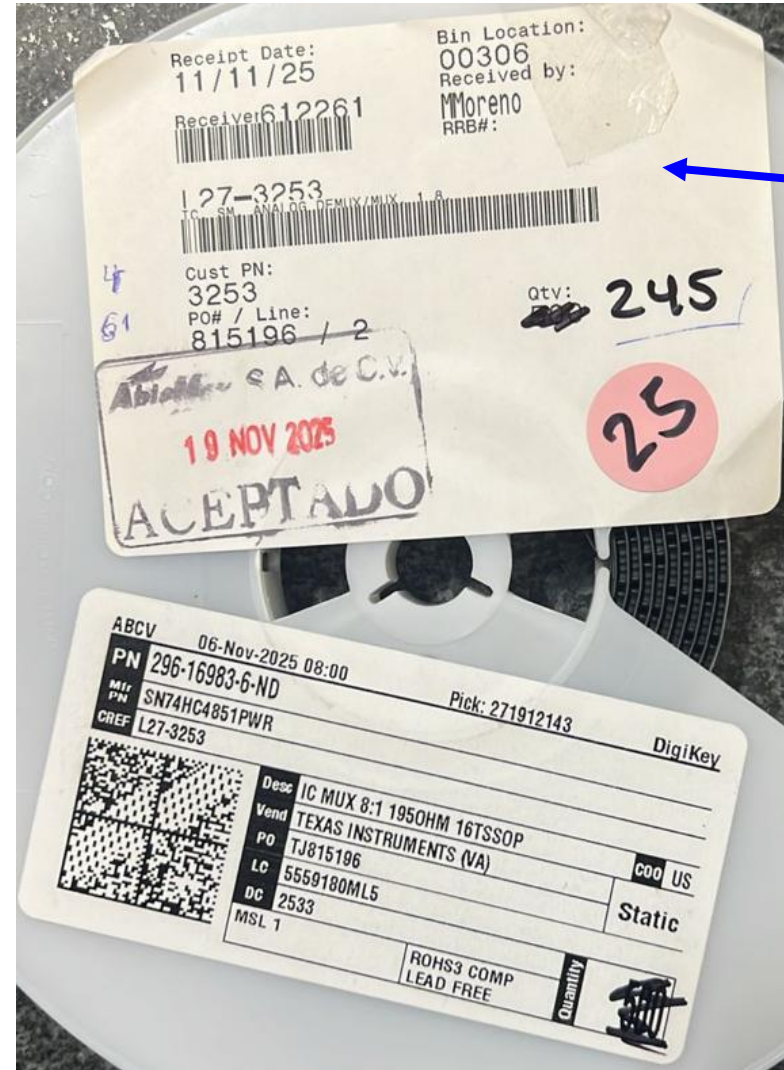
Labels with batch code **TI 5BK** (DMR 9254)

Electrical failure during ICT test, received on PO 815196/2 from Digi Key Supplier, we have assembled 255 pcs. in ASSY B27-812766-002-REVN Qty 64 S/O 665185 Purge # 612 DC 2533 Lot # 5559180ML5.

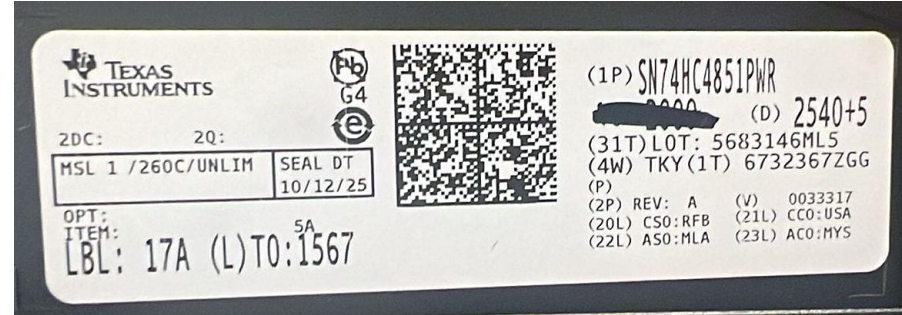
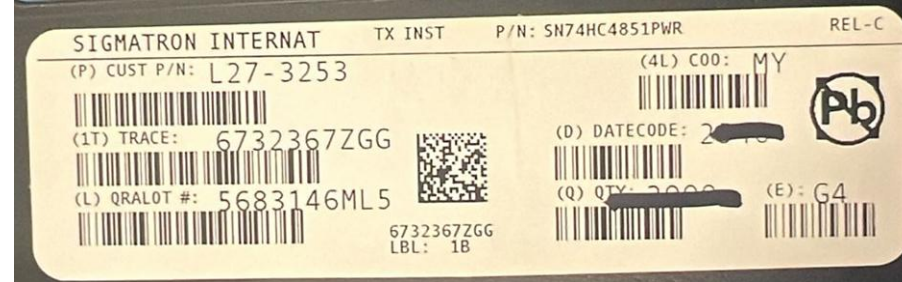
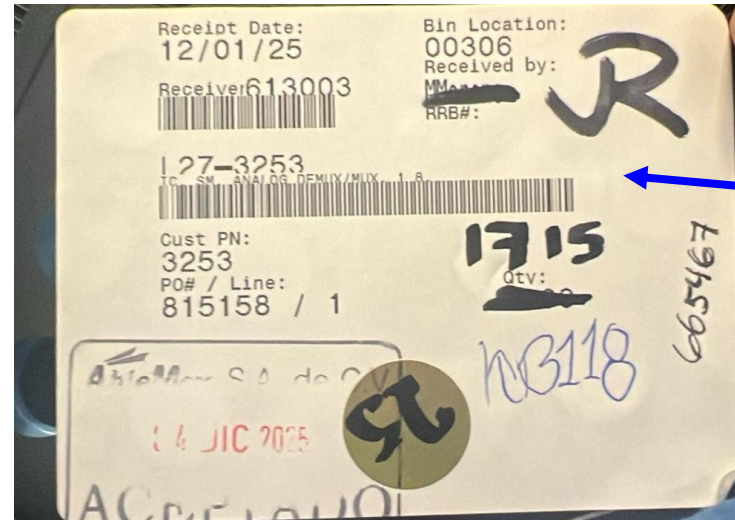
Labels with batch code **TI 5AK** (DMR 9267)

Electrical failure during ICT test, received on PO 815158/1 from Texas Instruments Supplier, Were assembled 281 pcs. ASSY B27-812766-001-REVN S/O 665467 DC 2540 Lot # 5683146ML5. DMN 26-003

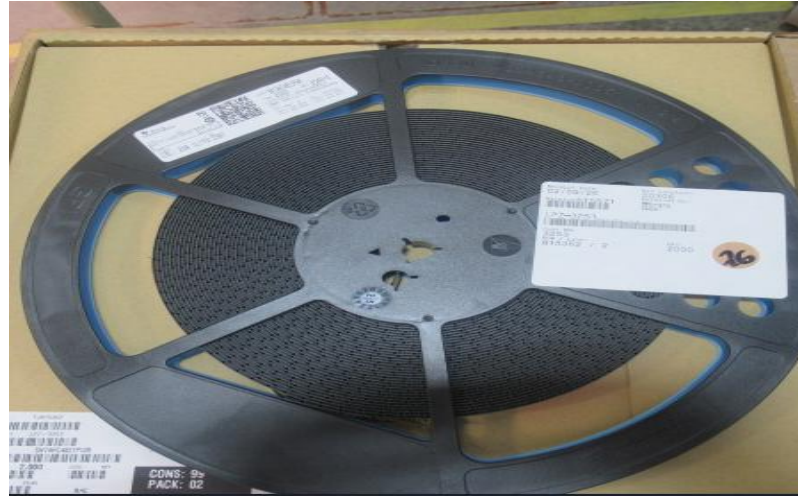
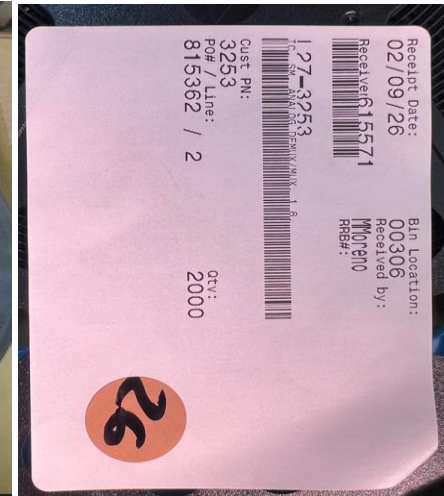
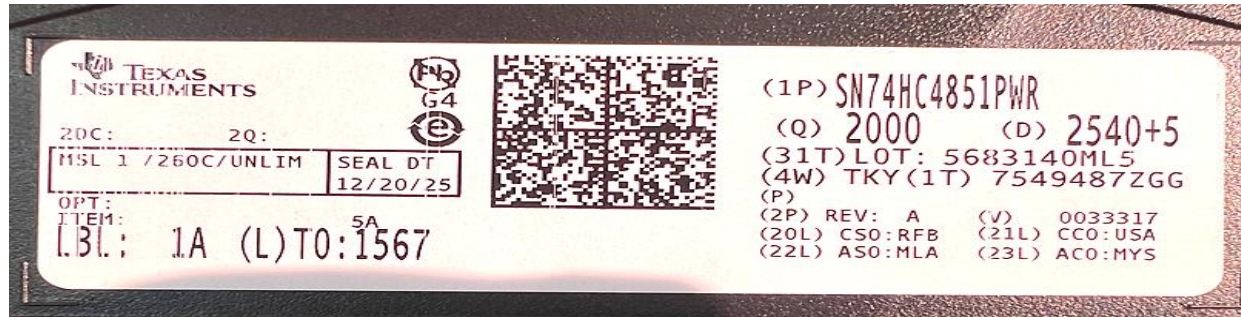
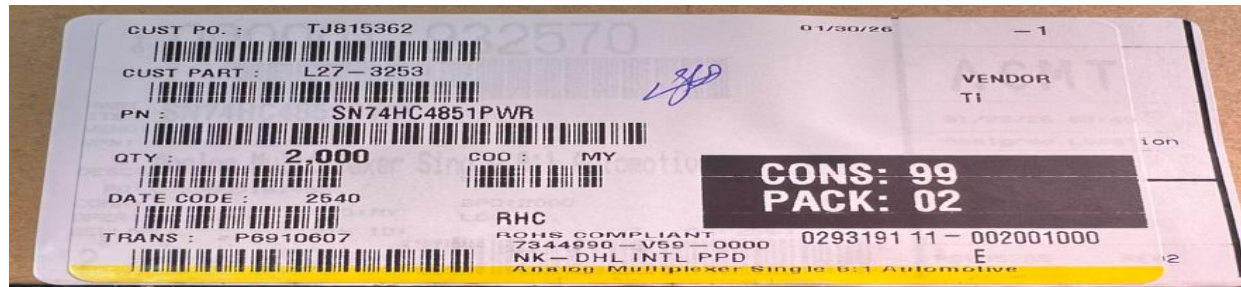
Suspicious per Electrical failure in ICT test AML SN74HC4851PWR DC 2540
Lot # 5683140ML5

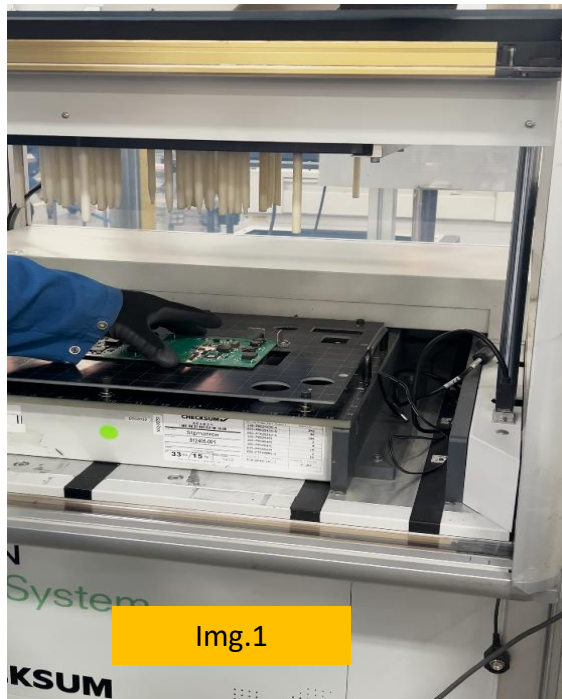
Img.1

To confirm that the anomaly is associated with the raw material corresponding to SigmaTron part number **L27-3253 (SN74HC4851PWR)**, a comparative validation was performed using the same PCBA under controlled conditions:

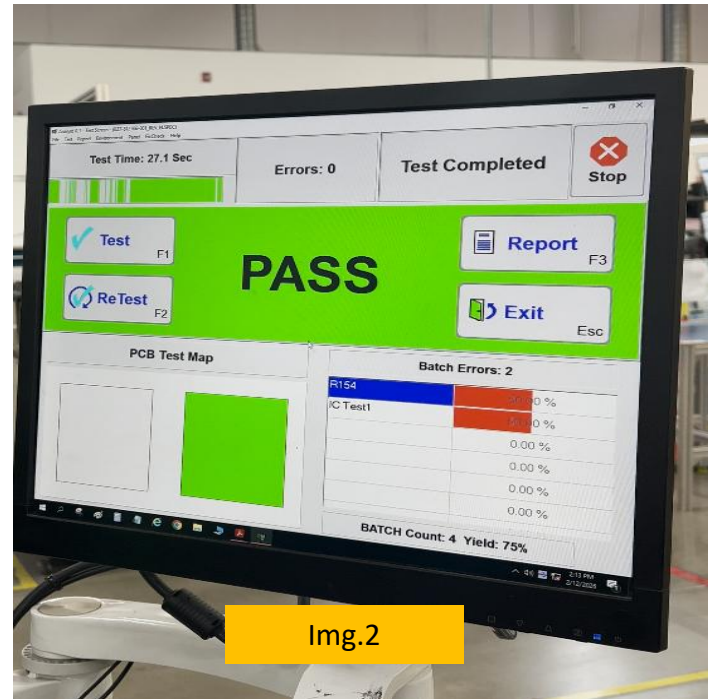
Img.2

1. Initially, the board was tested with integrated circuits marked **"TI 3BK"** (lot 3951531ML3). The unit successfully passed the ICT test, meeting all established electrical parameters (see *Img.2*).
2. Subsequently, the same previously validated unit had the integrated circuits replaced with components from the suspect lots. After repeating the ICT test, the unit failed electrically, reproducing the rejection condition observed during production (see *Img.3*).

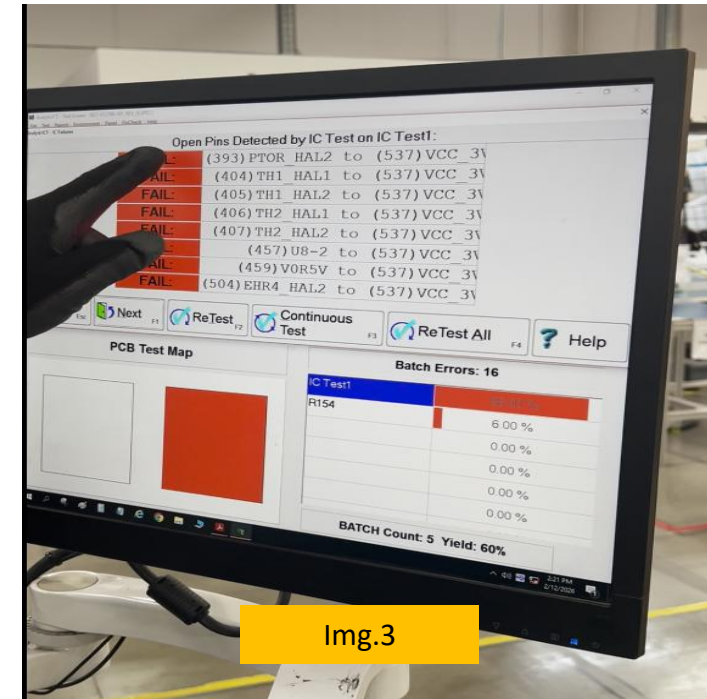
Img.3

This exercise confirmed that the failure is directly related to the electrical behavior of the ICs from the analyzed lots and is not associated with the PCBA or the assembly process.

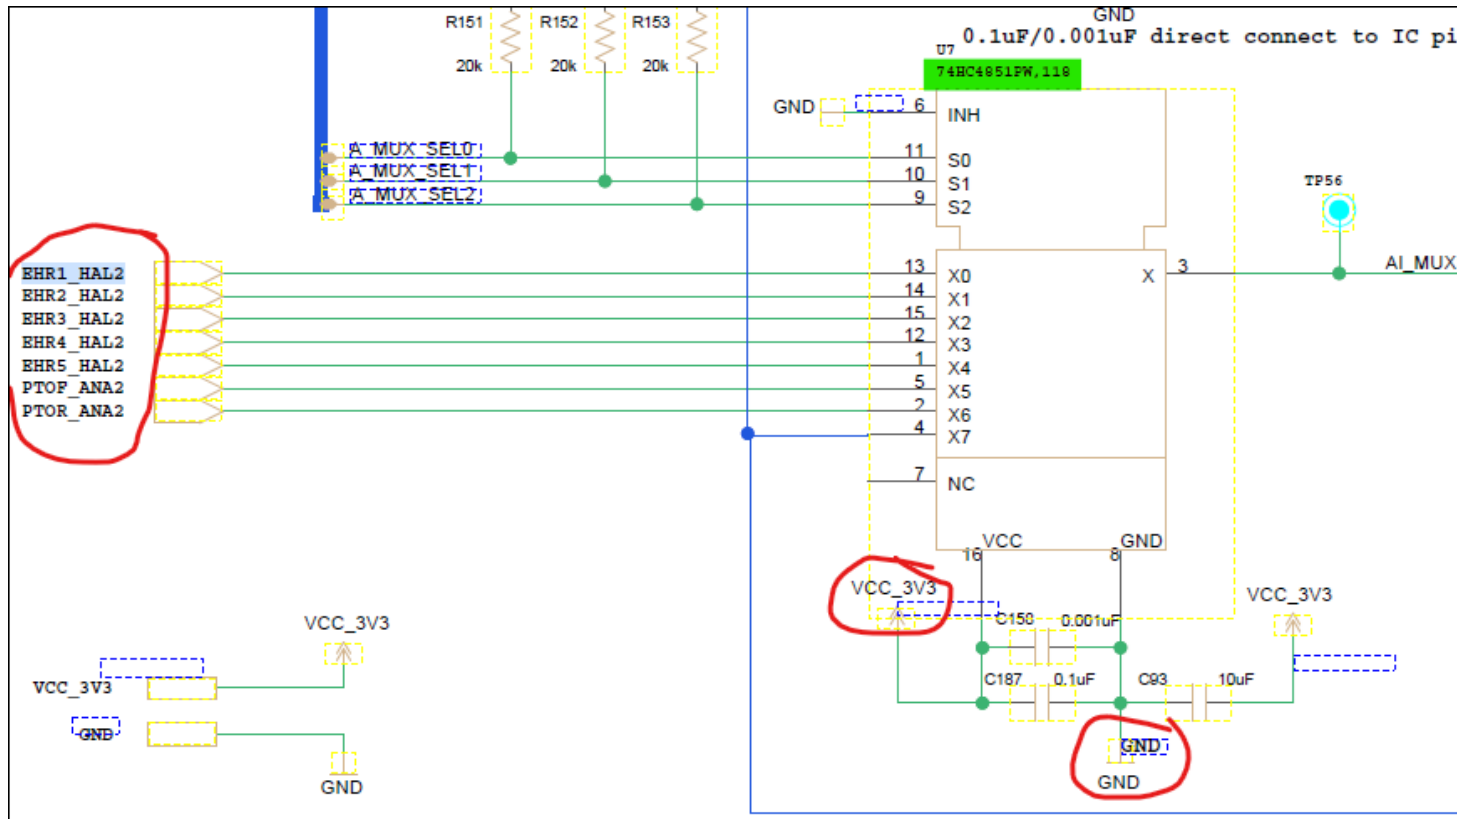
Img.5 Electrical schematic of the IC.

According to the electrical schematic, these nodes are connected to **IC U7 (74HC4851PW)**, confirming that the failure is directly related to the integrated circuit under analysis.

In the following image, it can be observed that EHR1_HAL2 (as well as the other failing “EHRX_HAL2” nodes detected during ICT) are connected to U7, which is one of the ICs in question (74HC4851PW).
