| Job Number: | AT22737 | Customer: | Serendipity | Date: | 2/9/2023 |
| Part No: | LMZ31707RVQR | Cust Part No: | N/A | PO # | 139903 |
| Manufacturer: | TI | Date/Lot Code: | 8AW | Quantity: | 250 |

| Process | General Results Summary |

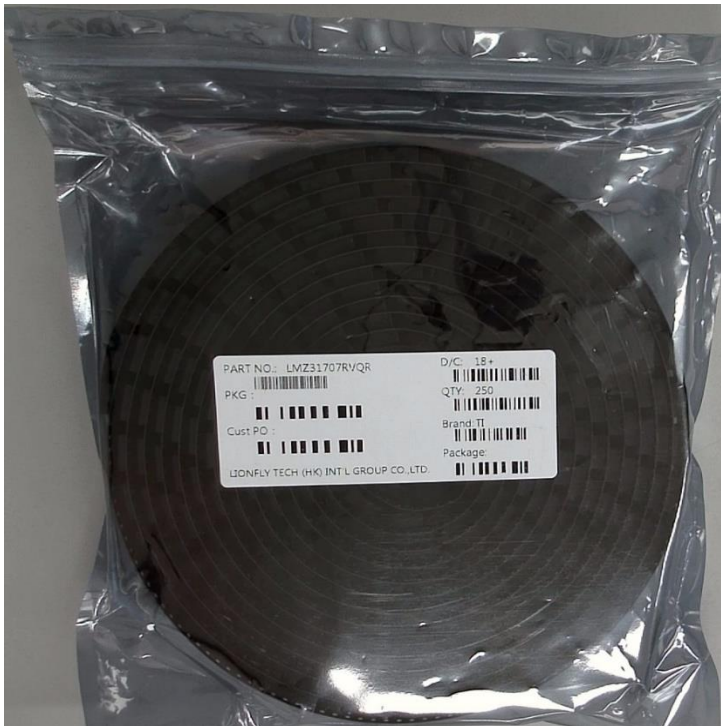
### Packaging / Factory Label Photo if Applicable

| Yes | No | Inc. | N/A | |
|---|---|---|---|---|
| <input type="checkbox"/> | <input checked="" type="checkbox"/> | <input type="checkbox"/> | <input type="checkbox"/> | Factory Label Present? |
| <input type="checkbox"/> | <input checked="" type="checkbox"/> | <input type="checkbox"/> | <input type="checkbox"/> | Labels Redacted? |
| <input type="checkbox"/> | <input checked="" type="checkbox"/> | <input type="checkbox"/> | <input type="checkbox"/> | Other Problems? |

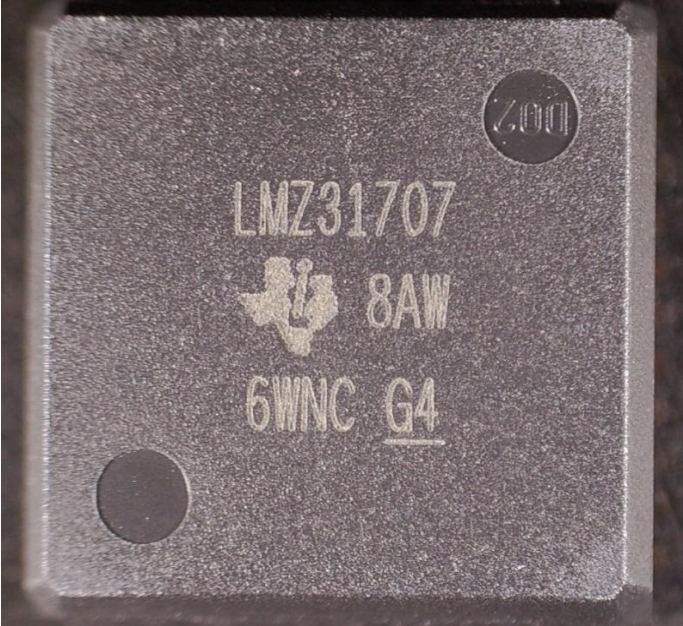
<p style="text-align: center; margin-top: 20px;">(54020, LMZ31707)</p>     | <p><b>Manufacturer Determined:</b><br/>           By Bag: <input checked="" type="checkbox"/> Marking: <input checked="" type="checkbox"/> Other: _____</p> <p><b>Date Code Determined:</b><br/>           By Bag: <input checked="" type="checkbox"/> Marking: <input type="checkbox"/> Other: _____</p> <p><b>Quantity Determined:</b><br/>           By Bag: <input checked="" type="checkbox"/> Counted: <input checked="" type="checkbox"/> Other: _____</p>

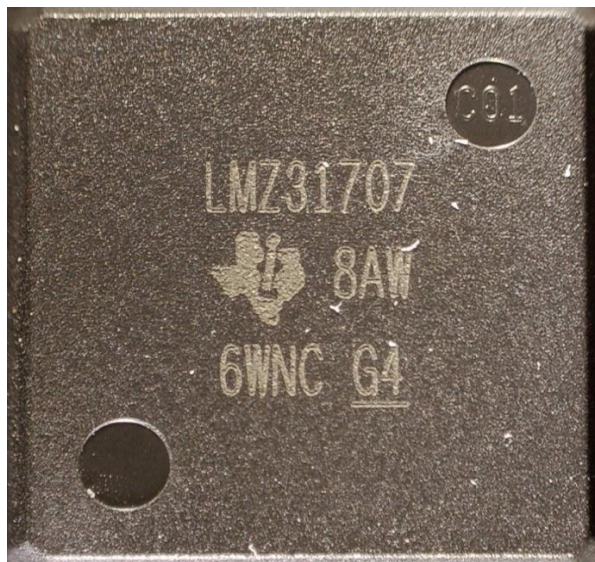
### Post Resistance to Solvents Photo

| Pass | Fail | Inc. | N/A | |
|---|---|---|---|---|
| <input checked="" type="checkbox"/> | <input type="checkbox"/> | <input type="checkbox"/> | <input type="checkbox"/> | Solution 1 on Marking<br>Isopropyl Alcohol, >90% @ 25°C |
| <input checked="" type="checkbox"/> | <input type="checkbox"/> | <input type="checkbox"/> | <input type="checkbox"/> | Solution 2 on Marking<br>Mineral Spirits /Isopropyl Alcohol 3:1 @ 25°C |
| <input checked="" type="checkbox"/> | <input type="checkbox"/> | <input type="checkbox"/> | <input type="checkbox"/> | Solution 3 on Surface<br>Acetone @ 25°C |

Notes: Parts are laser marked.

**Accept**

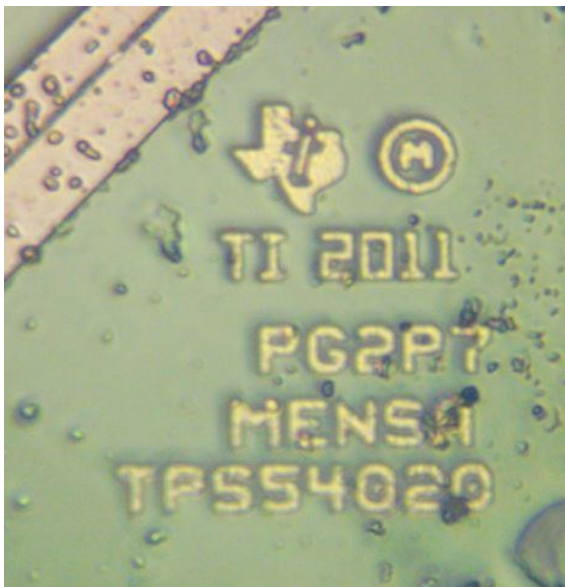
**Full Die Photo**

Die Information:  
TPS54020 PG2P7

Manufacturer:  
TI 2011 Mensa

**Results:**  
**Information Provided for**  
**Customer Evaluation**
