**Temperature Cycle Report for  
376 Ceramic Column Grid Array**

## INTRODUCTION

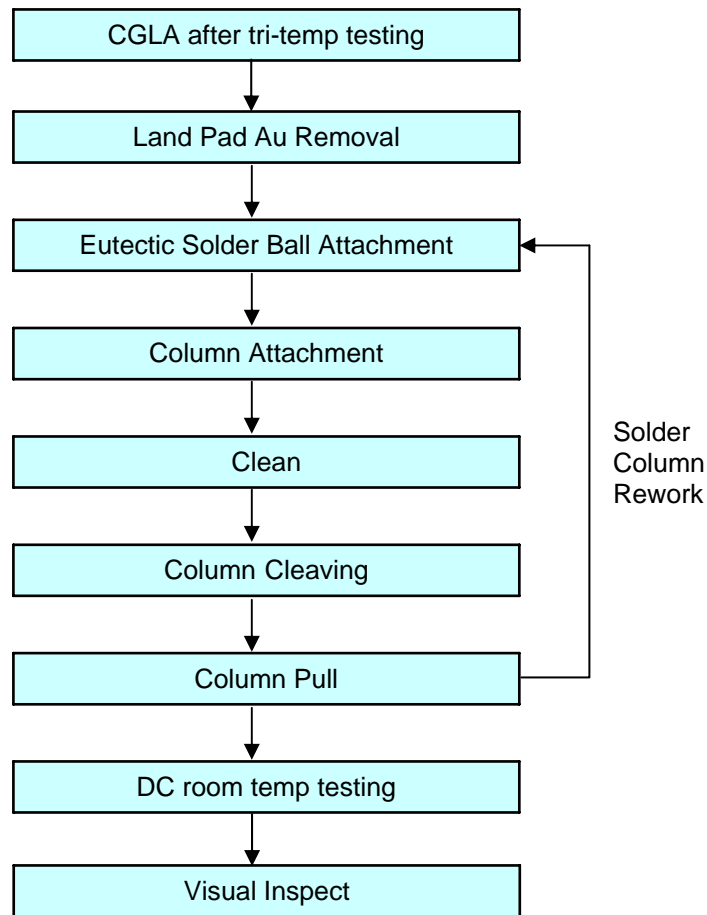
Solder columns were attached to the ceramic package with eutectic solder (63 Pb/ 37 Sn) normal reflow. The column attach process flow shows the land pad gold metallization being removed before column attach (see figure 2). Removing the gold plating enhances the joint reliability by avoiding rich gold tin intermetallic formation. The columns are 0.51mm in diameter and 2.21mm in height from the board to the bottom of the package.

**Figure 2 – 6sigma Column Attach Process Flow**

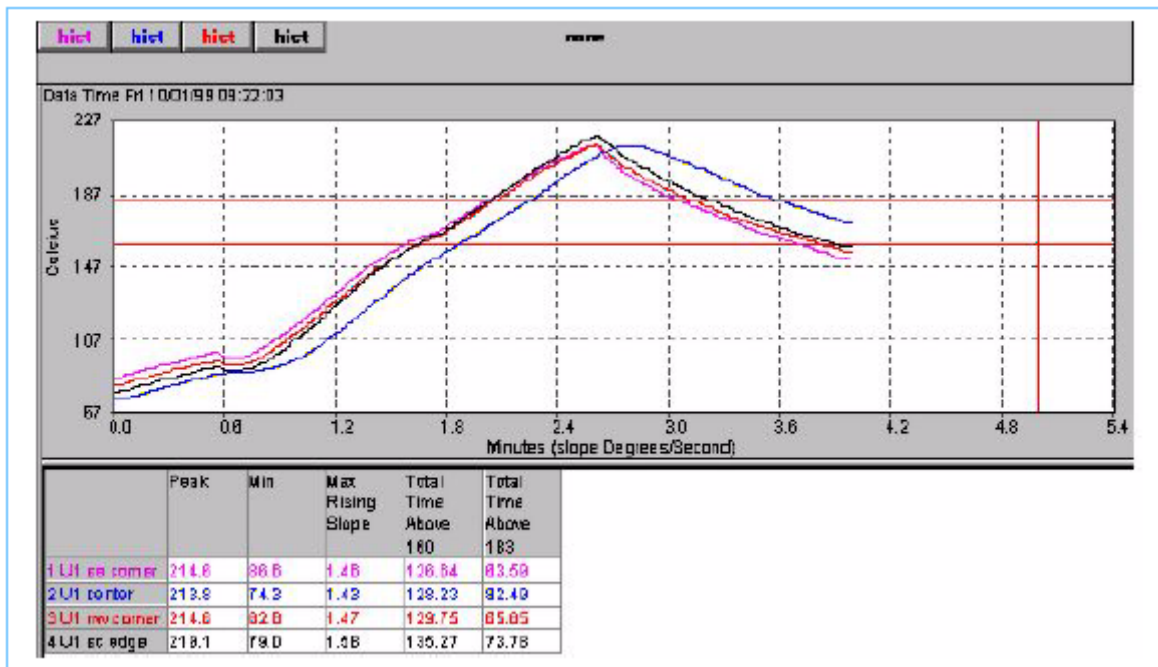
Figure 3 – Reflow Profile

The temperature cycle boards were laid out on 4 layer PCB with landing pads sizes of 0.89mm for the 1.27mm pitch columns and 0.81mm for the 1.00mm pitched columns (see figure 4 and 5). In order to isolate any columns after a failure, probe pads were strategically connected to the daisy chain. The boards were able to accommodate 16 parts per board and were mounted using the recommended reflow profile from 6sigma (see figure 3).

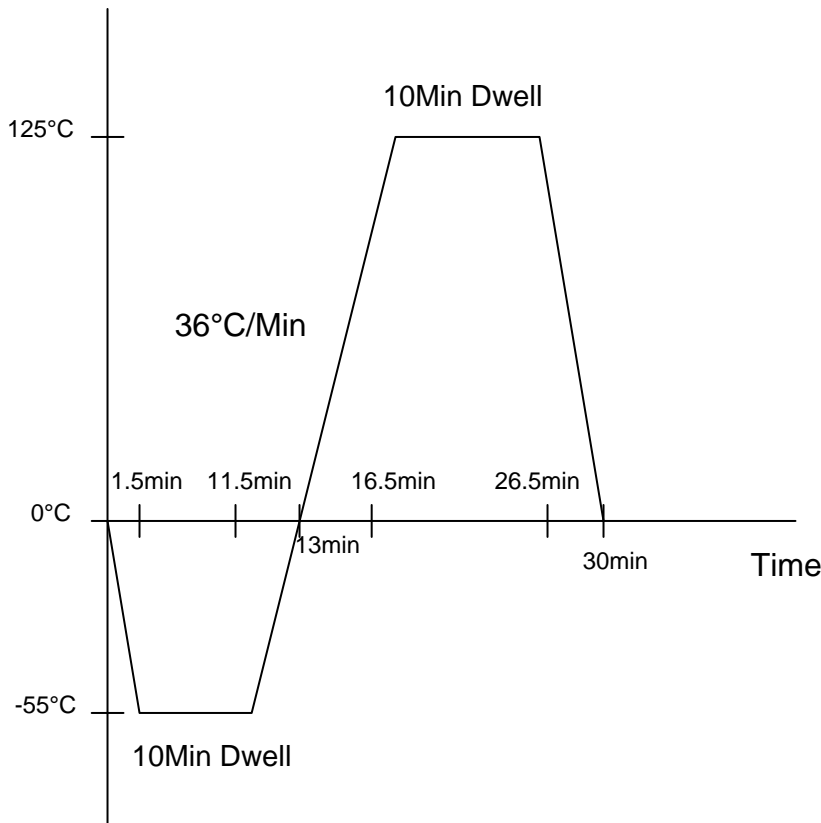
Two temperature cycle boards (16 parts per board) were used resulting in thirty two units for this evaluation. The thermal profile for this testing, following JEDEC Standard JESD22-A104C with test condition B and soak mode 3, was a -55°C to +125°C temperature range with a 10 minute soak time at temperature and a 36°C per minute ramp rate (see Figure 7). One cycle was completed every 30 minutes resulting in 48 cycles per day. The resistive interconnect of the units under test was continuously monitored. The average resistance measure was 15Ω and a device was considered a failure if the resistance changed more than 10% or 1.5 Ω. The units were stressed until a cumulative 25% failure rate was achieved.

**Figure 7 - TMCL PROFILE**

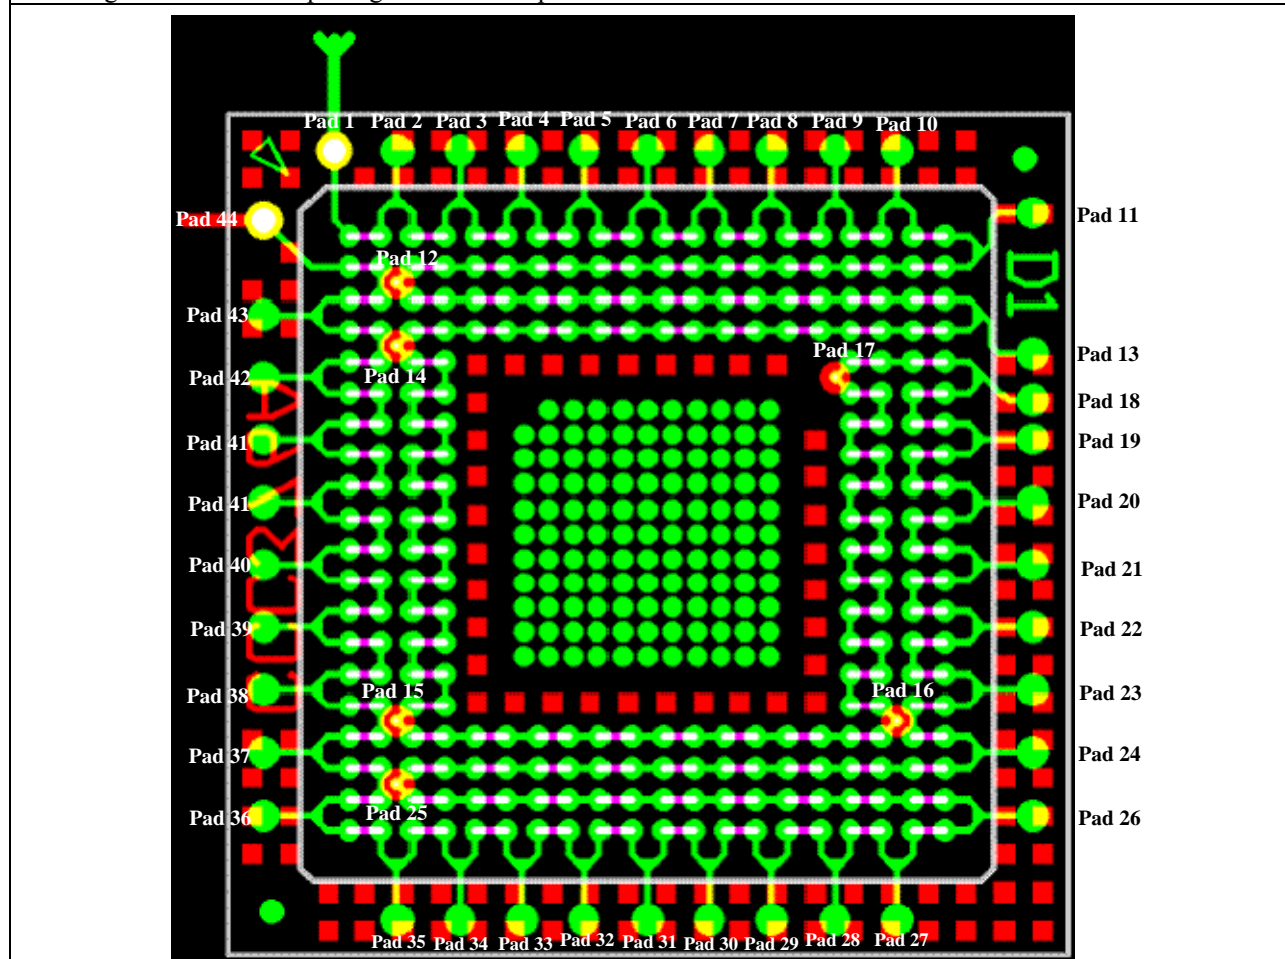
Curve tracing found an open between the pads on the PCB board as indicated in the diagram below.

The diagram of board and package. It shows all pin locations.

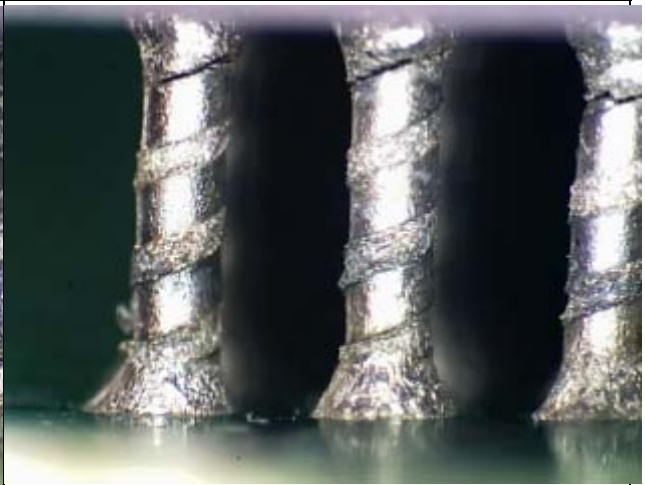
Figure C. The image of the contacts between the column and PCB board showed no anomalies on SN15.

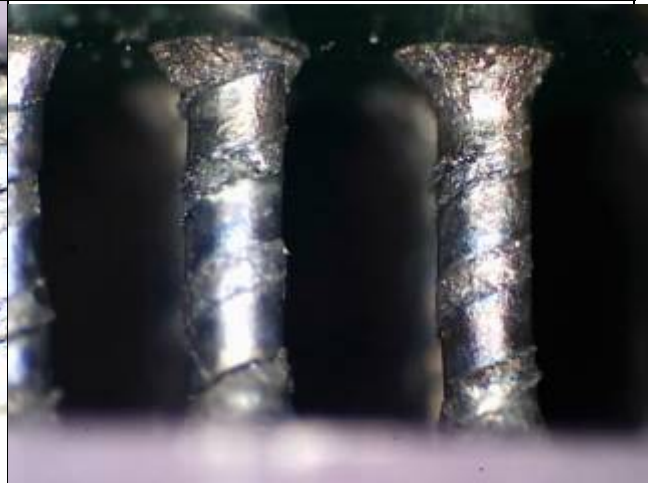
Figure F. The image of the contacts between the column and the PCB board showed no anomalies on SN21.

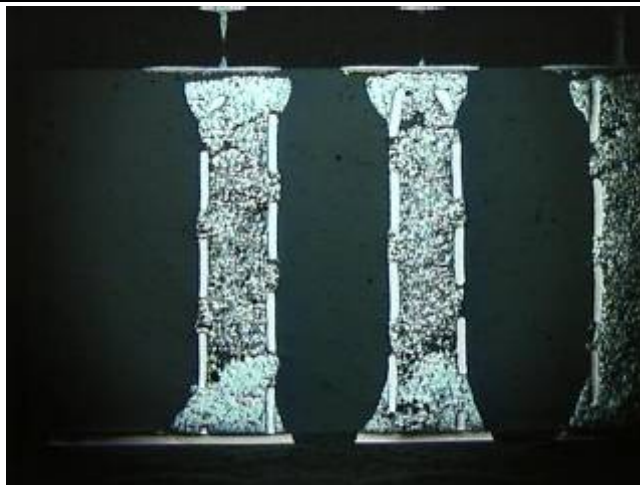
Figure M The cross section image of the open column shows the gap at the contact between the column and the pad of the package on SN3. The location of the column is the first row from the bottom and the first two pins from the left.

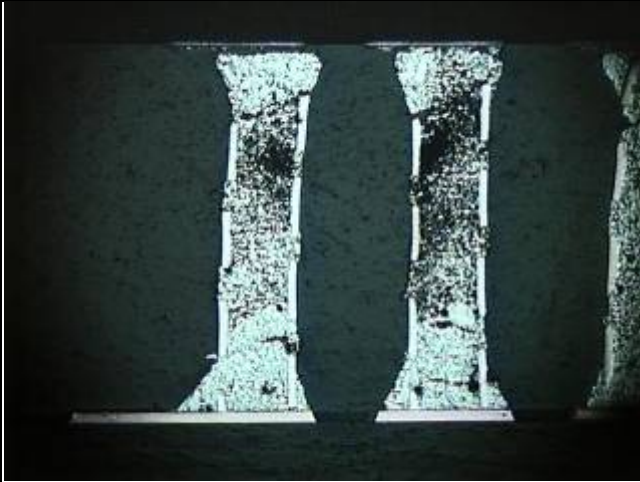
Figure Q. The cross section image of the open column shows the gap at the contact between the column and the pad of the package on SN15. The location of the column is the first row from the top and the first two pins from the right.

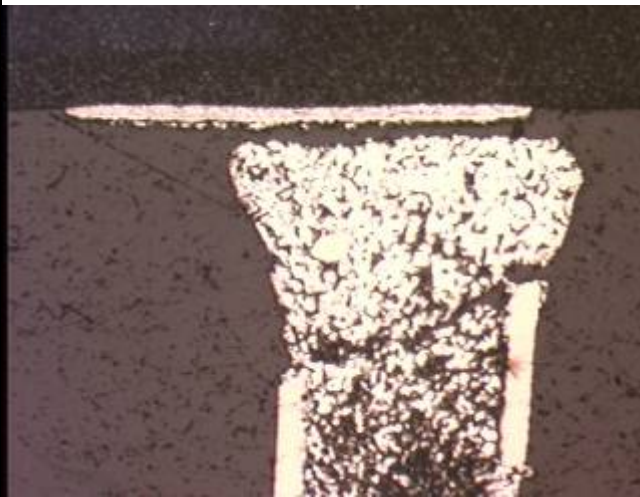
Figure S. High magnification photo of the first contact between the column and pad of the package on SN15.

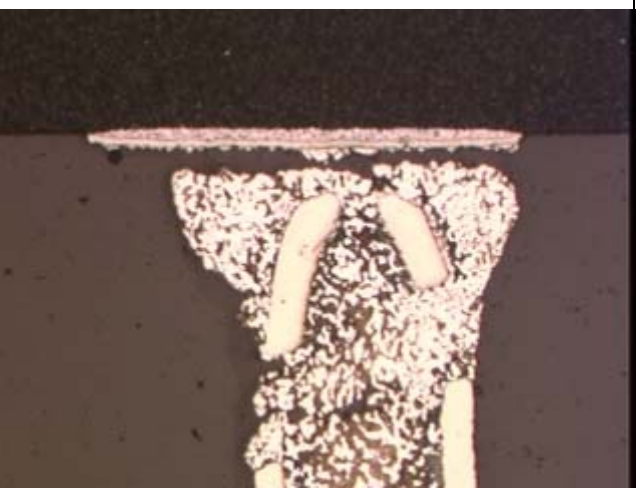
Figure X. High magnification photo of the second contact between the column and pad of the package on SN21.

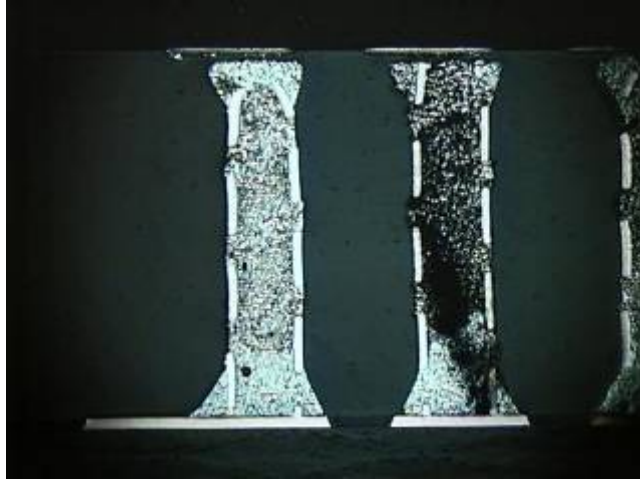
Figure CC. The cross section image of the open columns shows the gap at the contact between the columns and the pad of the package on SN27. The location of the columns is the second row from the bottom and the first and the second columns from the left.

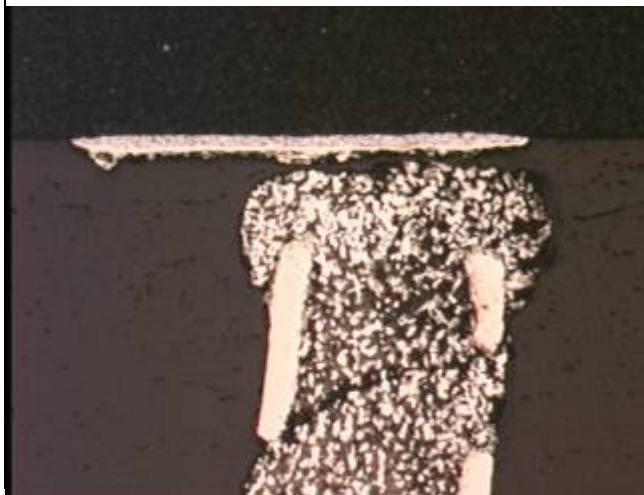
Figure II. High magnification photo of the first contact between the column and pad of the package on SN29.

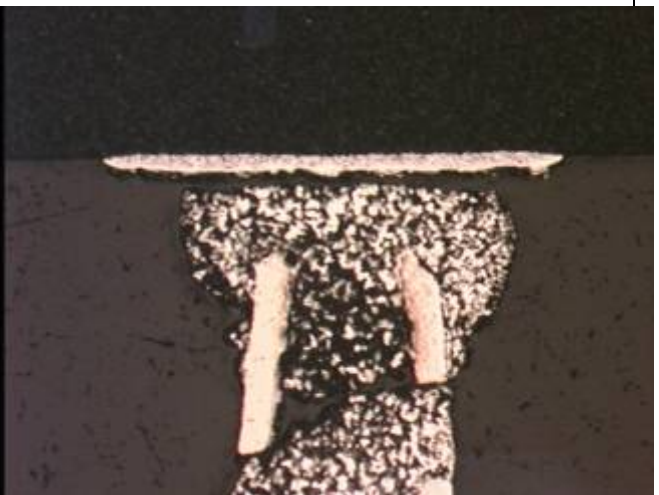
Figure JJ. High magnification photo of the second contact between the column and pad of the package on SN29.

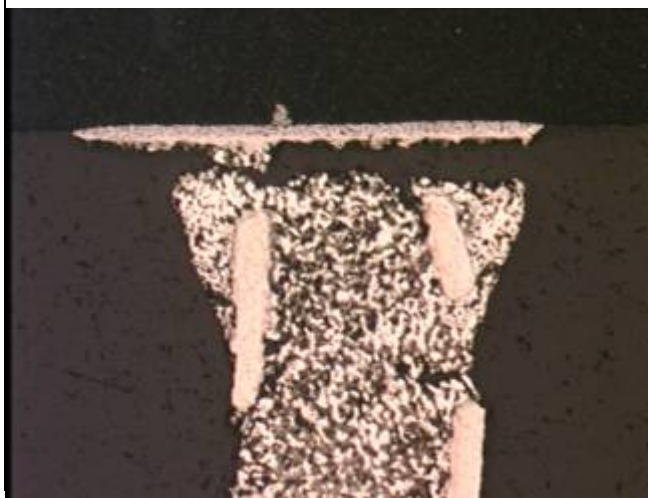
Figure MM. High magnification photo of the seventh contact between the column and pad of the package on SN29.

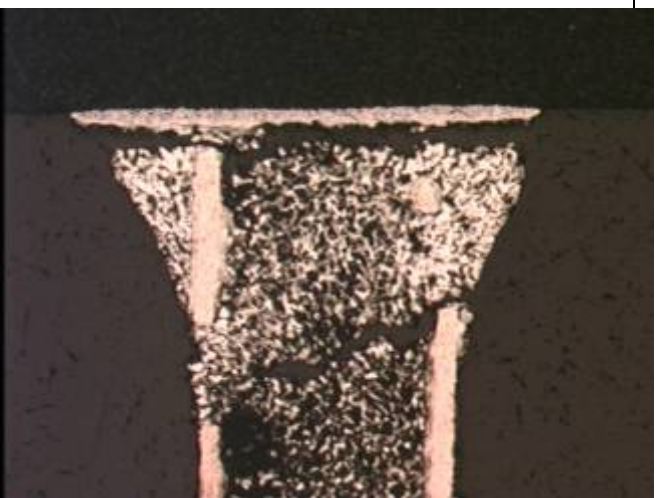
Figure NN. High magnification photo of the eighth contact between the column and pad of the package on SN29.
