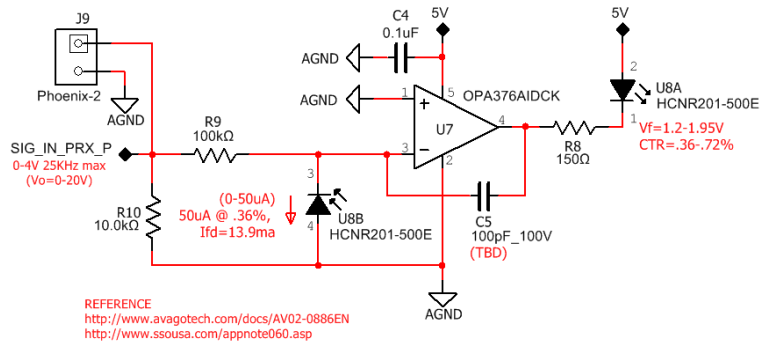
Test conditions:

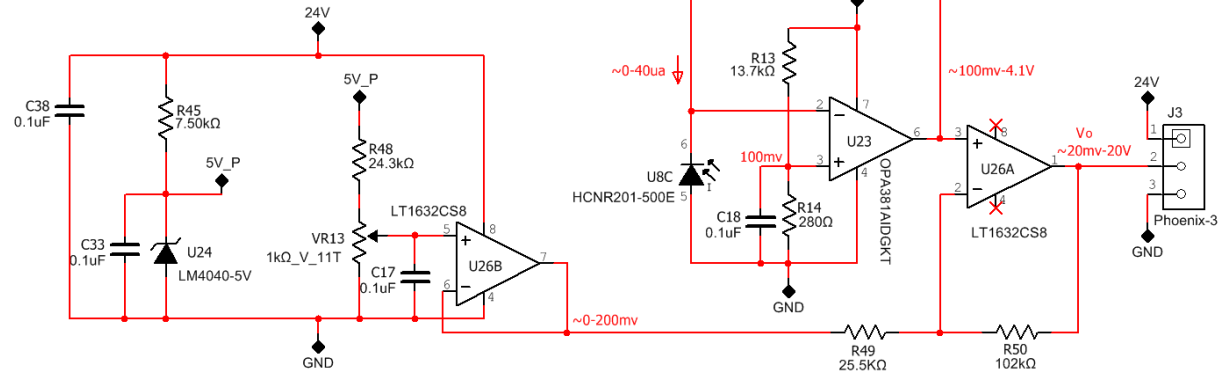
0-4Vpk triangle wave input at SIG_IN_PRX_P. C40 = 0pf
 Scope image captured at output of U23. ~500khz distortion circled in red. Triangle wave was chosen over sine wave since the distortion is easier to see.

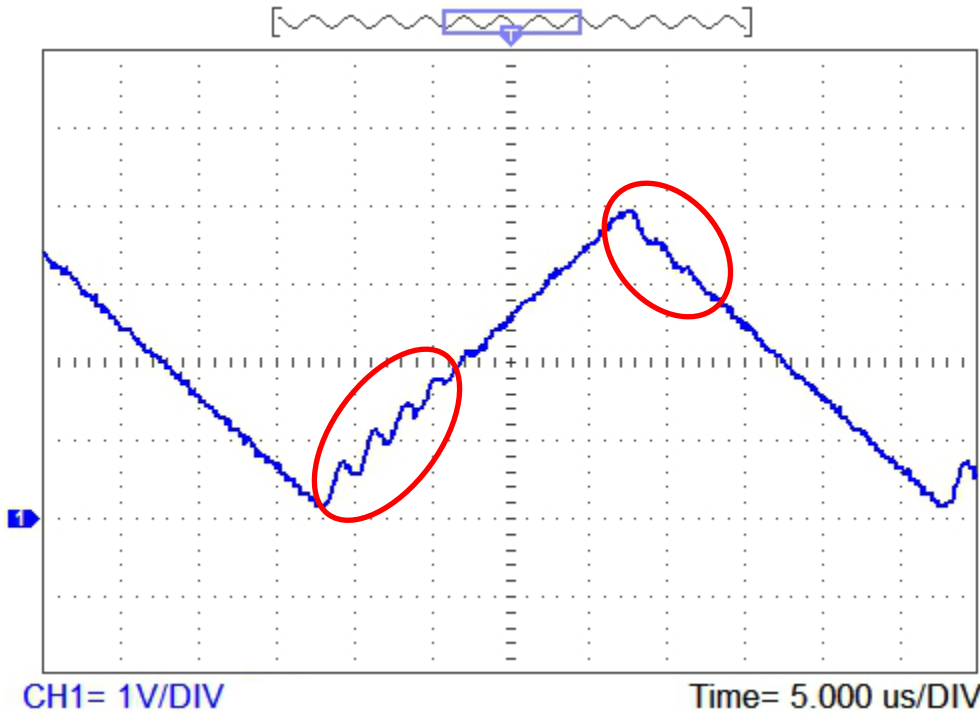
Adding a 12pf cap at C40 suppresses the ripple but also attenuates the signal at 25khz.
