MDIO interface Access Issue Debug

Capture of waveforms at Phy end

Version 0.3

02 Dec 2022

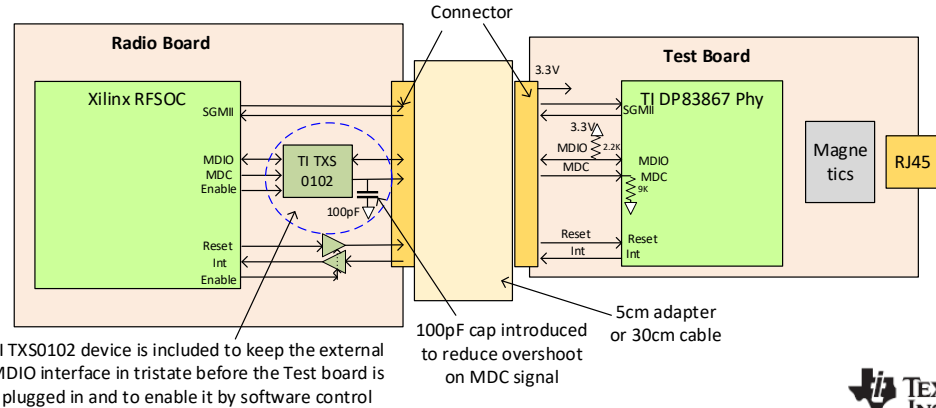
The 1GE Local Management port is implemented as shown to the right

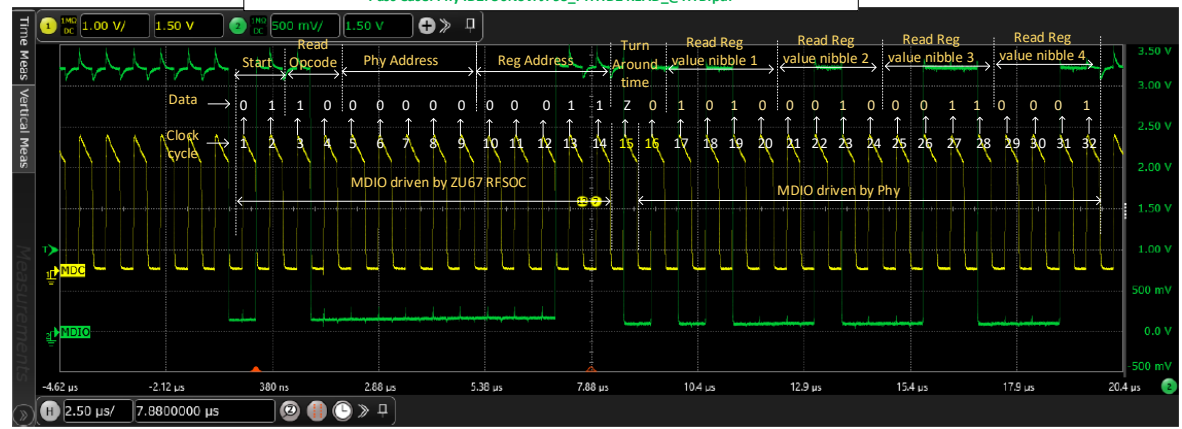
Fail Case: Phy ID2: 30Nov: JP95_PHYID2_READ_FAIL2@HTB.pdf

MDIO access PHYID2 read waveform for Passing vs Failing case captured at Phy end

MDIO read access to PHYID2 register

Register address: 0x3
Register data: 0xA231

In fail case value read is 0x4463
(bits shifted to left by 1)

Observation: Between the 14th Clock cycle rising edge and 15th Clock cycle rising edge, ZU67 and Phy device are expected to tristate the bus. However in the Fail case, it appears the Phy device is driving 0 (seems to have started driving the read response 1 clock cycle early)

On comparing the MDIO read access waveform in Pass and Fail case, we find that during the turnaround time (duration between RFSOC driving and TI Phy there is a difference.

In the fail case, the TI Phy device seems to have started driving seems to have started driving the Read register value one clock cycle early compared to expected.

With removal of the 100pF capacitor on TXS0102 MDC output, we are not seeing MDIO access failures. However there is higher overshoot on the MDC signal. H
