SN65176 Communication issue

Problem Description

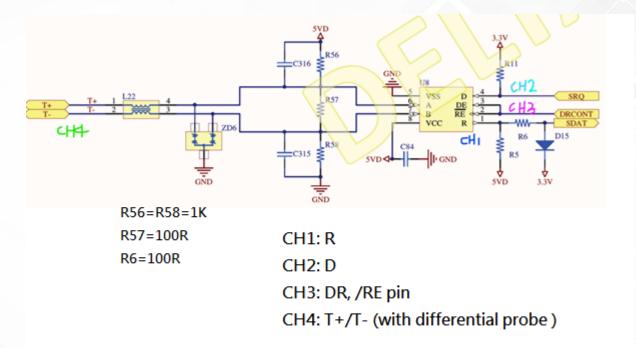
Schematic

Why the V_AB differential voltage dropping out to -550mV after /RE pin is pulled low by MCU? It could cause the communication error between Motor Drive and Encoder.
