The problem I am experiencing is that there is ripple on my +VBUS rail when those 3 IC are switched on.

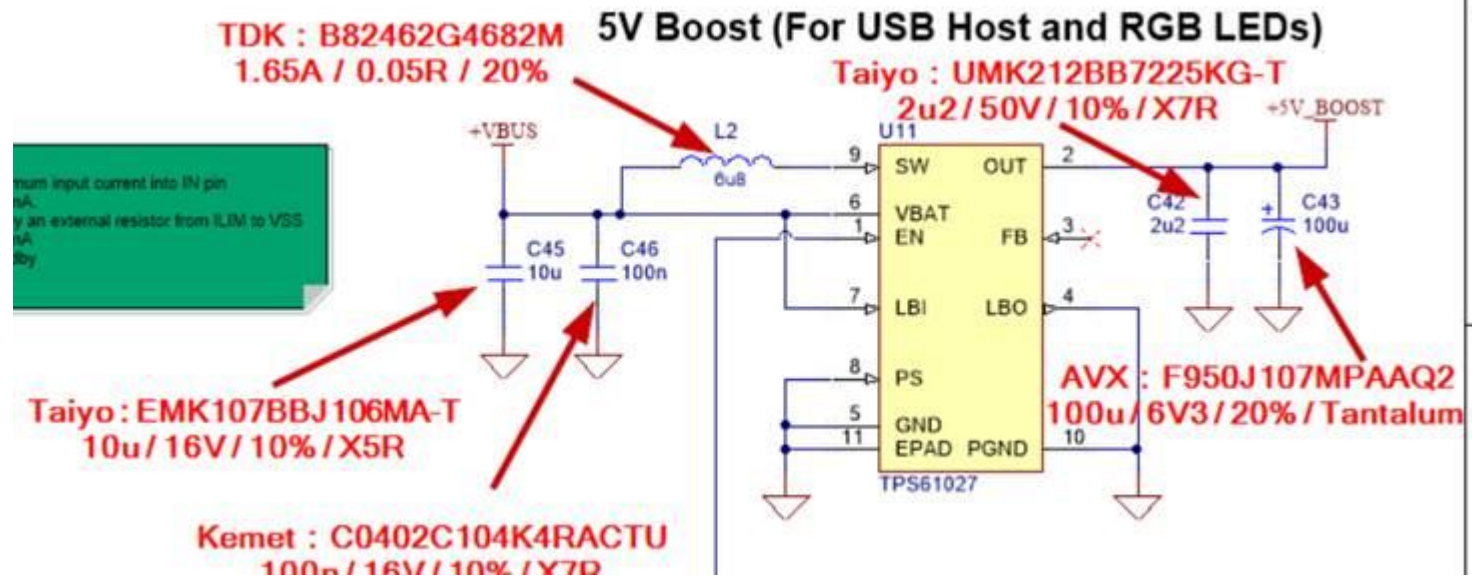
As a reminder, here the schematics for the 5V Boost converter

If nothing is connected to the 5V_BOOST (output of TPS61027) then the VBAT and VBUS are noisy.

As soon as I connect something to the 5V_BOOST, I get those 100+mV ripple on the VBUS. In the following example I only use a 220uF capacitor connected between 5V_BOOST and GND.
