# TUSB2036 Troubleshooting

## Symptoms

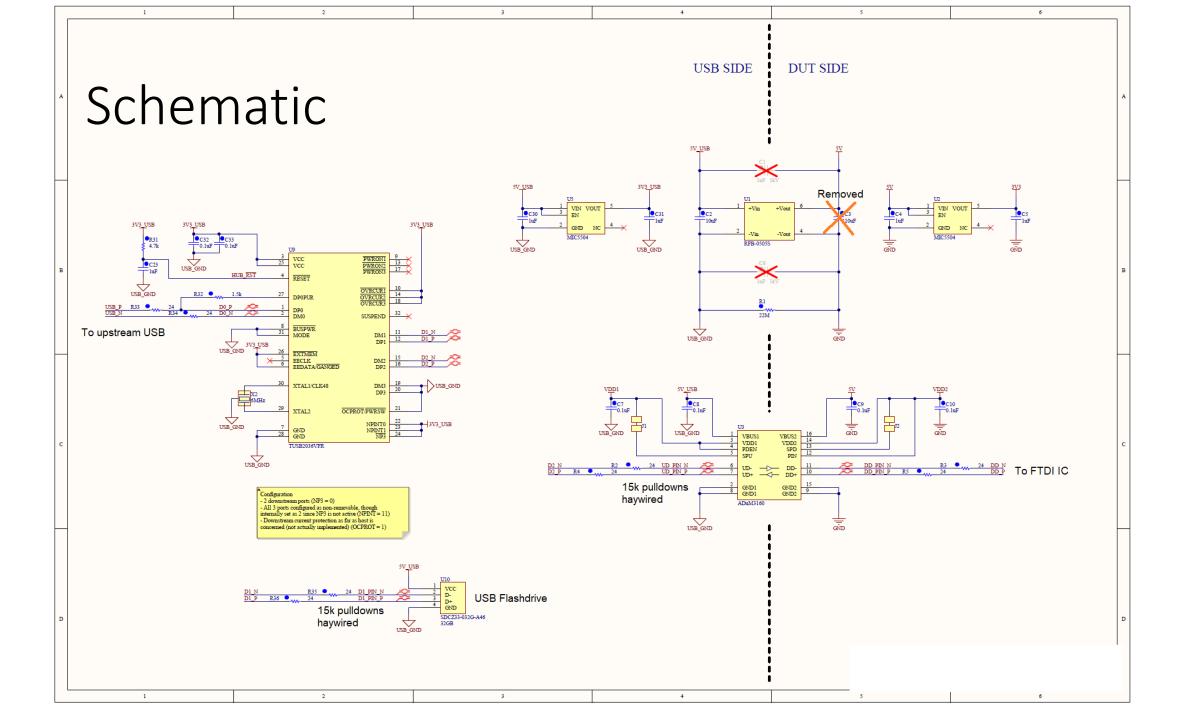
#### Power-on Reset

- CH1 3.3V\_USB
- CH2 Reset
- CH3 XTAL1 pin
  - Due to 1MS/s rate the 6MHz oscillation is not shown properly. I have confirmed that it is working fine.
- Timing from 90% VCC (2.97V) on VCC to V(IT)+ (1.8V) on reset

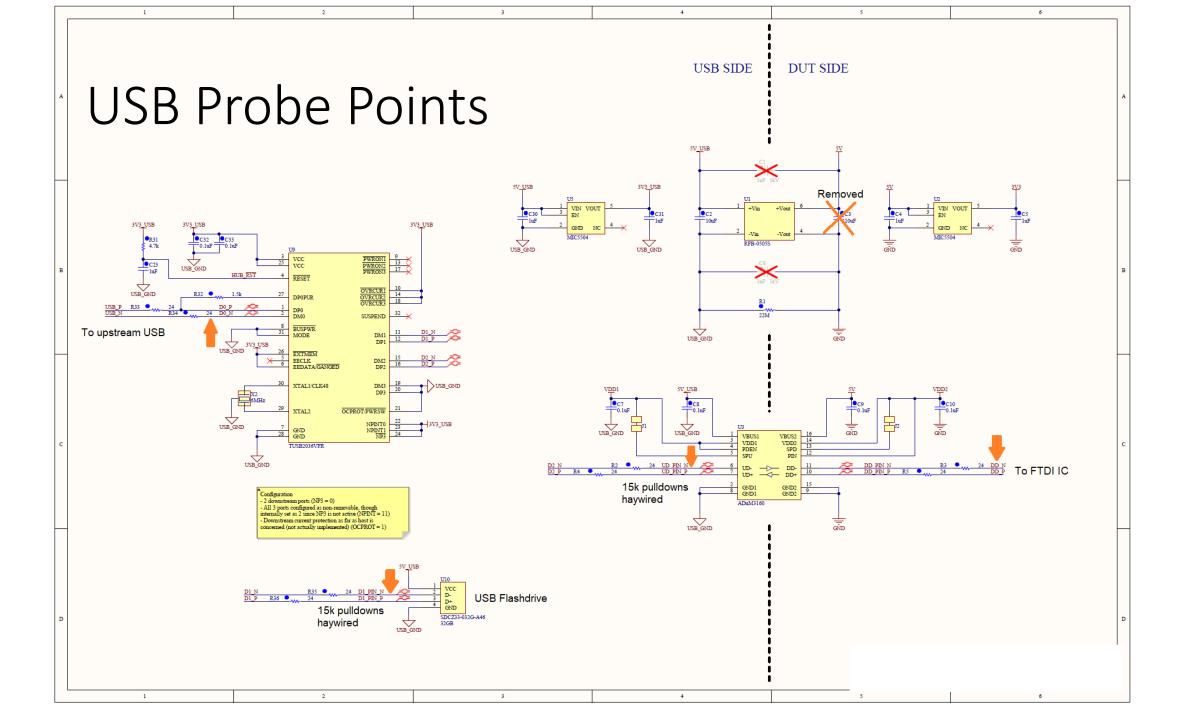
### Upstream Port 0

R33 and R34 on TUSB2036 side (PD0 and PM0)
