TUSB320LAI Accessories Support Test

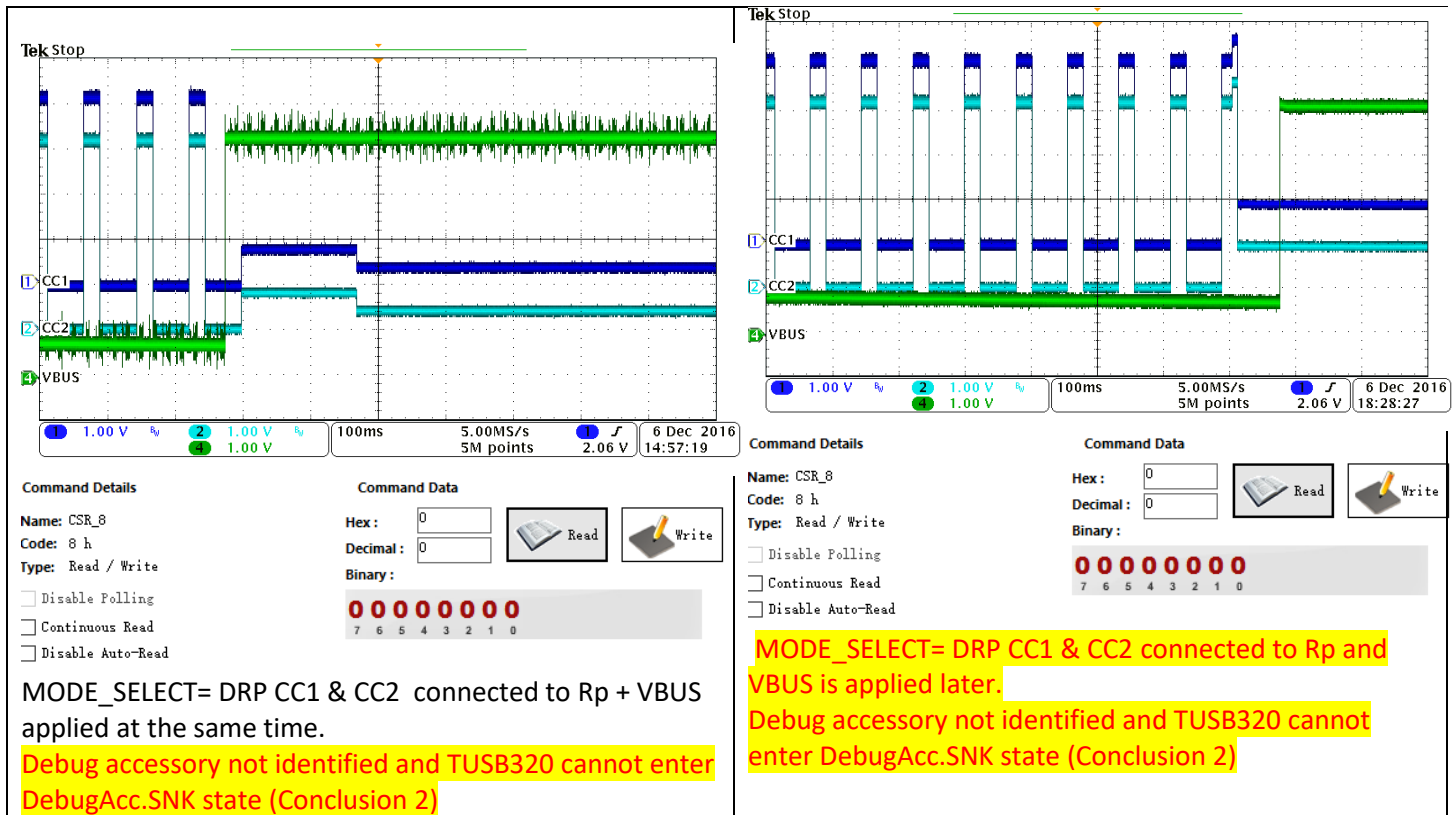
DRP Connected to Accessories

1. The most strange thing, if the CC1 and CC2 detected Rd at DRP mode, DebugAcc.SRC is detected (Reg 0x08[3:1]=110). While if the CC1 and CC2 detected Rd at UFP mode with accessory support, DebugAcc.SNK is detected (Reg 0x08[3:1]=111).
2. At all the case, if the CC1 and CC2 detected Rp, the device cannot enter DebugAcc.SNK state.
