TXS0102-Q1 Spike issue

TXS0102-Q1 Noise issue

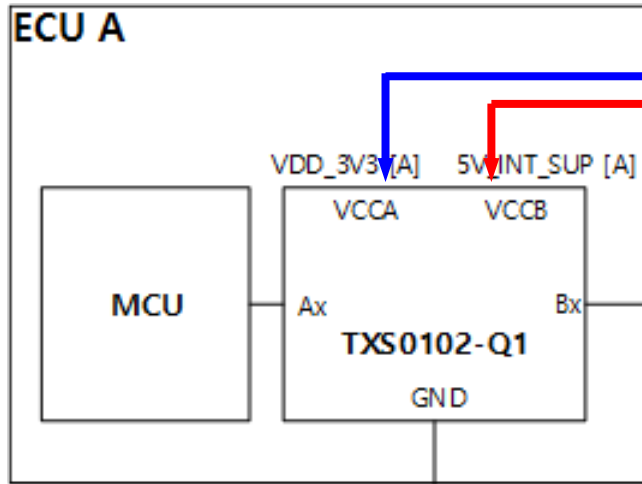
Board-A

The voltage spikes are occurred on the A pin of TXS0102-Q1 on both ECU-A board and ECU-B board, respectively as above waveform. But these spikes are not occurred when removing each TXS0102-Q1 on the ECU-A and ECU-B boards that is the bypass.
