Errata Report - For TI

Phenomenon + Some Facts

Analysis of the Reason for Errata 1

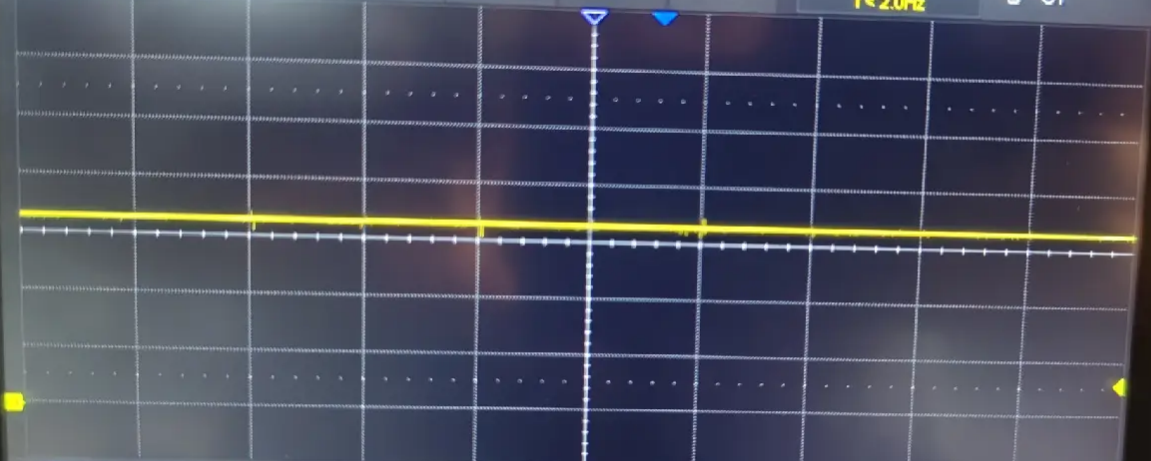
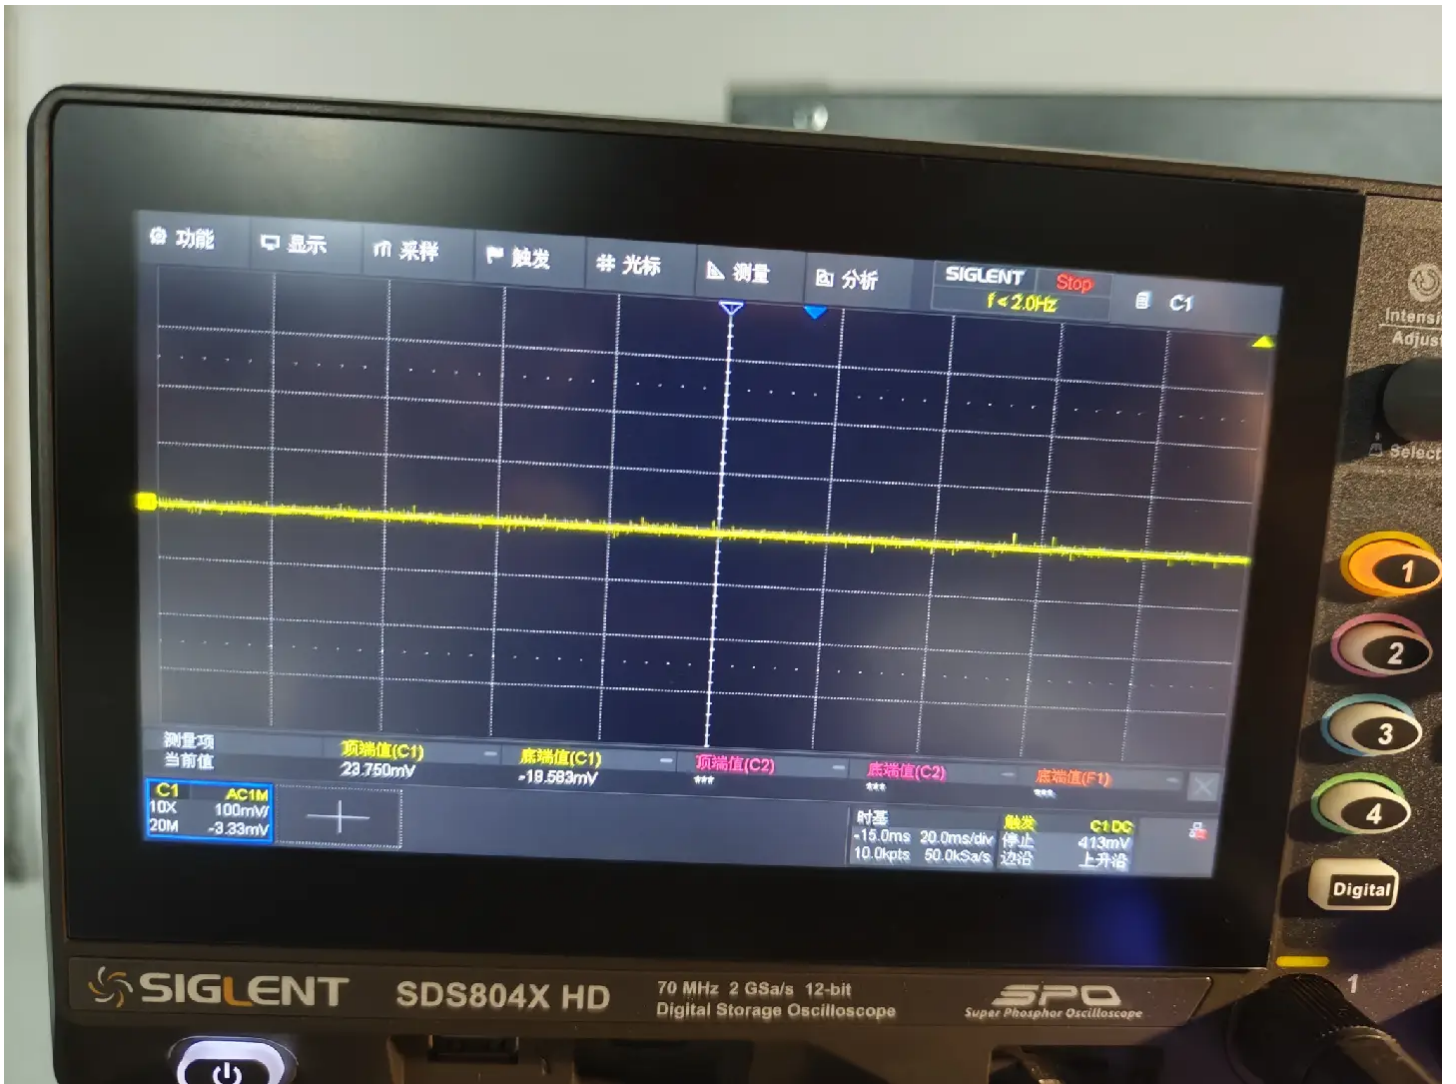
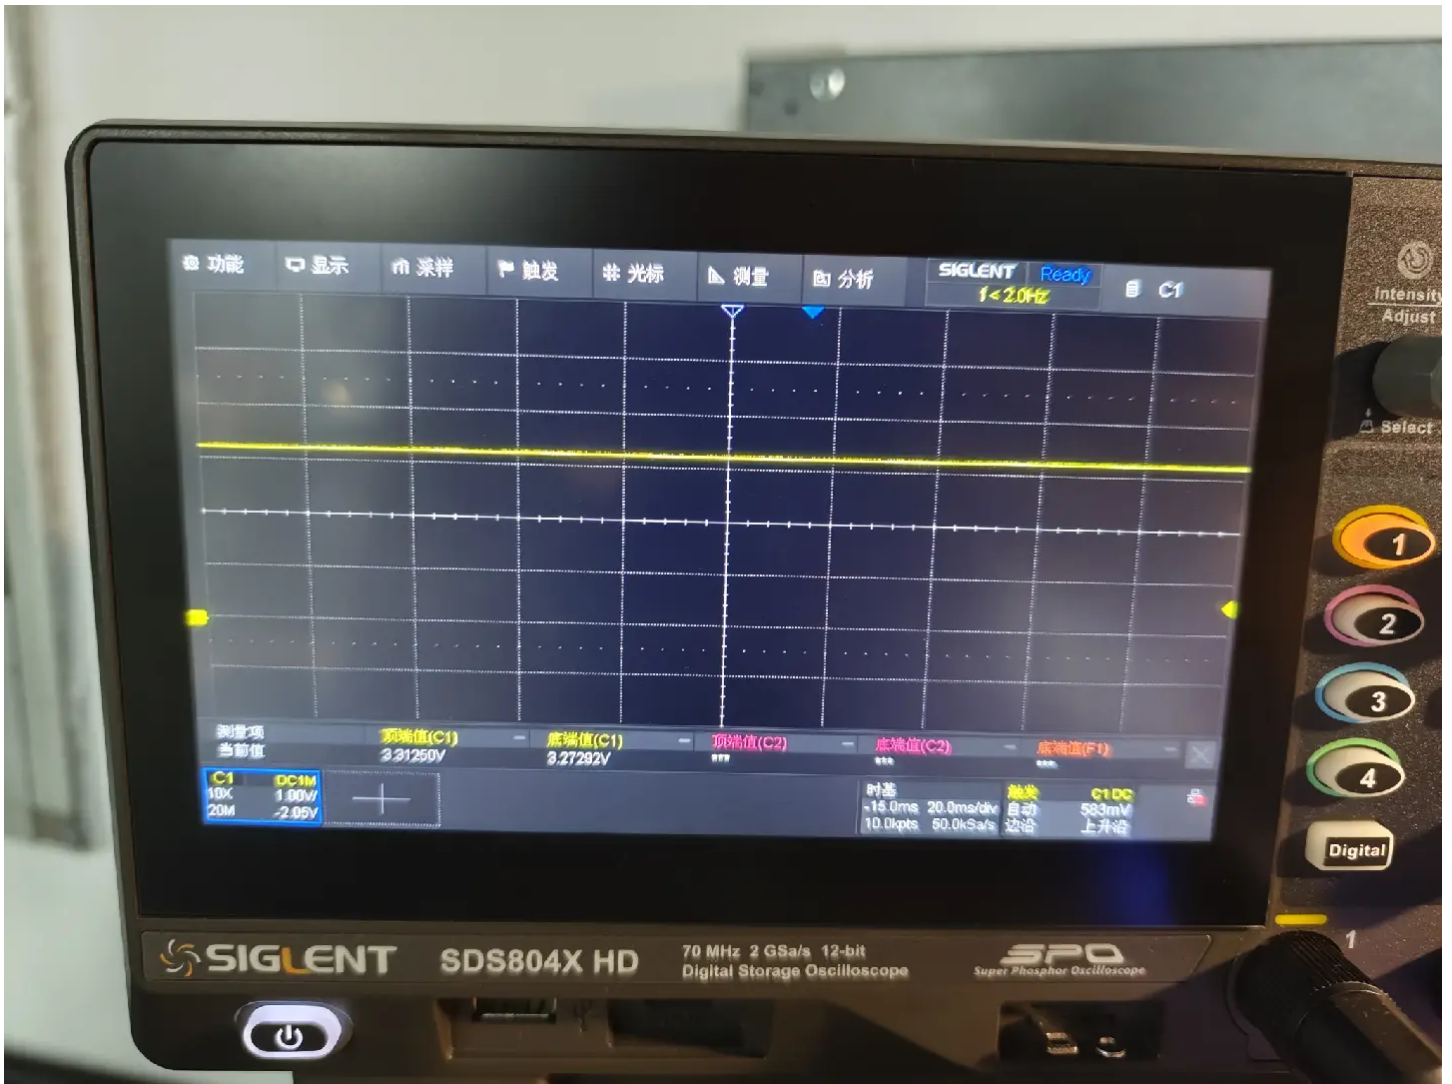
The DC stability of the CAP1 network is OK, remaining stable at 3V3. After the charger is powered on, there are small spikes in AC stability, and these small spikes do not disappear after the charger is removed.
