### TPS65130 Vpos ripple issue in Power-save mode:

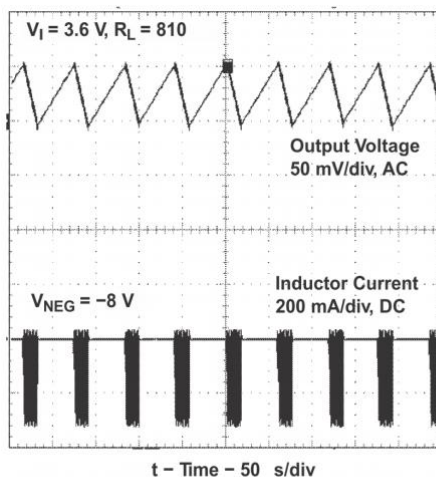
**Figure 47.  $V_{NEG}$  in Power-Save Mode**

... with a AC level of about 50mV, very similar to the one in the figure 47 of the datasheet:

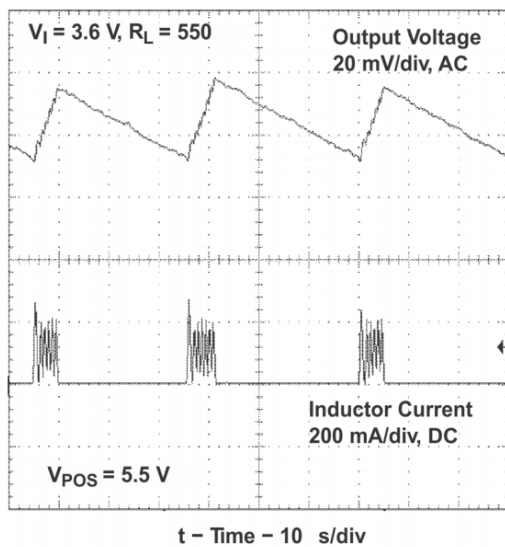
**Figure 46.  $V_{POS}$  in Power-Save Mode**

But in nearly the whole of the units for this batch of production, the waveform for the positive rail is not as expected, producing a very high amount of noise:

... with an AC level of about 200mV, far away from the expected in the figure 46 of the datasheet:

If we replace the IC in a unit with the problem, with one from an older production date, the problem is solved. If we replace the IC with one of the same reel, the problem persists.

We have produced a preproduction lot of ten units, with the same hardware, but older chips, and none have this problem.
