UCC256302 frequency stability issue

Problem description

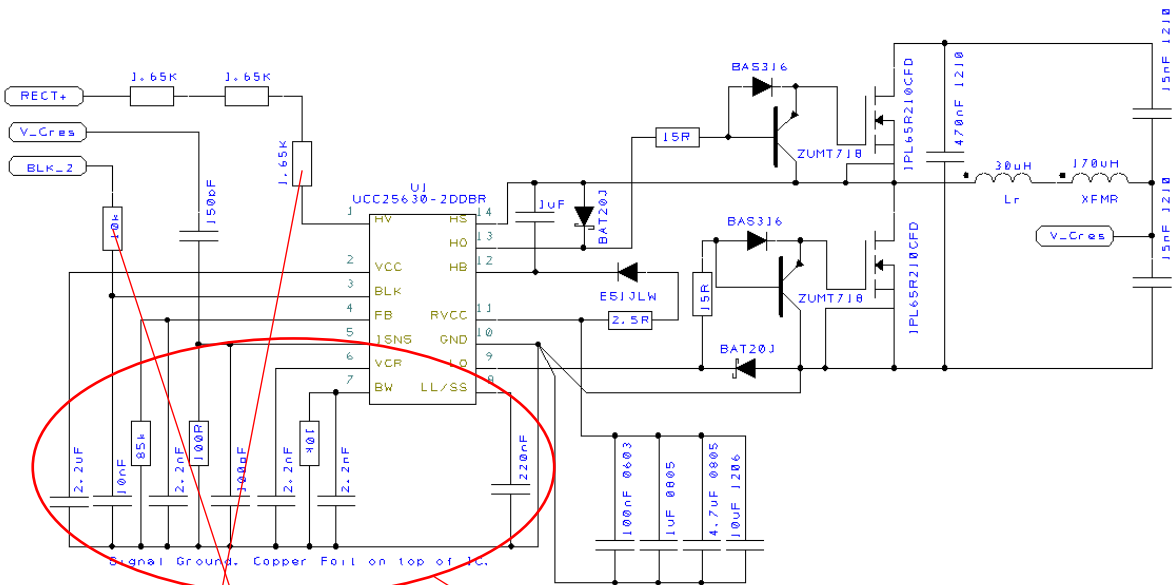
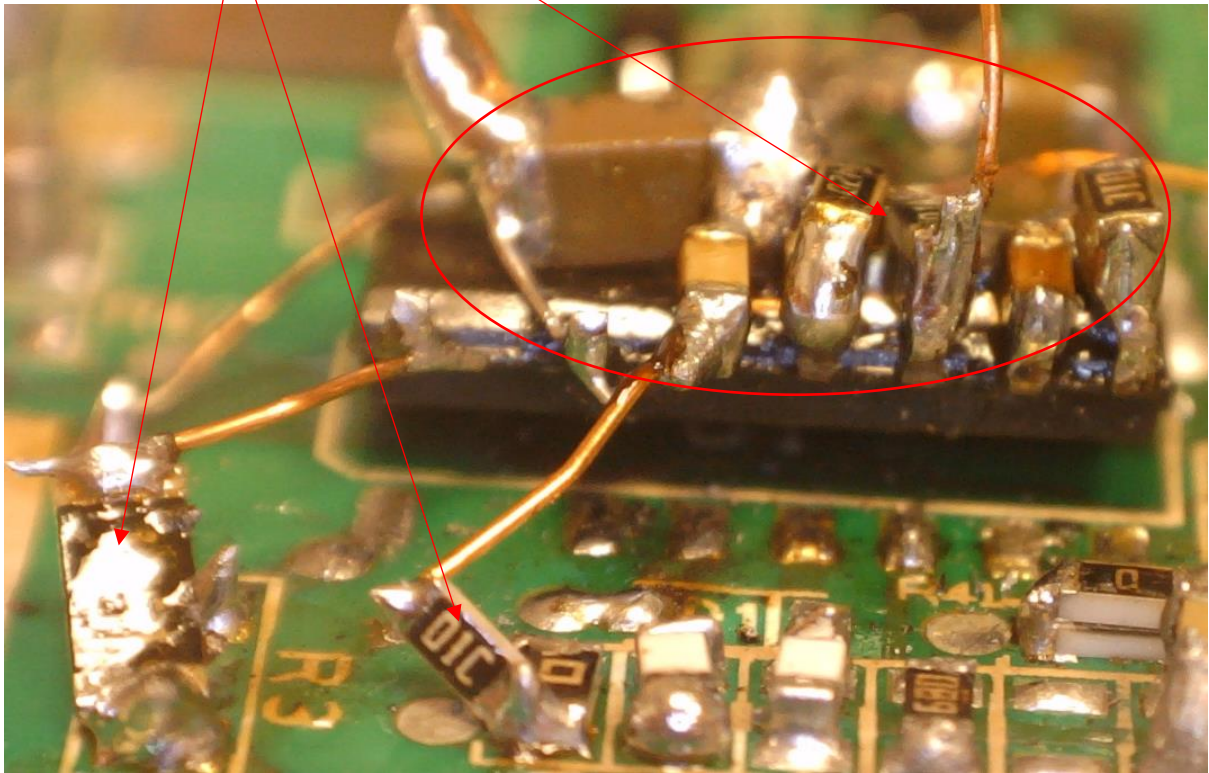
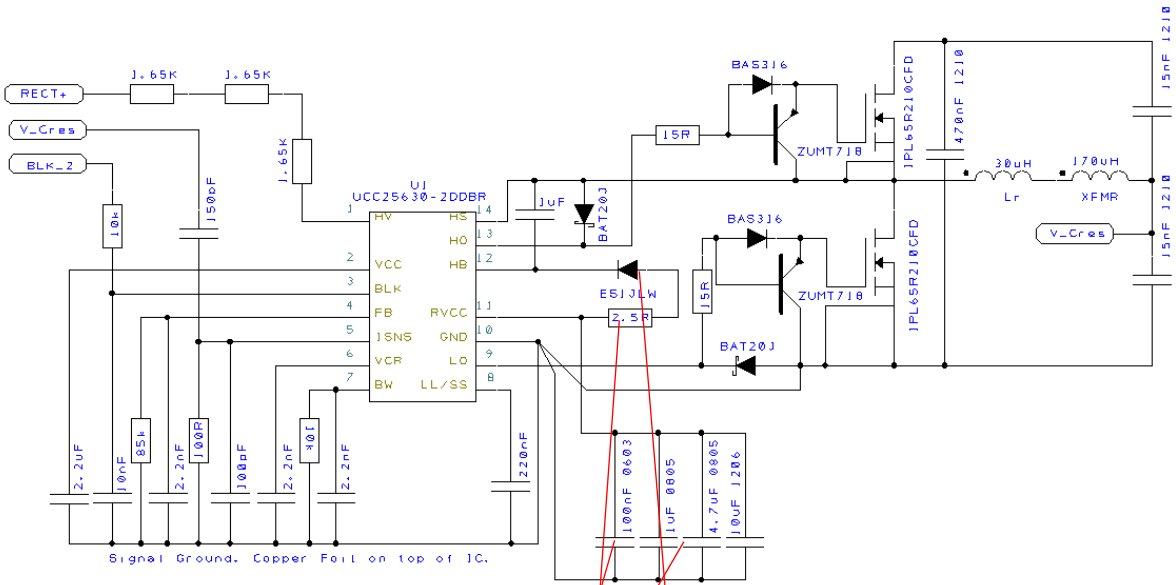
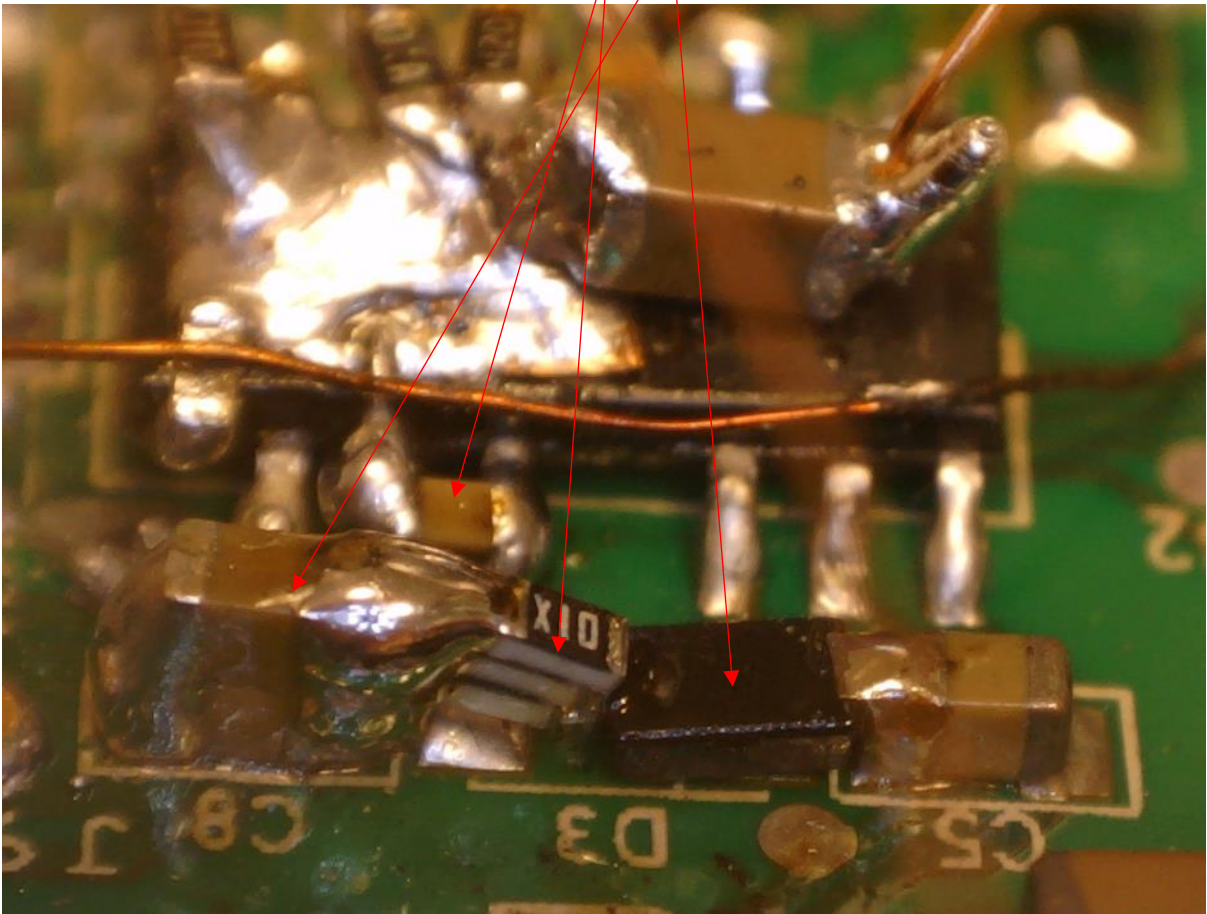
Schematic and physical structure

- To eliminate the possibility of control loop issue, the IC is run open loop with just 85k 0603 resistor and 2.2nF 0603 ceramic capacitor from FB to GND.
- To eliminate the possibility of layout issue, a copper foil plane is made on top of the IC body and connected directly to GND pin. The following pins are connected to this ground plane and decoupled with ceramic capacitors.
LL/SS, BW, VCR, ISNS, BLK, VCC.
- VCR is run in oscillator mode (no feed from resonant capacitor voltage)
- RVcc has additional decoupling 100nF + 1uF, + 4.7uF + 10uF ceramic capacitors
- HV pin is lifted to eliminate any capacitance (as per layout guidelines)

Even with these modifications, significant frequency jitter can still be observed.
