一、异常现象，出现一颗 TPS62135 异常 SW 无输出，电压跌落，PG 拉低后级通过 PG 控制的电源使能拉低导致后级掉电。时间约 240us。

此处电路设计为：12V - 5V - 3.3V

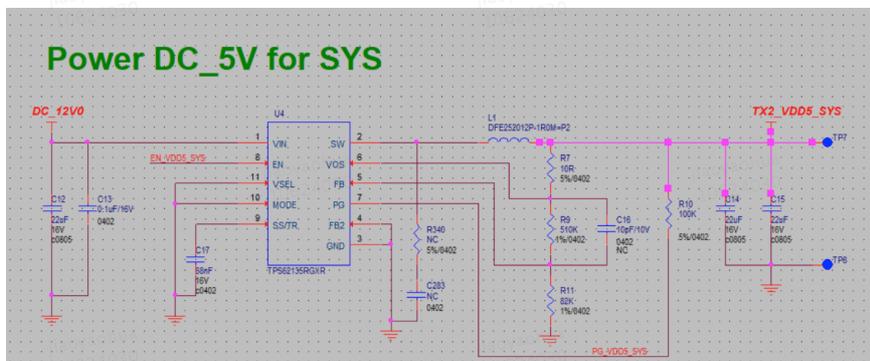
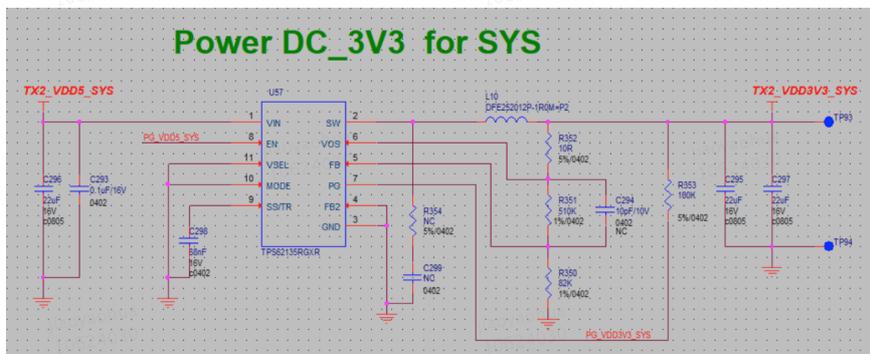
可以明显发现, 在 5V 电压开始跌落的时候, SW 不再有 PWM 输出, 同时电感的纹波电流归零。当跌落出 $5V \times 96\% = 4.8V$ 时, 5V Power Good 主动拉低。

在拉低后的 8us 左右时, 会有一个冲击电流, 峰值电流超过 4.7A (状态有点类似开关 In-rush)。对应的一个 PWM 占空比较大。

但是在出现电压跌落 SW 位置的电压并没有置零, 像是上管处于了 MOS 管的放大区, 电压幅值约为 4.5V。
