Report No:	SZ07282021001
Date:	2021/07/28
Page:	1/10

Project Inspection Report

Company : Beijing Yuanda Innovation Technologies Ltd.
Address : Room 506, Building 1, No.10 Caihefang Road, Haidian District, Beijing
Sample Name : LMZ14203
Manufacture : TI
Date Code : N/A
Package Type : SMT-TO
Sample Number : 4 PCS
Check Number : 4 PCS
Date of Received : 07/19/2021
Date of Tested : 07/19/2021 ~ 07/27/2021

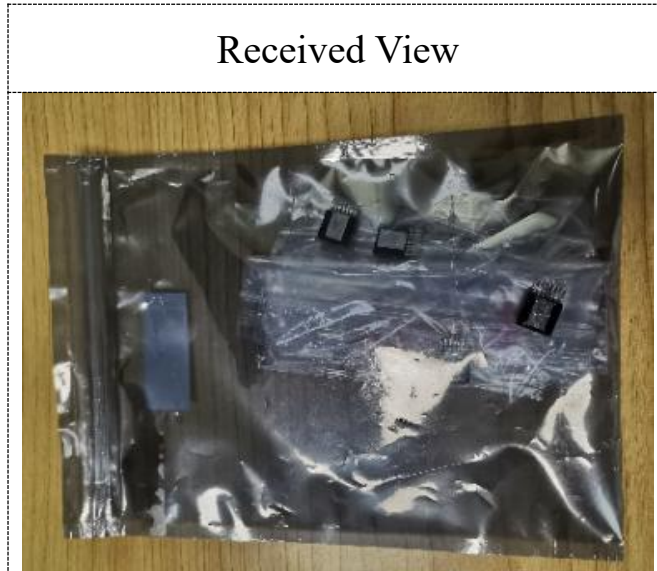
Received View

Gross Weight	50g	Parts Total	4 PCS
Number Of Boxes	N/A	Full Label	Non Present
Package type	Bulk	Moisture protection	Non Present
MSL	N/A	ESD protection	Non Present
