1. Current design analyze regarding noise
2. Further design check regarding remaining noise
3. General Layout improvement

1. Current design analyze regarding noise

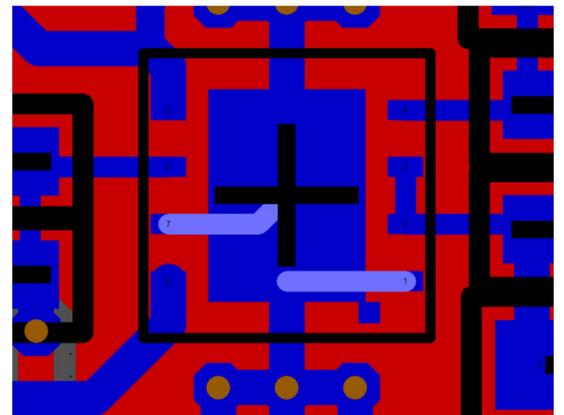
The noise disappears completely when the two red marked capacitors are removed. The right part of the schematic (beads and capacitors) was found on some sources on the internet to “improve the audio output”. As mentioned in the LM4871 datasheet an additional improvement is not needed but we thought it would be good. It was not unfortunately...
