# Failure Analysis Report

## Device Analysis Services

FA QEM-CCR-1706-01197

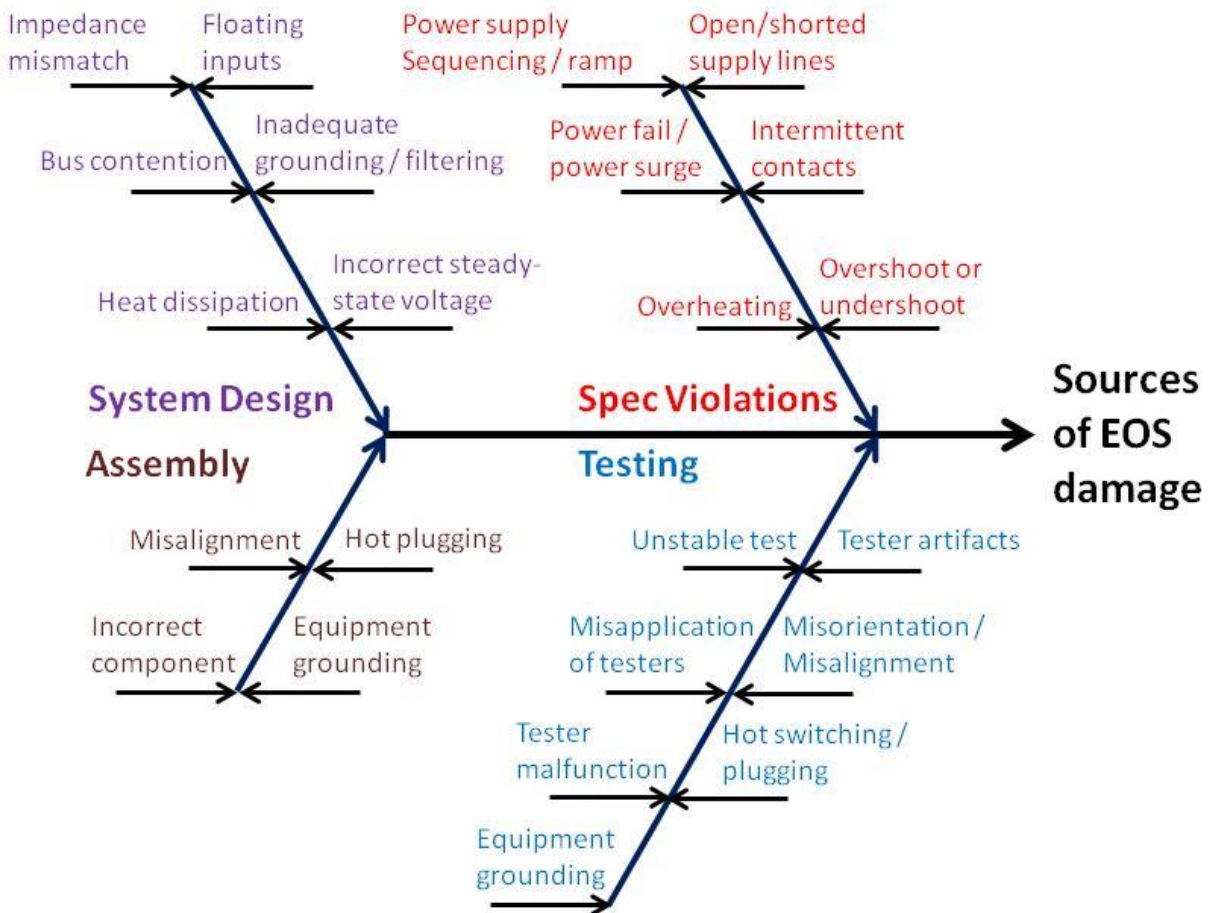
The unit failed due to the EOS damage observed. An over-voltage/over-current condition or event is the most likely cause of failure and we recommend that the customer evaluate the application environment for possible sources of transient or steady-state Electrical Overstress. Detailed analysis and measurement of the customer's board environment and the customer's test environment will be required to identify the specific cause of the EOS. Please consult the below fishbone diagram for a listing of such possible causes.
