Marutakatechno Co., Ltd.  
550-1 Yahata  
Fujieda Shizuoka Japan, 426-0009

August 17, 2018

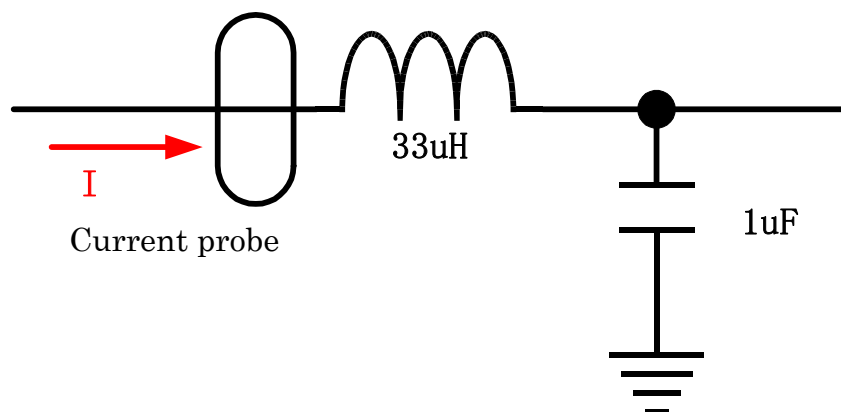
The problem is output at FAULT terminal goes from Hi to Lo, which consequently causes output at PWM to stop. I have three questions regarding this problem. The surrounding circuit is formed similar to TPA3111D1EVM with  $8\Omega$  speaker and LC filter of  $33\mu\text{H}$ ,  $1\mu\text{F}$  on output side. The power voltage for audio amp is DC24V.

Q2: The output of FAULT terminal varies even under exact same operation. One time I try put on certain music, voice guidance or beeps on our device, output to FAULT terminal stays high and they are emitted perfectly fine. But another time I try turn them on making the exact same operation, the output is switched to low for some reason and the output to PWM stops resulting no sound coming out of the device. I wonder why that happens? I felt the IC but it was not overheated. I checked the input side but there was no abnormality. Then I replaced the capacitor of the LC filter attached to output side from  $1\mu\text{F}$  to  $1000\text{pF}$  and the phenomenon has not been detected so far. I included the current waveforms of output side in the following sheets. I would appreciate it if you could look at them, point out any problem and suggest countermeasure against the problem. The waveforms were taken by putting current probe before the LC filter.
