2 X 15W AMPLIFIER FOR PA SYSTEM

APPROVALS	DATE	PROJECT	Smart Systems
ENG: -		*	quarters - Cochin
DSN: -			legality Road,
CHK: -			Trivandrum - 682021, India
		PROJECT REVISION:	DOCUMENT REVISION:
		TITLE:	DESIGN ITEM:
		*	
BOM:		REFERENCE DOCUMENTS	
ASSY DWG:	SIZE:	CAGE CODE:	DWG NO.
FAB DWG:	B		
PCBDWG:	SCALE:	FILE NAME:	40 2X15W AMP.SchDoc
		SHEET:	40 OF 54

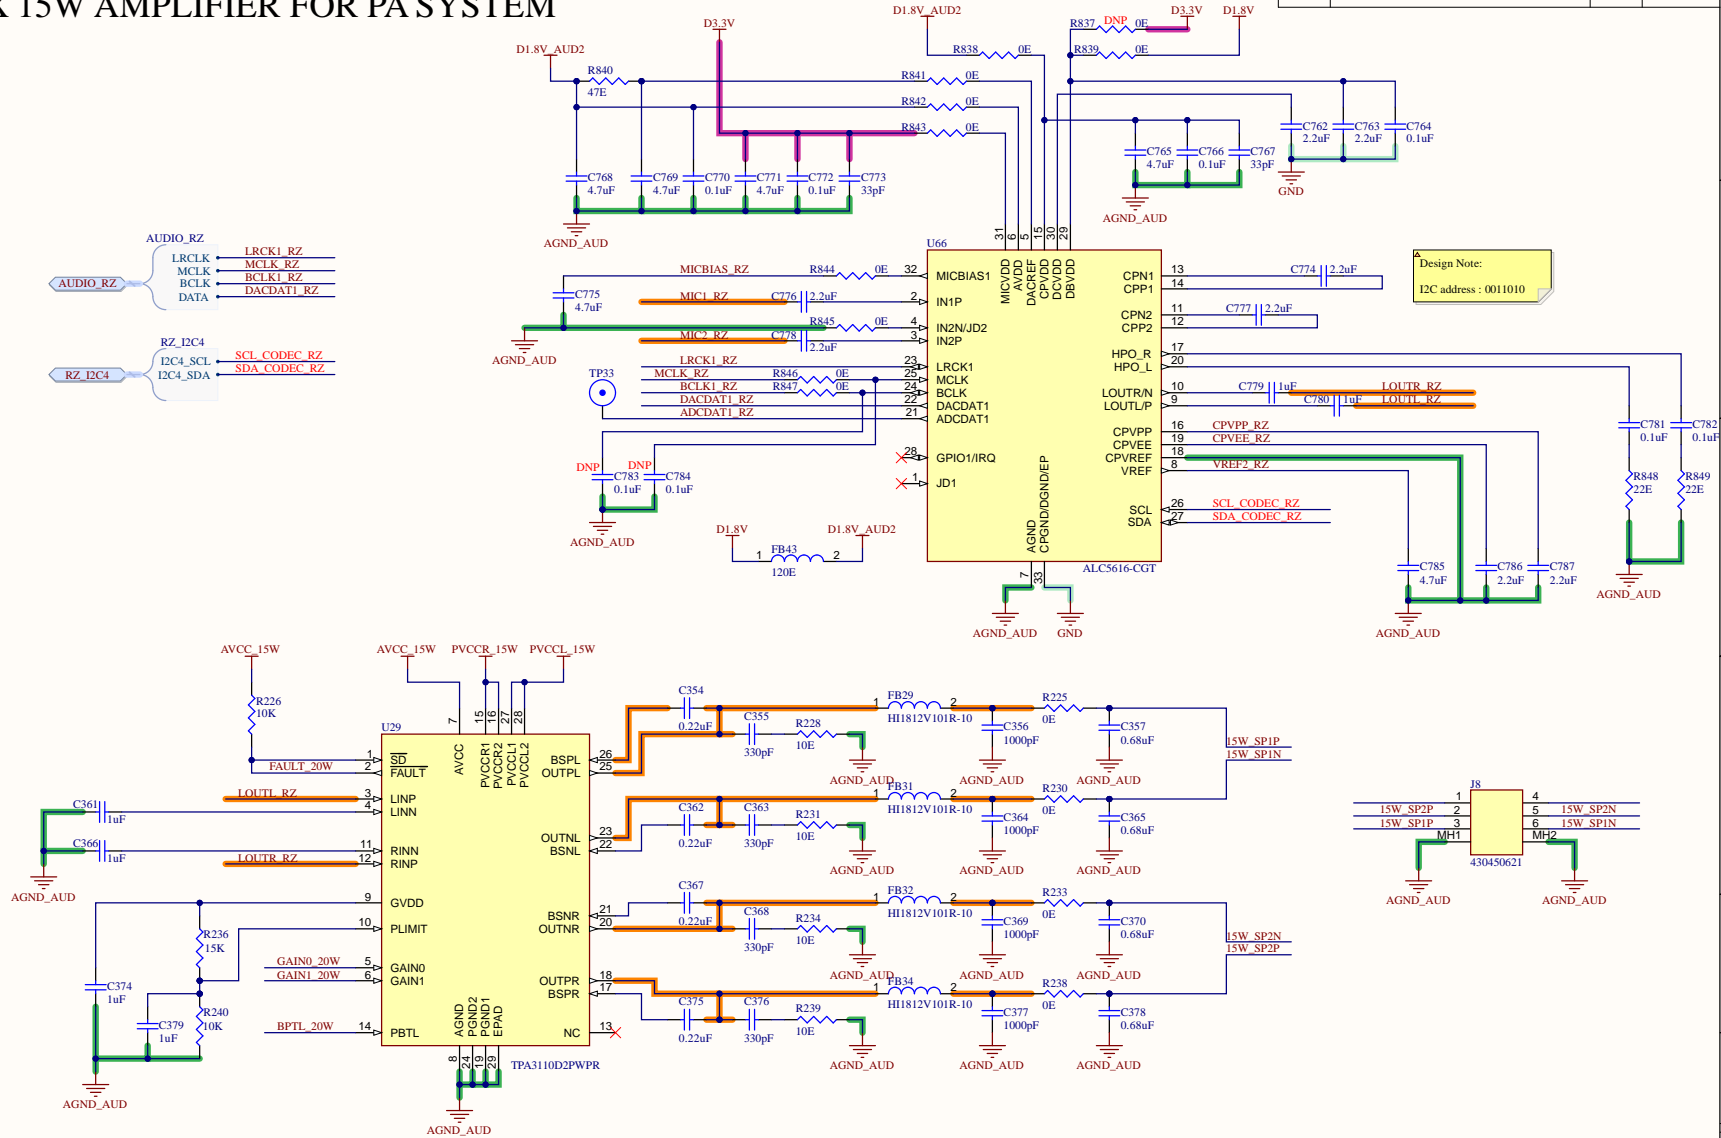
- 1) While probing the LINP and RINP pins without providing any inputs, the pins show 2.5V and then drop to 0V every 420 milliseconds. (Since the SD and FAULT pins are shorted in the circuit, I suspect this behavior is due to the chip restarting because of the DC fault detection.) Is the 2.5V observed the bias voltage?

- 2) In our circuit, we have shorted the SD and FAULT pins. While probing these pins, it shows a pulled-down state for 420 milliseconds and released for 2.5 milliseconds. (I believe this is due to a DC fault.)
