# measurement environment

# Oscilloscope observation of SDI and SDO of a **single** ADC

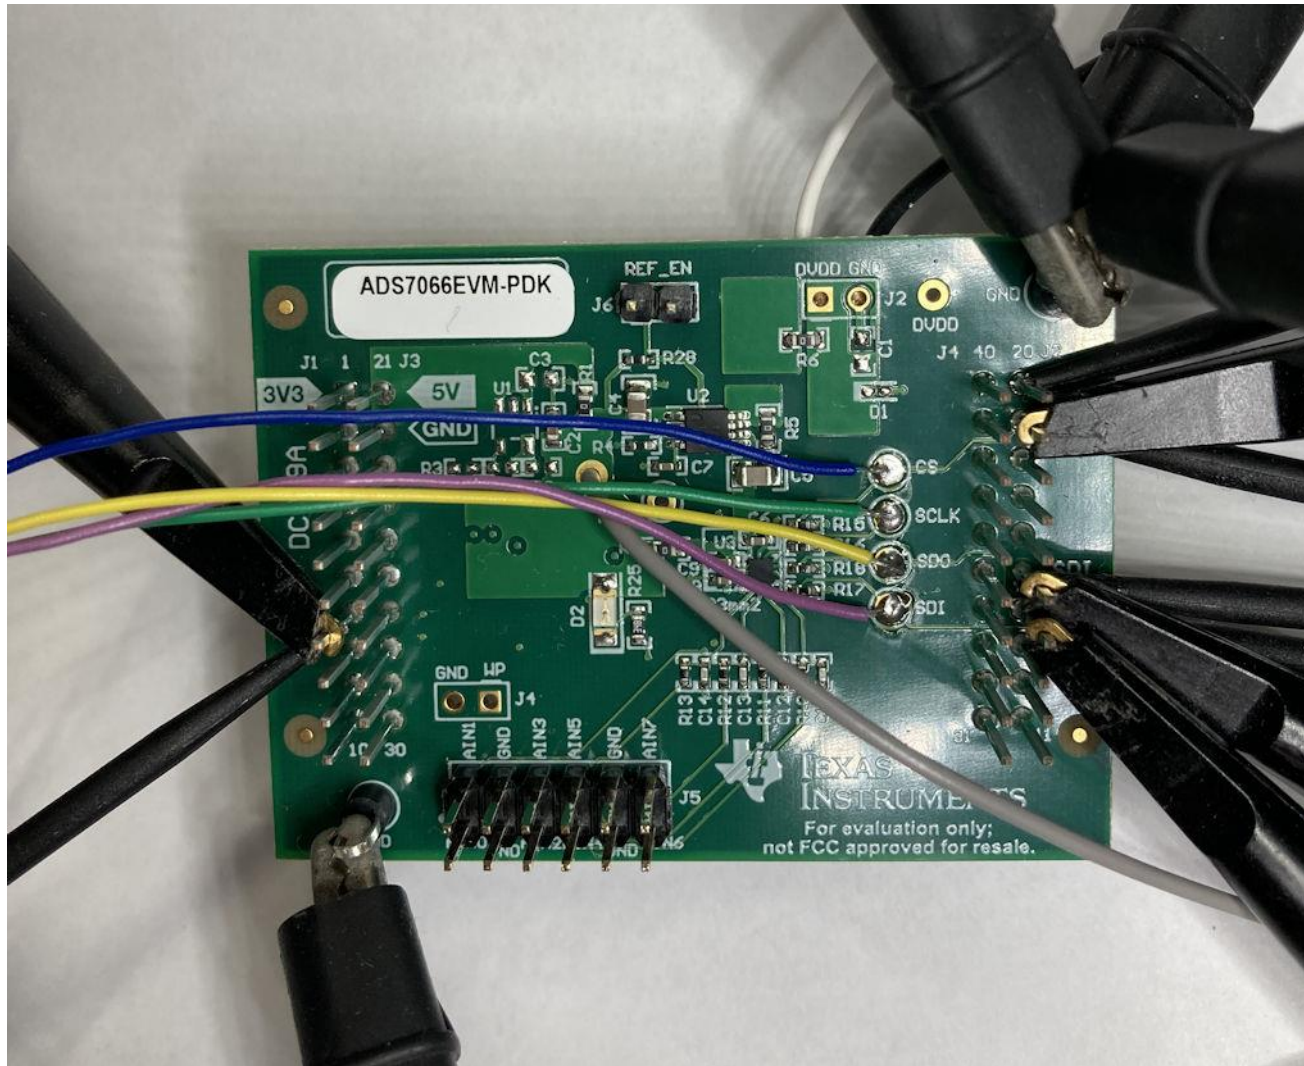
Using the official evaluation board.  
The ADC is driven by an external  
FPGA.

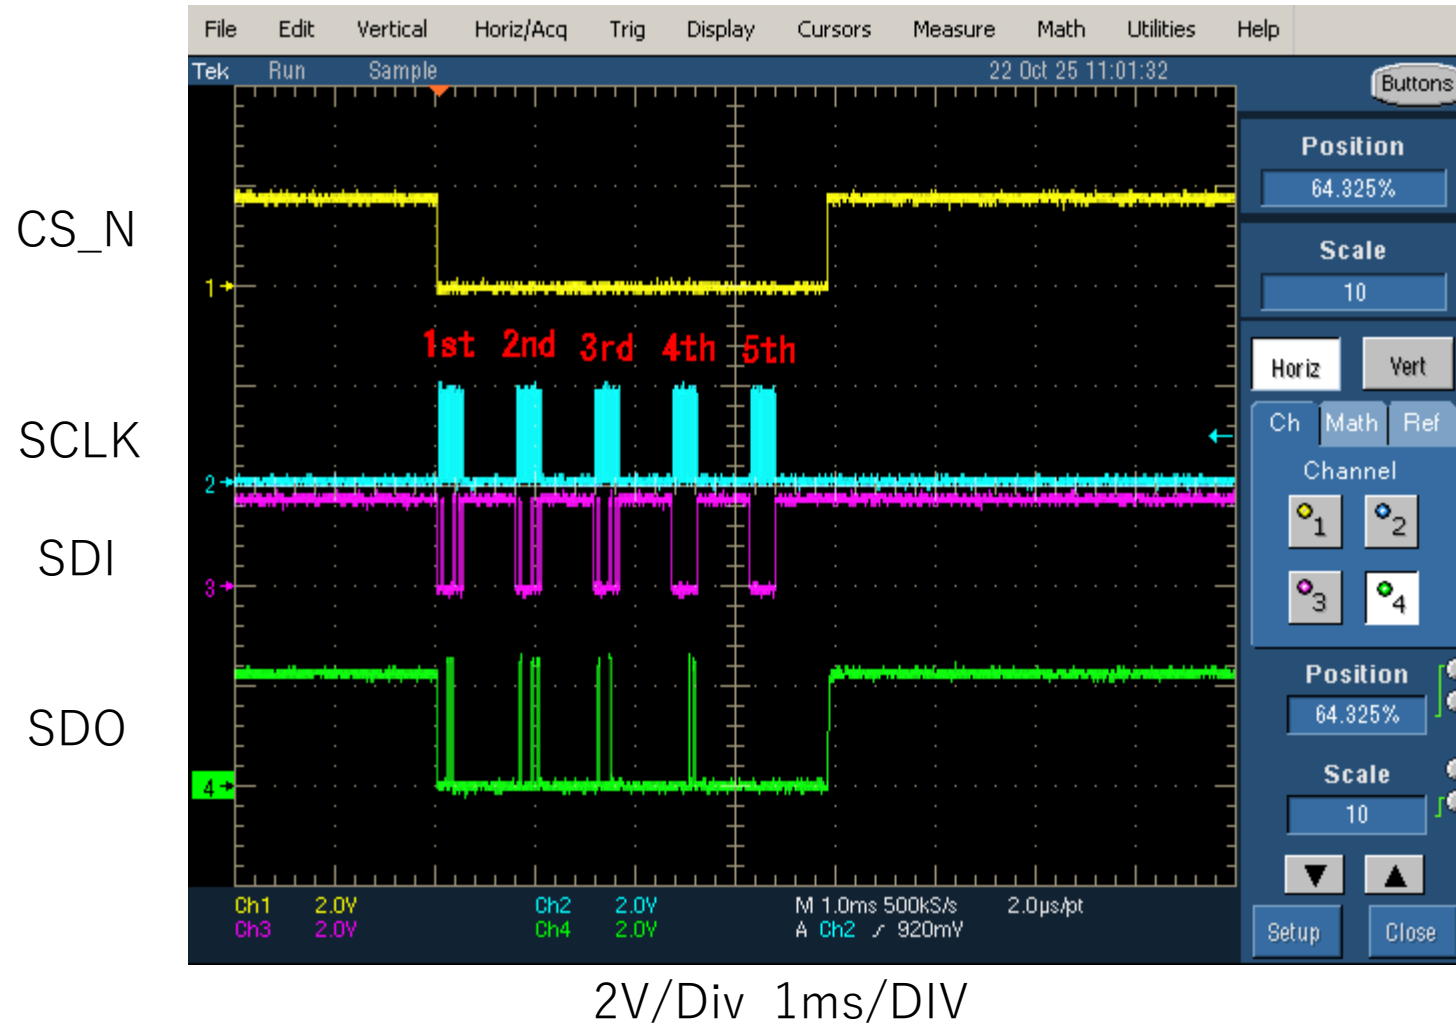
**Repeatedly wrote** the following 24-bit frames:

1st frame: 08018C (hex)

2nd frame: 08018C

3rd frame: 08018C

4th frame: 000000

5th frame: 000000

It was confirmed that writing 08018C enables the reference voltage output.
