## RM46L852: Arm-based microcontrollers - INTERNAL forum

**Part Number:** RM46L852

My customer ABB motion just found the following issue in our HErcules Part:

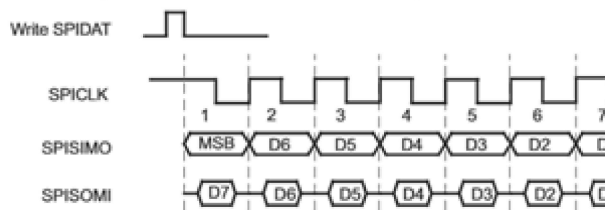
Figure 27-11. Clock Mode with Polarity = 1 and Phase = 1

So this one would do what we want, data is armed on DAT write and outputted on rising & latched on falling just as master does:
