# Q 20240502

As shown on the right  
In front of the imaging lens after DMD reflection  
There is some unevenness as shown in the photo.  
The strength of the unevenness is 50% compared to the center.

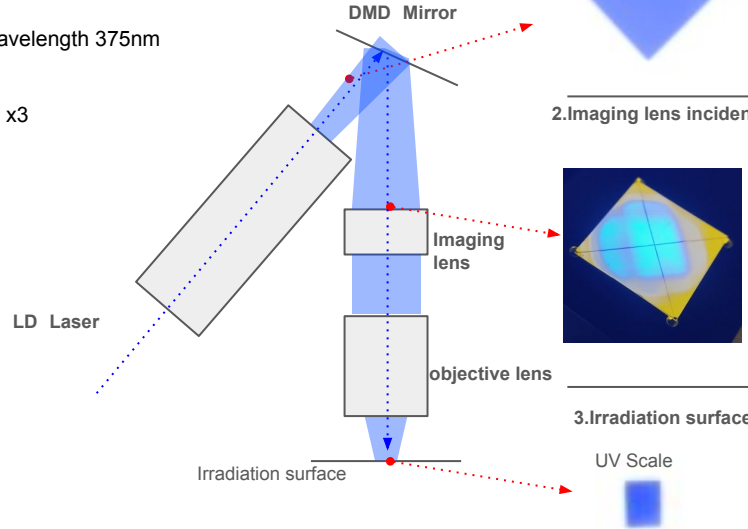
Unevenness occurs in front of the imaging lens.  
The intensity of the unevenness is 50% of the median.  
Is it diffracted light?
