OPA4344 used at feedback circuit of AC/DC converter

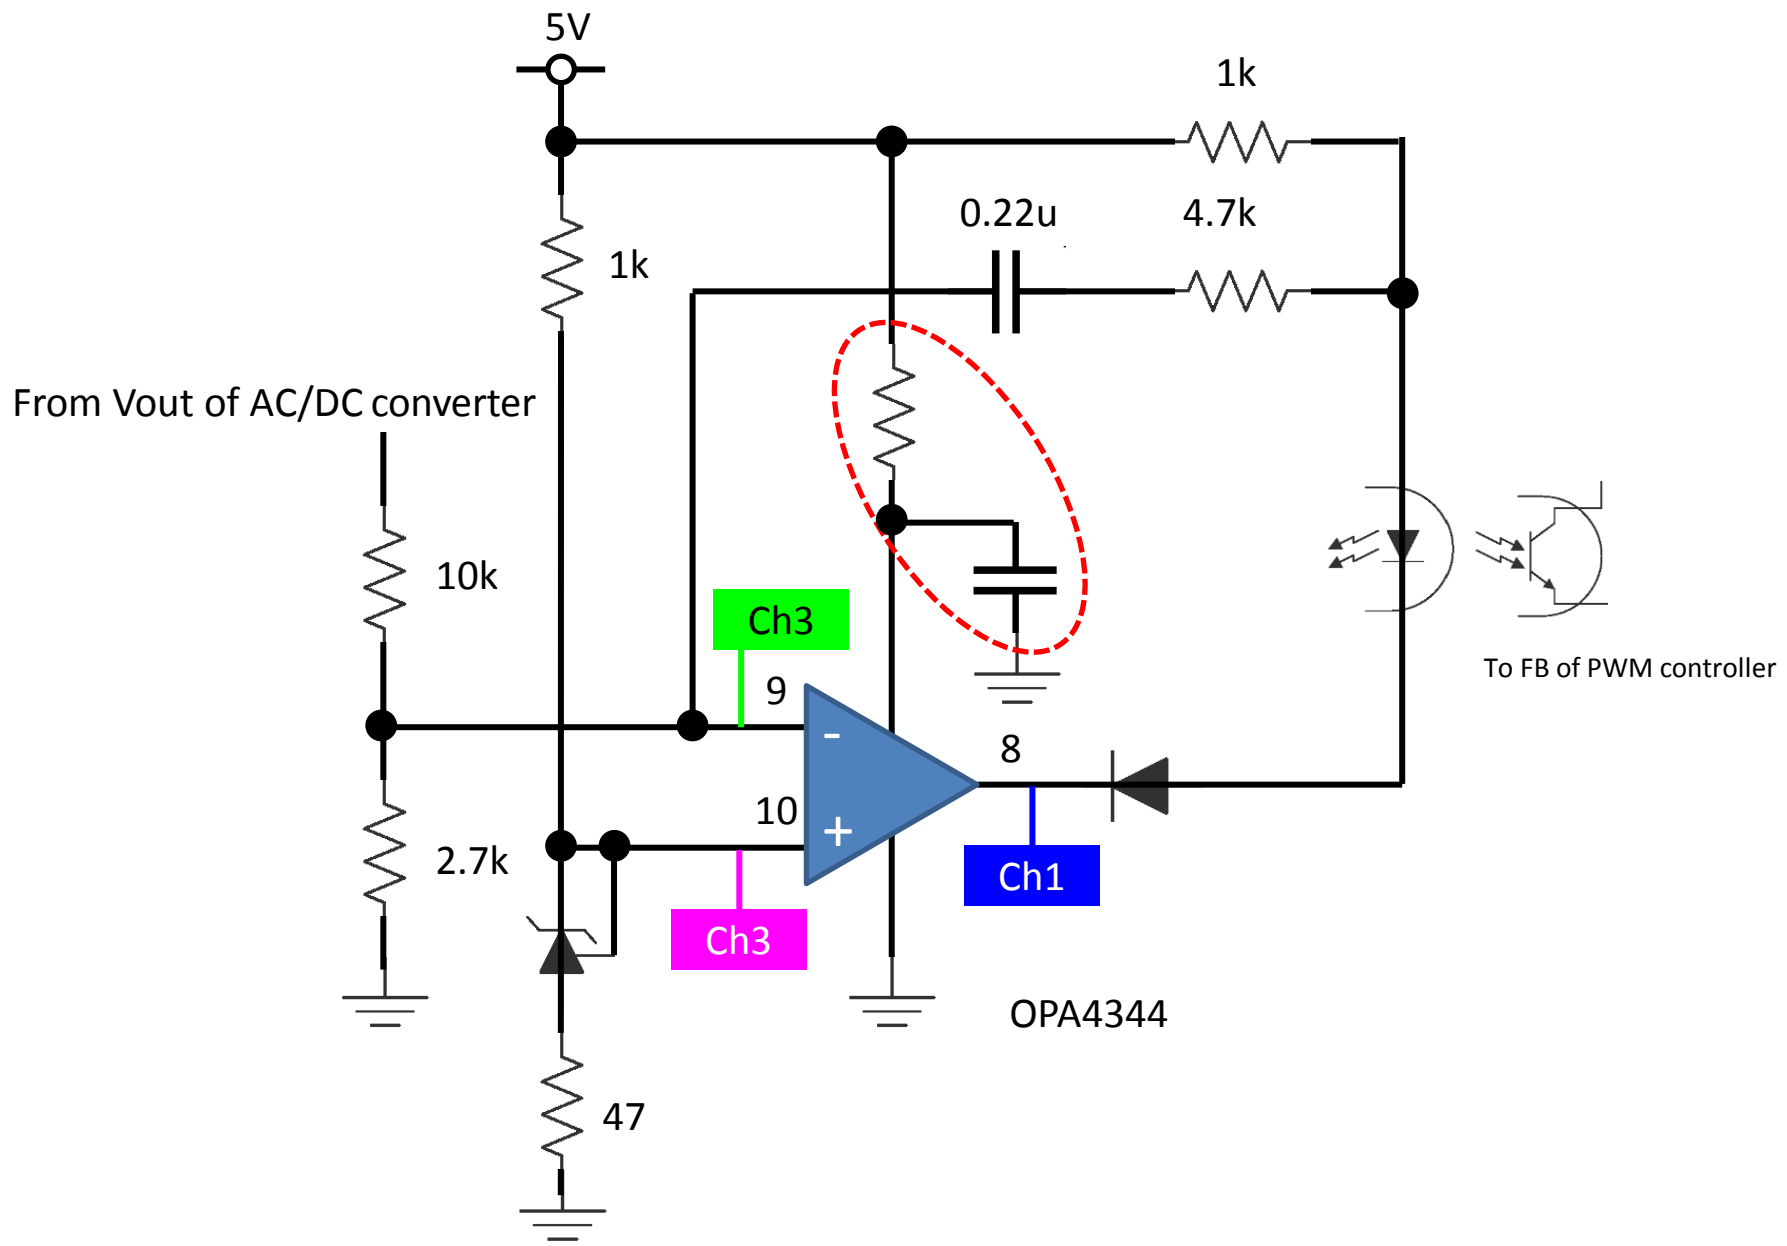
Ch1 : Output of OPA4344 (8pin)

Ch2 : Ignore this waveform

Ch4 : -IN of OPA4344 (9pin)

Ch3 : +IN of OPA4344 (10pin)

Feedback control is operated normally before this point.

But it's uncontrolled suddenly.

We have not found any trigger of this behavior.

This behavior is fixed by adding RC filter on VCC of OPA4344.
