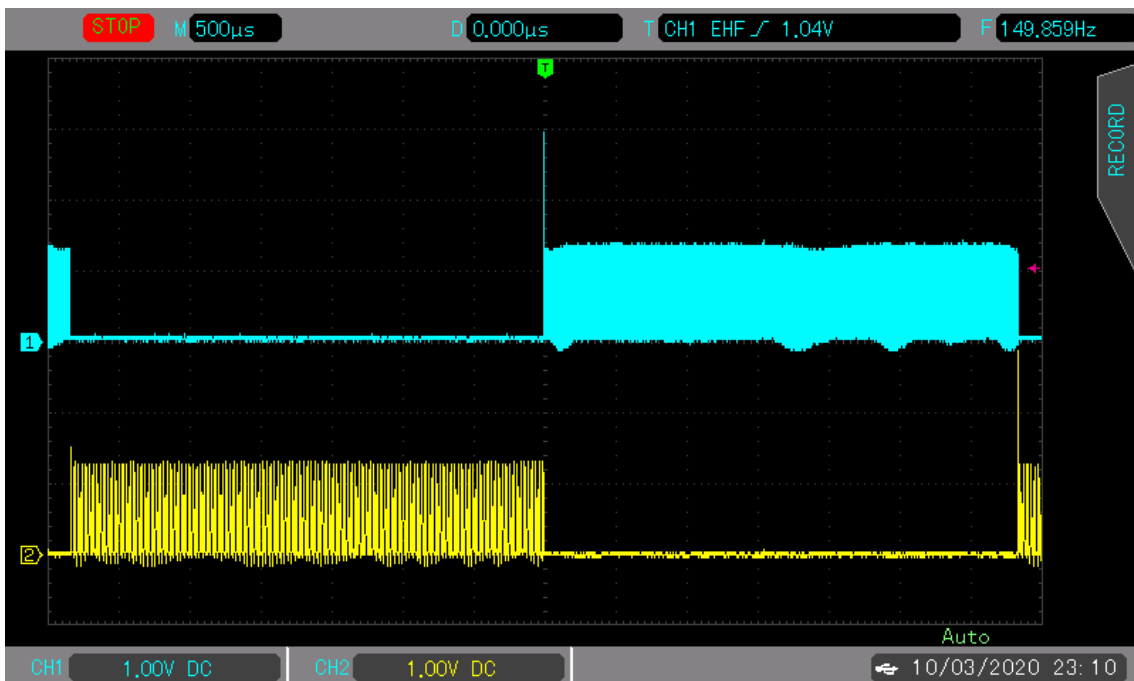
2) Sensor signals: Vpeak between 1.2V and 2V; frequency around 4MHz (250ns), Time sample 3.3mS:

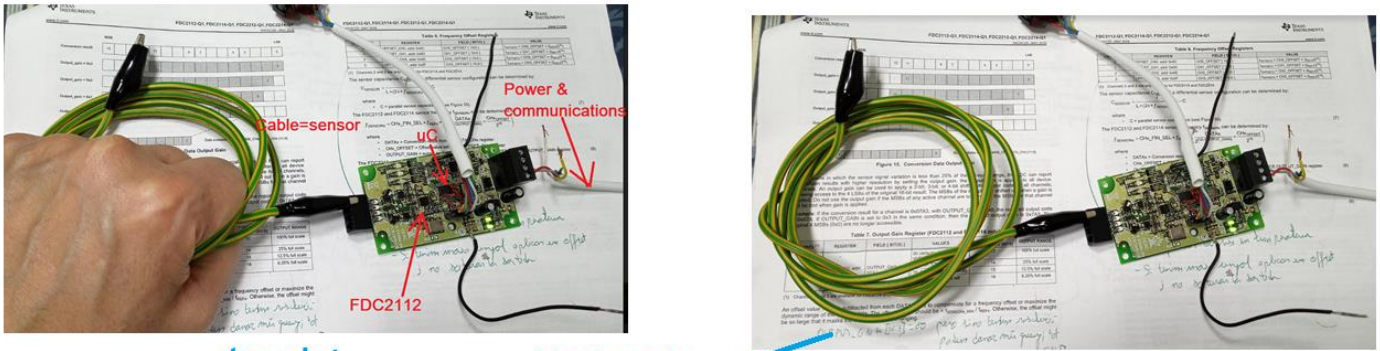
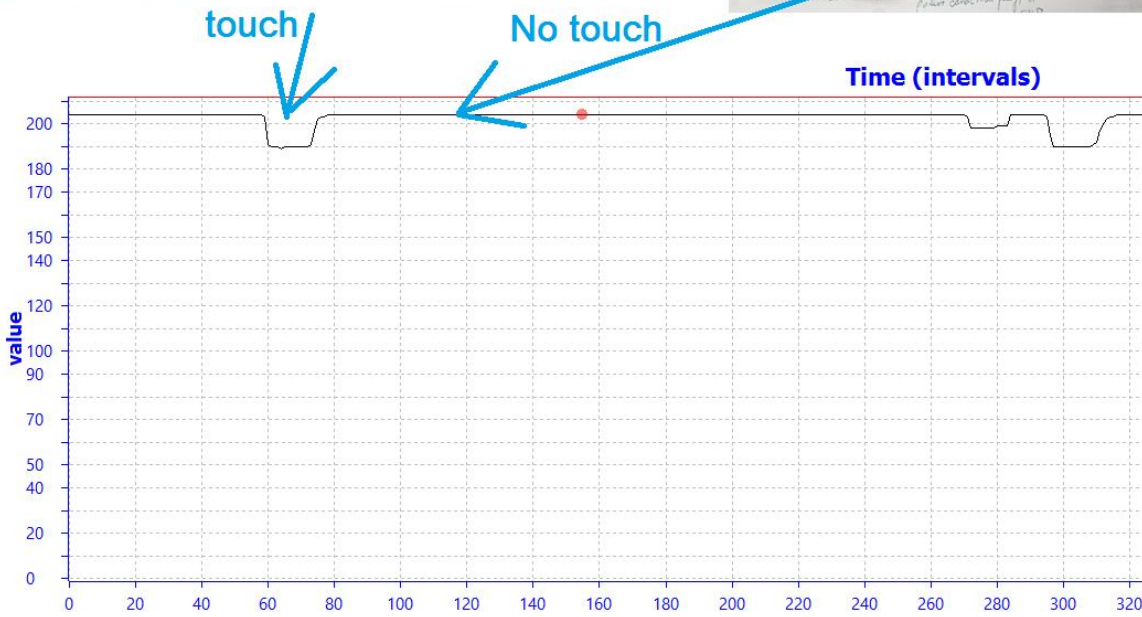
Regarding the software, I don't check the status registers. I just read the DATA_CH0 and DATA_CH1 **every 10ms**; and finally getting this results:

The black is one channel, and the red the other one.

From touch to not touch means, from 190 counts to 205. Just only 15 counts, which is a really poor signal.
