Trouble shootings for TI PSR controllers

Meeting troubles in the debugging process is very common for power supply designers. The troubles may include smoke when you first power the supply or it doesn't start up at all without any light or noise. The fundamentals of debugging should be to make sure the components are assembled right as the schematic and no wrong connections in the PCB[1]. In this paper, I will assume that you have checked the board and have repaired the failure components. We will focus on the design issues in the remainder of the application note. This application note can be used for TI's primary-side regulated (PSR) controllers and switchers such as UCC2870X, UCC2871X, UCC2872X, and UCC2891X.

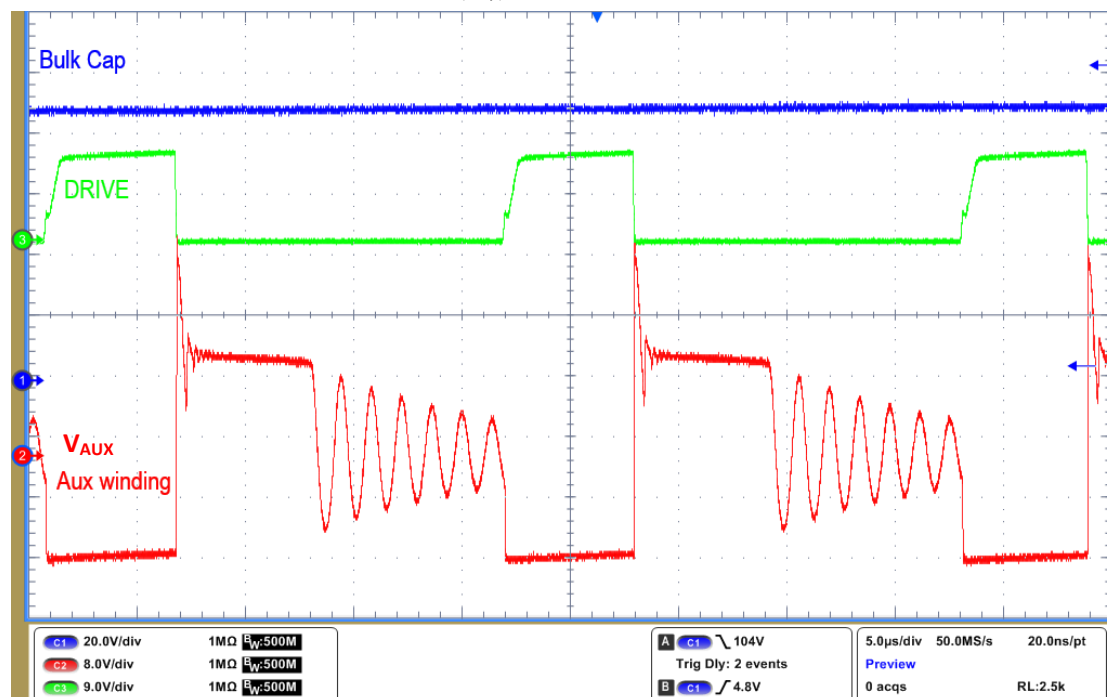
Figure 3. The waveforms needed to distinguish Input UVLO issue

However if you believe your calculation is right, but there is shutdown or startup issue, capturing the last three cycles of V_{BLK} , V_{AUX} and DRV like in Figure 3 is suggested. You can distinguish the root cause by checking below items.

- Is the voltage of V_{BLK} too low? - Too small bulk cap value would make the ripple on VBLK too much, especially at low-line input and full load. A rough suggestion for Bulk cap selection is about $2\mu\text{F}/\text{W}$. For 10W design, 22 μF cap(22 μF is standard value) is suggested.

- Is the V_{AUX} waveform flat and V_{AUX} approach to $V_{BLK} * N_a/N_p$ during MOSFET on-time? - If not, there is something wrong; you need to check the transformer turn ratio and the voltage on primary windings during Q1 on-time. A common issue is [improper BJT selection](#).

- Is the current from VS pin at startup (for the issues where there are only three cycles of pulses) V_{AUX}/R_{S1} larger than $I_{VSL(run)}$. Make sure the current is larger than $I_{VSL(run)}$, or else go back check the related parameters.

- Is the current from VS pin at last switching cycle (for the issues where there are many cycles) V_{AUX}/R_{S1} lower than $I_{VSL(stop)}$. - If yes, it will cause the converter to shut down.

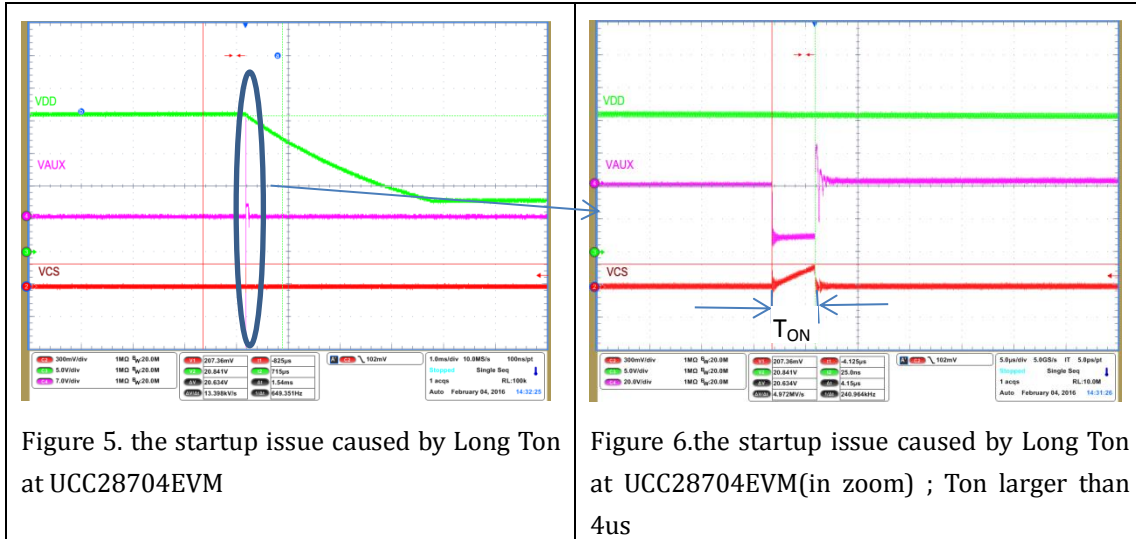
Phenomenon: TI PSR controller and switchers checked the on-time of MOSFET by detecting the voltage on CS pin on the very first cycle after VDD UVLO on. If the voltage on CS pin doesn't reach $I_{PP(min)}$ in desired time, IC will confirm the fault and discharge VDD to $V_{VDD(off)}$ where $I_{PP(min)} = V_{CST(min)}/R_{CS}$. For UCC28704 and UCC28730, this desired time is typical 4μs. For UCC28700/1/2/3, UCC28710/1/2/3, UCC28720/2, UCC28740 the desired time for T_{on} fault is 1/

$F_{SW(max)}$. As for the first cycle, $T_{on} = \frac{L_{PRI} \cdot I_{PRI}}{V_{blk}}$, too high inductance or very low input voltage can cause this startup issue. Figure 5 and Figure 6 showed the Ton fault of UCC28704 circuit.

Potential Solutions: To verify the issue, increasing input voltage, decreasing L_{PRI} or increasing R_{CS} can be used. However circuit designer should check the power system design completely to find out why the Ton time is so large.

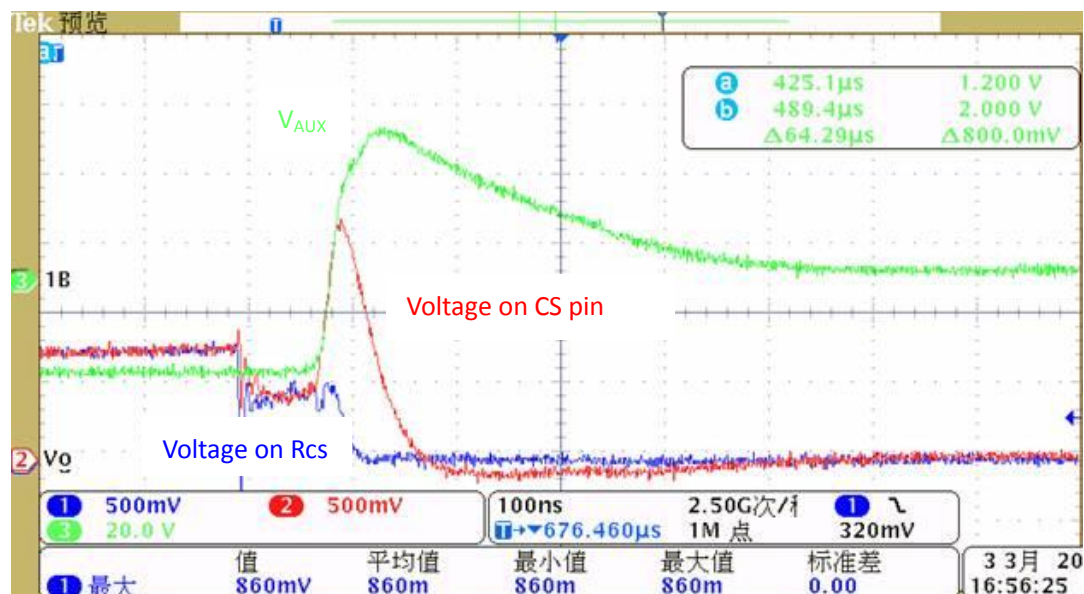
Figure 7. OCP caused by the noise

Phenomenon: The typical noise caused by the suddenly raised dv/dt of V_{ds} is like Figure 7. The voltage peak on CS pin after MOSFET turn off exceeded the over current threshold V_{OCP} , for UCC28710 its typical value is 1.5V. The noise can be serious if there is bad layout and too high R_{LC} .

Potential Solutions: Improve the layout of CS circuit and MOSFET to decrease the noise is suggested.

The situation would be better with smaller R_{LC} . However change R_{LC} resistor will also impact the constant current regulation. Make sure R_{LC} is close to the controller package.

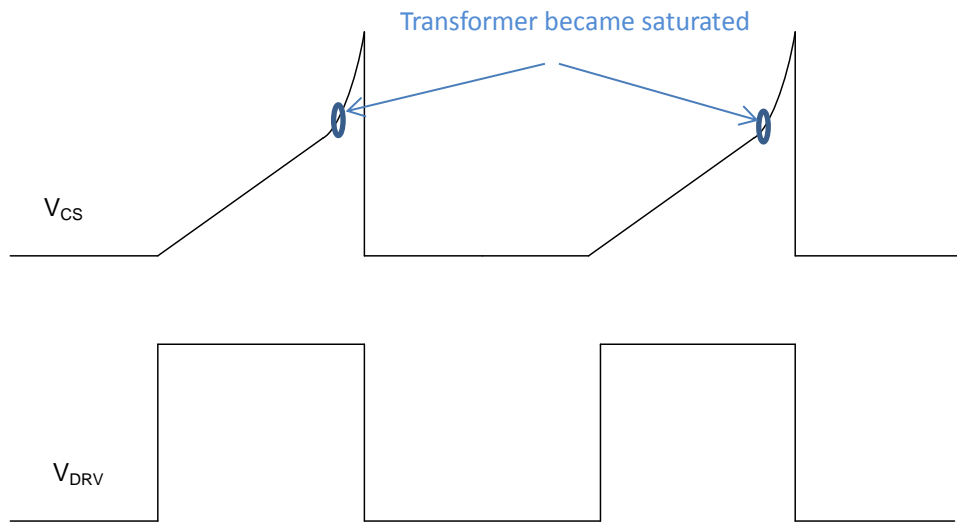
Figure 8. OCP protection caused by transformer saturation

Phenomenon: The typical saturation for transformer is like Figure 8. The current through R_{CS} increases rapidly when the transformer became saturated.

Potential Solutions: Check the transformer design to make sure no saturation happens. The

equation to check B_{MAX} is that $B_{MAX} = \frac{L_{PRI} I_{PK}}{N_P \cdot A_e}$ where $I_{PK} = \frac{V_{CST(max)}}{R_{CS}}$ for UCC2870X, UCC2871X and

UCC2872X; $I_{PK} = \frac{V_{CCR}}{R_{IPK}}$ for UCC2891X; N_P is the primary winding turns of transformer; L_{PRI} is the
