## ***Build Robust System on KeyStone Devices***

### **ABSTRACT**

For a complex system, robustness is very important. The KeyStone devices provided lots hardware protection mechanisms to help user to implement a robust system, such as the memory protection, EDC/ECC and System trace. This application note discusses how to use these features to build a robust system on KeyStone device. Example codes are provided along with this application note.

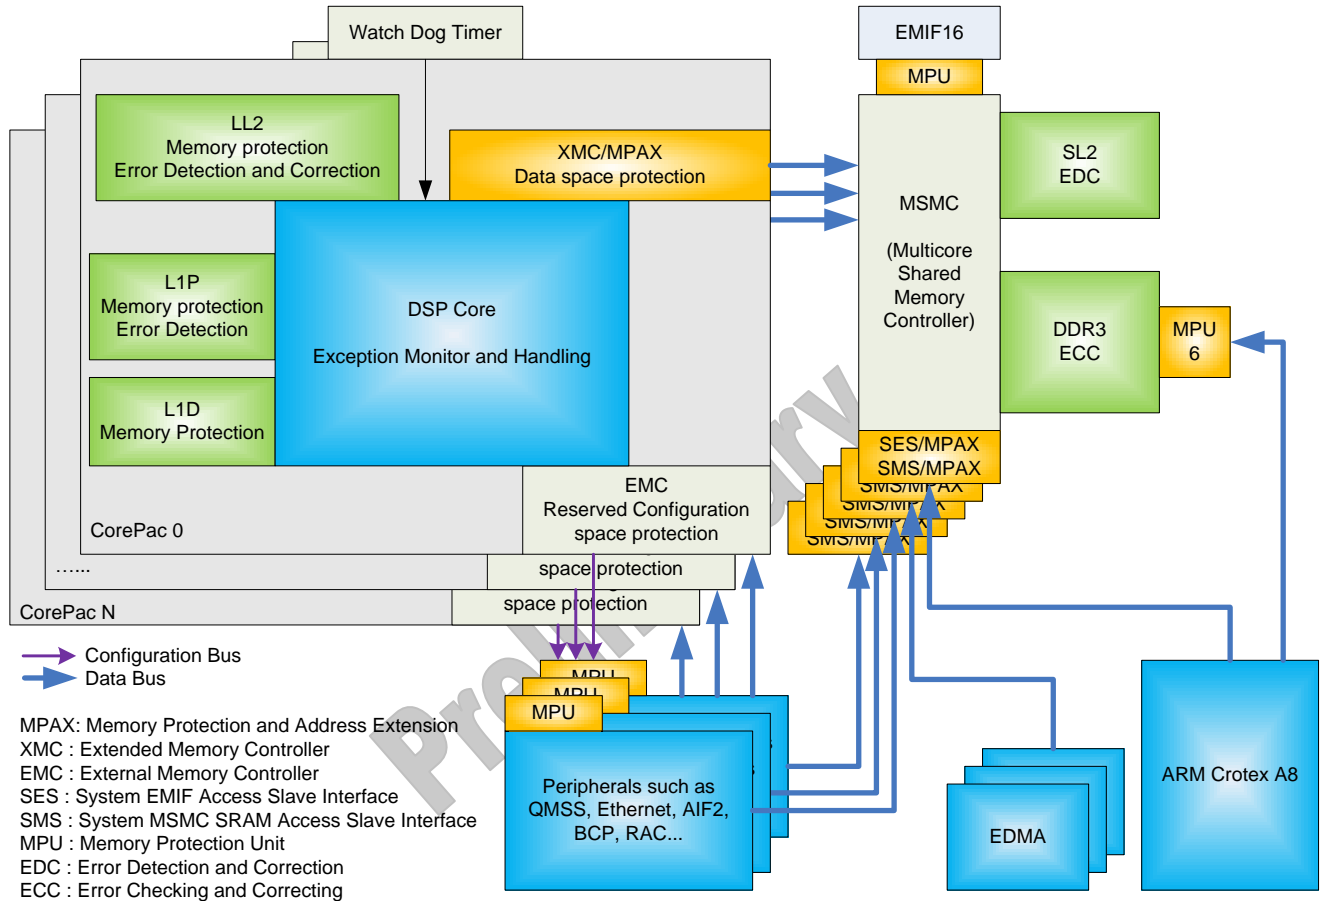
**Figure 1. Robust system on Keystone devices**

The KeyStone devices provide many features, which can support users to build robust application on it. Following figure shows those features.

Above figure shows, LL2, L1P and L1D integrate memory protection modules inside them; LL2, SL2 and DDR controller integrate error detection and correction modules inside them; L1P integrates error detection module inside it.

In above figure, MPAX and MPU are actually modules attached on bus, which monitor the bus to detect and prevent illegal transfer.

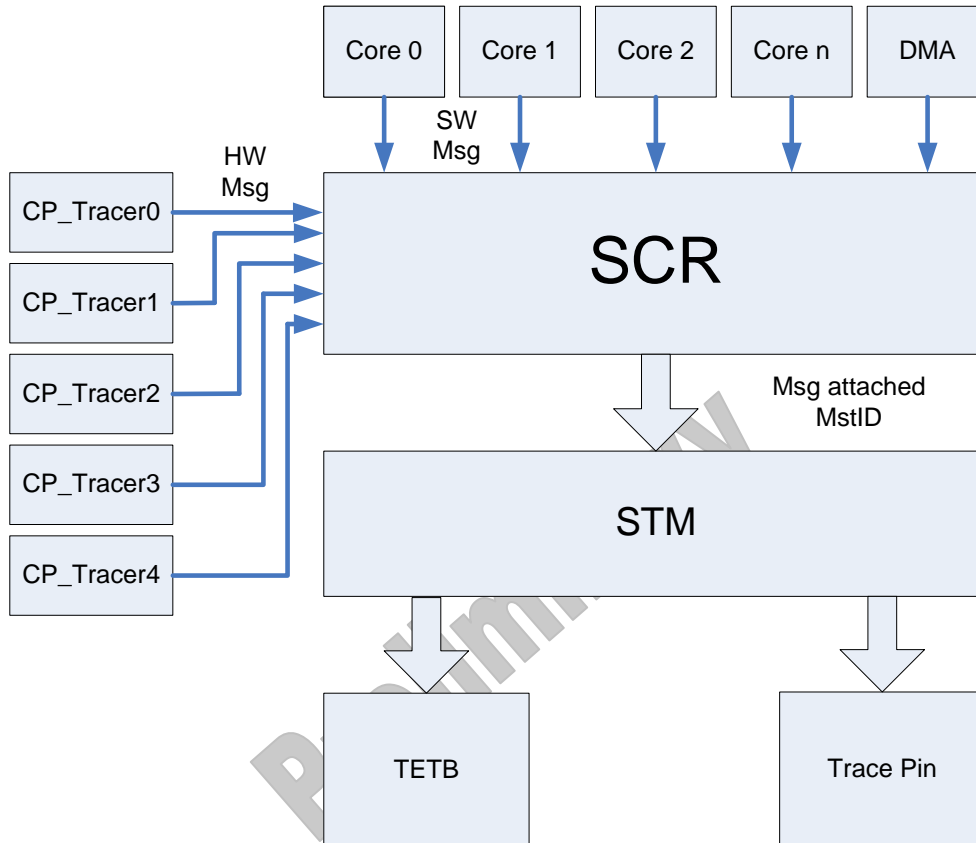
**Figure 3. STM architecture on Keystone Devices**

Following figure shows the System Trace Module architecture of KeyStone devices. The software message is generated by the DSP core or EDMA, in the application, the software or DMA write the STM messages to the dedicated memory address, which route the message to the STM module, when the software or the DMA read these memory address, it's always return 0.
